SELLER'S DISCLOSURE OF LATENT DEFECTS AND FIXTURES CHECKLIST

RESIDENTIAL INSPECTION

844 Heard Ave
Augusta, GA 30904

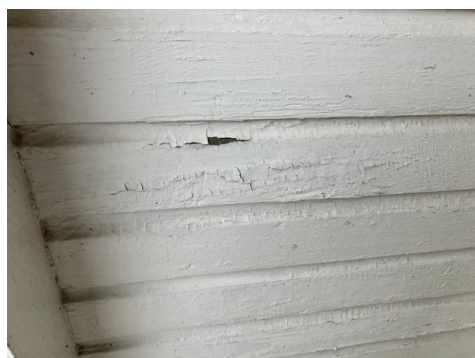
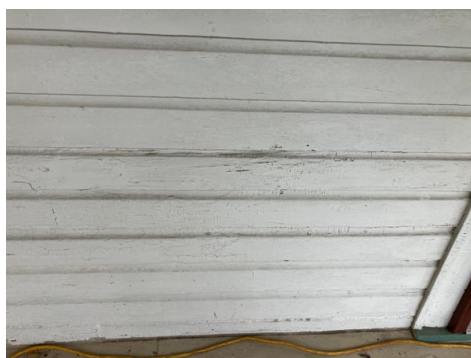
Siding Front porch

The wood siding at the front porch is in good condition but is beginning to have peeling paint. Keep siding scraped and painted to maintain in good condition.

Contact a qualified professional.

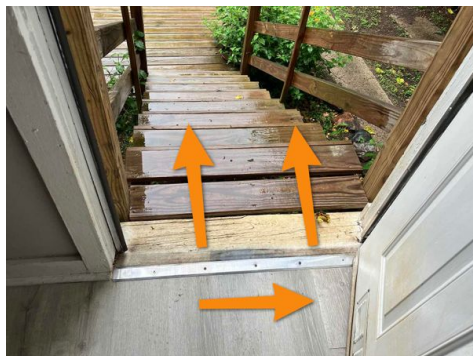
- The front entry door deadbolt will not engage properly. Have adjusted as needed for ease of operation.
- The rear exit door to the steps binds slightly on the floor. Have repaired as needed.
- It is noted that the rear exit steps from the laundry room do not have a landing installed. Recommend having steps improved with landing for safety if future improvements are made.

Door binds on floor/no landing for steps at exit.

Contact a qualified professional.

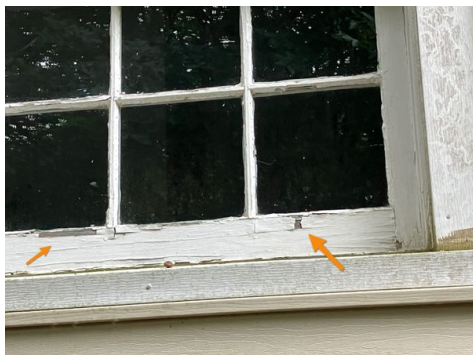
The exterior window trim is in good condition but there is peeling paint noted on multiple areas that need to be scraped and painted to maintain in good condition. Any remaining single pane windows will need to have glazing compound kept intact. See example pictures.

Window trim/cracked glazing compound

Contact a qualified professional.

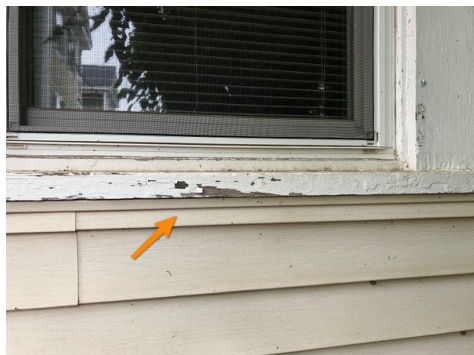
Peeling Paint Exterior wood trim

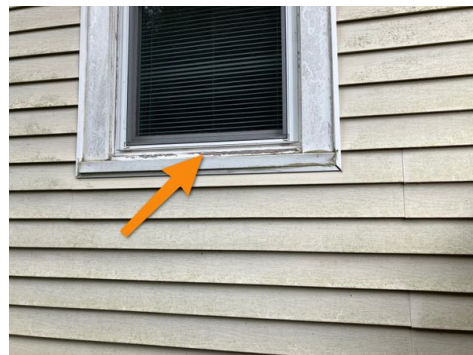
Peeling paint on exterior wood trim

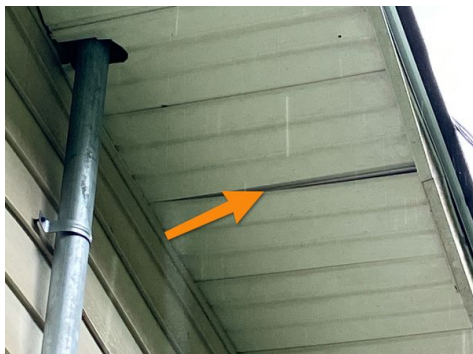
Left Side

There are some gaps noted in multiple areas of the vinyl soffits at the left side exterior and rear right side corner, etc. Have any gaps in vinyl soffits eliminated and seal to reduce pest entry points.

Contact a qualified professional.

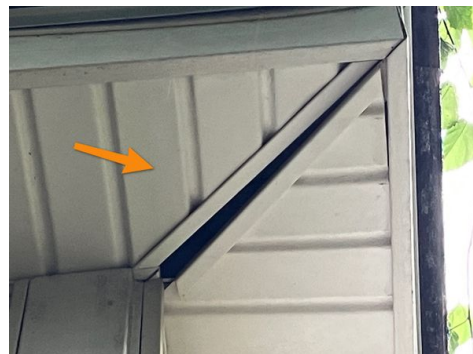
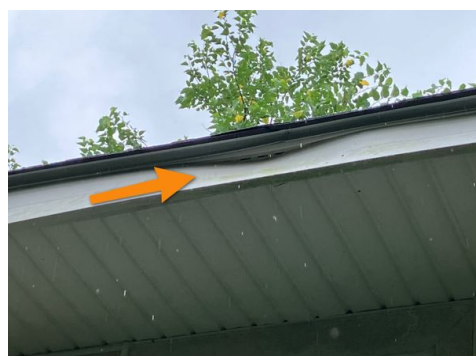
-The aluminum cladding on the left side fascia board is noted to be warped/gapped at the left side roof edge.

Aluminum cladding on fascia left side

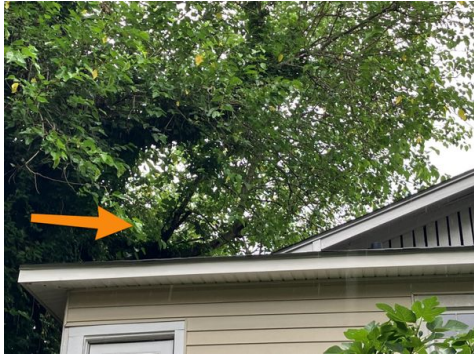
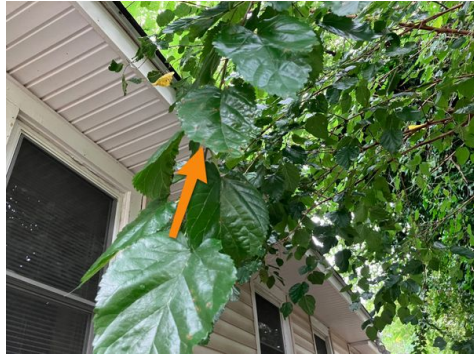
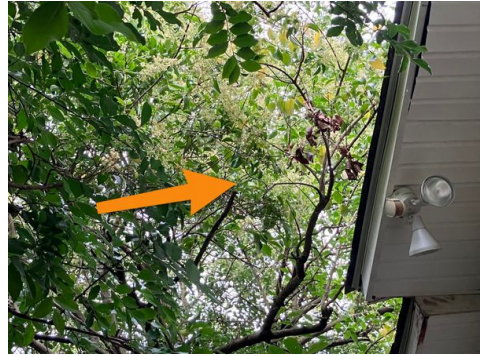
Have all tree limbs trimmed 6-10 feet from the roof to prevent damage or reduce pest activity.

Contact a qualified professional.

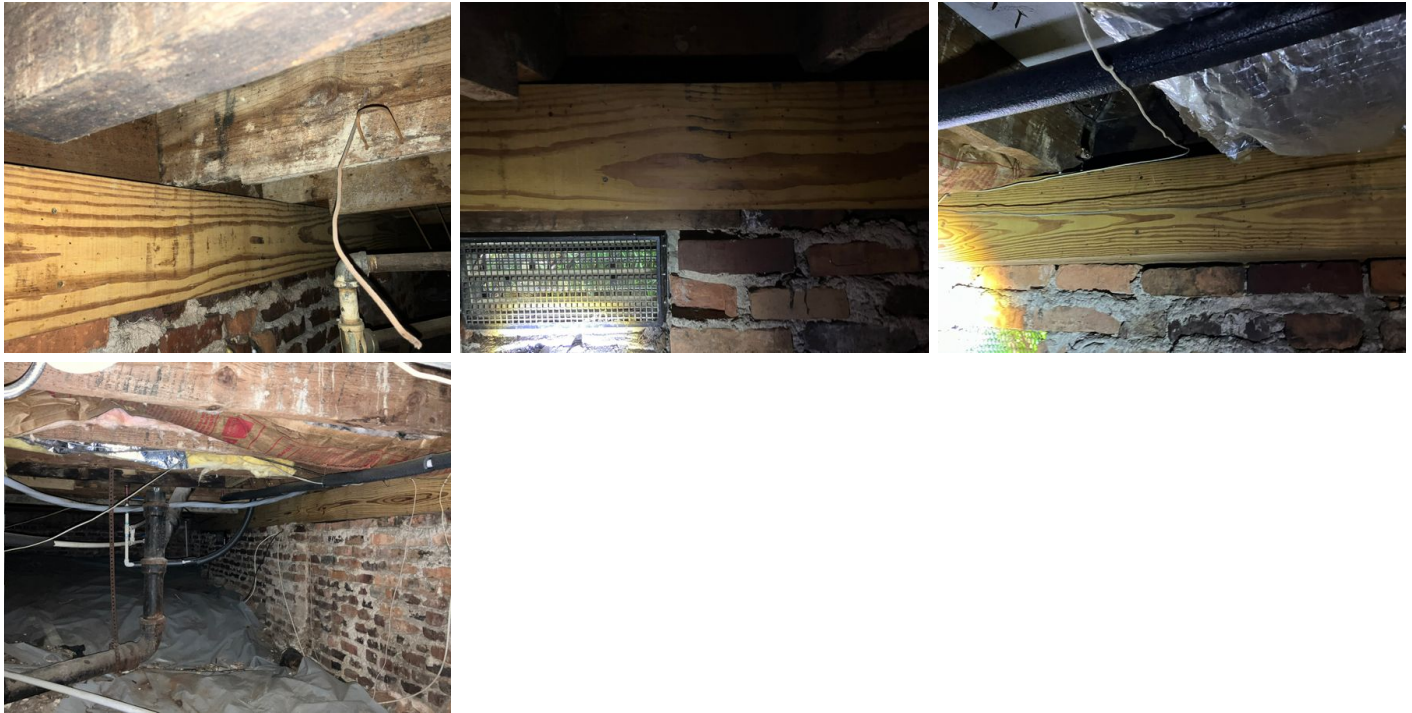
FLOOR JOISTS/SILLS: Prior Repairs - Adequate

There are prior repairs noted in crawl space, including replaced rim joists, sistered/replaced floor joists, etc. All repairs look to be adequate, seller should disclose any information regarding prior damage and repairs.

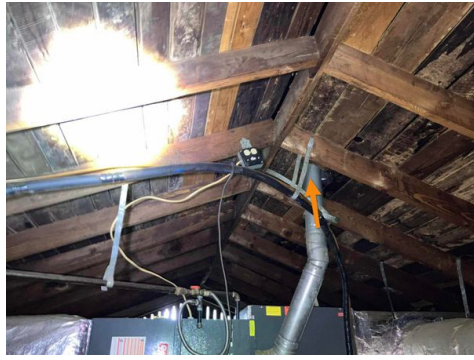
There is uplift noted on the flange for the gas furnace flue at the roof penetration. Have re-sealed and secured to reduce chance of leaks.

Contact a qualified professional.

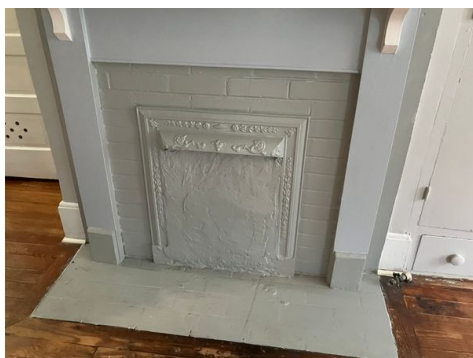
Bedroom

The original fireplaces are coal burning fireplaces. They are considered decorative and cannot be used for solid fuel burning.

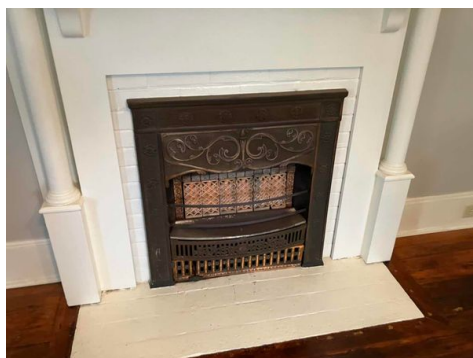
Living Room

The vintage gas heater in the living room firebox is not considered safe to use and does not have a shut off valve at the gas line to the unit.

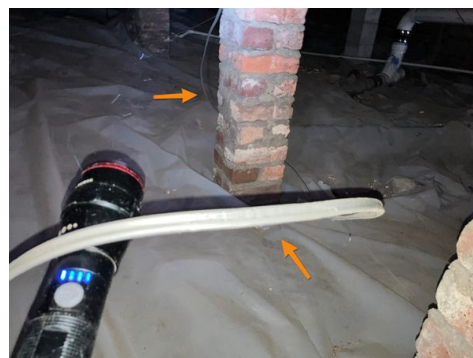
UNSUPPORTED CIRCUIT WIRE CRAW SPACE

Contact a qualified professional.

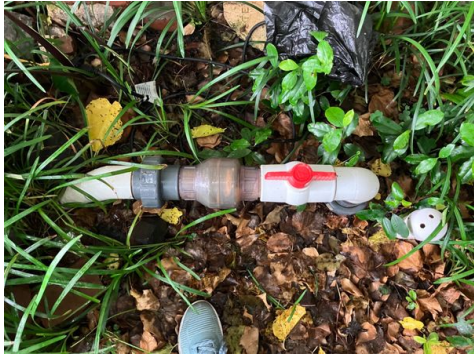
There is a lift station/sewage eject pump installed at the right side exterior foundation wall. This is behind powered with an extension cord around to the electrical receptacle on the front porch. Have a licensed electrician provide a designated GFCI electrical receptacle at the exterior with protective cover for the pump. The use of extension cords is not recommended for safety.

Sewage eject pump/lift station

Contact a qualified professional.

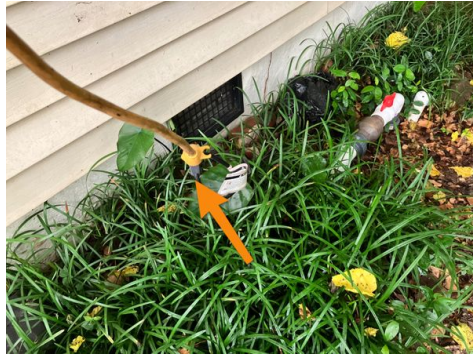
Powered with extension cord

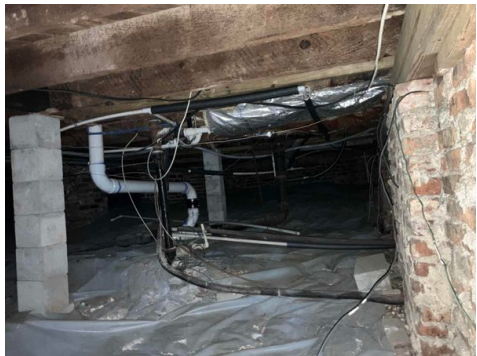
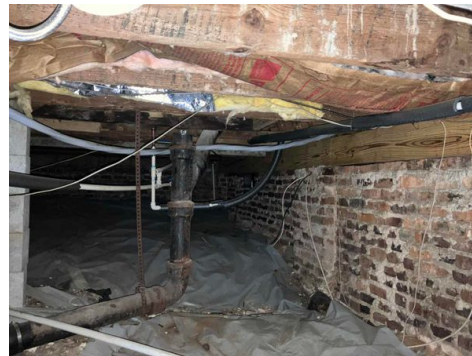
The water drain/vent lines in the home have been partially updated, and are a combination of cast iron and plastic pipe. The cast iron is beyond its average life expectancy. Anticipate that the remaining sections of cast iron drains will need to be replaced as issues arise. Seller should disclose any previous leaks and repairs.

Contact a qualified professional.

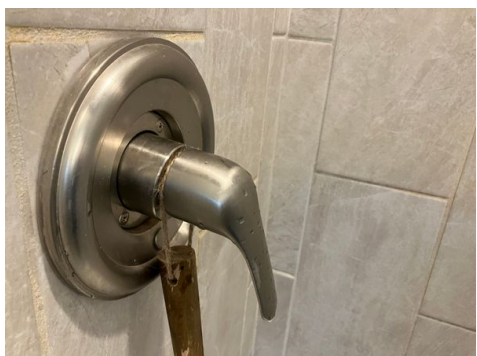
-The shower control and handle are loose/unsecured the right side bathroom shower. Have properly secured to reduce chance of leaks.

Right Side Bathroom Shower Control loose/unsecured

Contact a qualified professional.

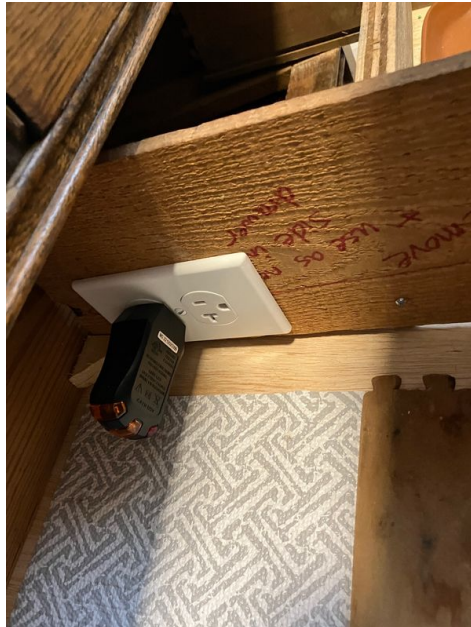
Master Bath sink base cabinet drawers-
receptacle not connected to Power

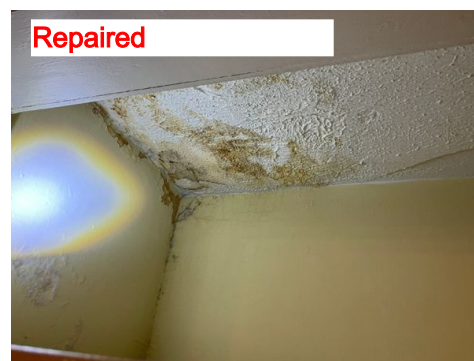
There are stains and patching repairs in the kitchen ceiling behind the refrigerator from prior leaks. Stains appear dry but should be evaluated to ensure no active leaks from roof/roof penetrations. Consult seller to define any prior repairs made.

Patching/Stain in ceiling behind refrigerator

Contact a qualified professional.
