# REPAIR REQUEST LIST

4909 Dreamweaver Ct 5  
07/11/2025 11:11 am

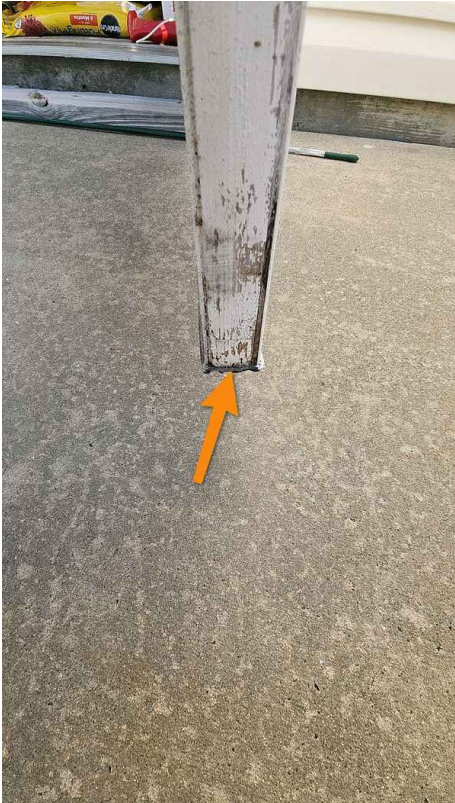
## 3.2.1 - Exterior: Exterior Doors DOOR CORE ROTTED

The wood core on the entry door has soft water damaged wood present at the lower corner(s) of the door. Evidence suggests the door needs to be repaired or replaced. Recommend a qualified contractor to evaluate the condition of the door, the extent of damage, and to make the necessary repair(s)/replacement.

Location  
Exterior Storage Room

Repair Requested. Replace door

Recommendation  
Contact a qualified general contractor.

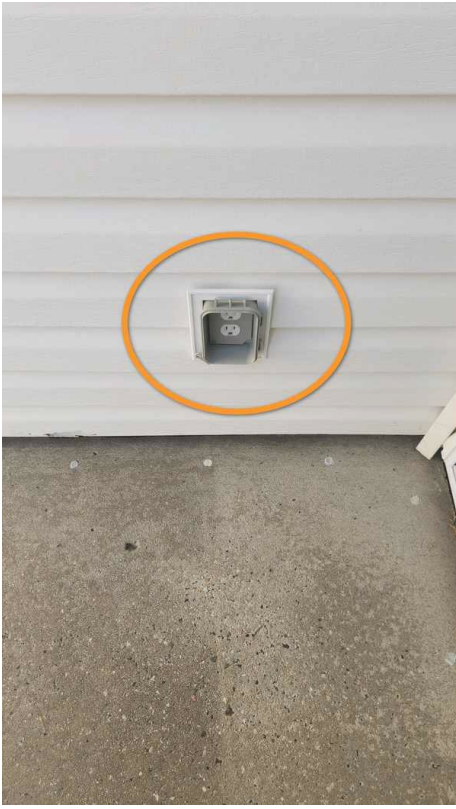
## 3.3.1 - Exterior: Lighting Fixtures & Receptacles WEATHERPROOF COVERS - BROKEN/MISSING

The inspector observed missing or broken exterior receptacle weatherproof covers. This condition creates a potential electrical hazard and indicates the need for repair or replacement. Recommend a licensed electrician to evaluate and make the necessary repairs.

Location  
Rear

Repair Requested. Repair

Recommendation  
Contact a qualified electrical contractor.

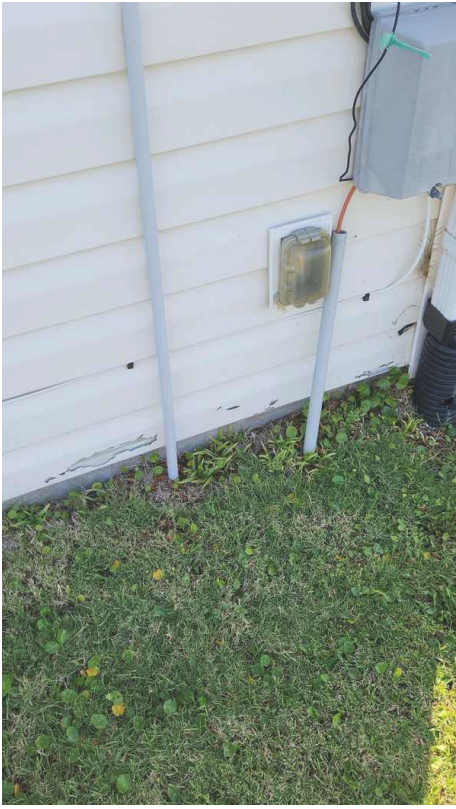
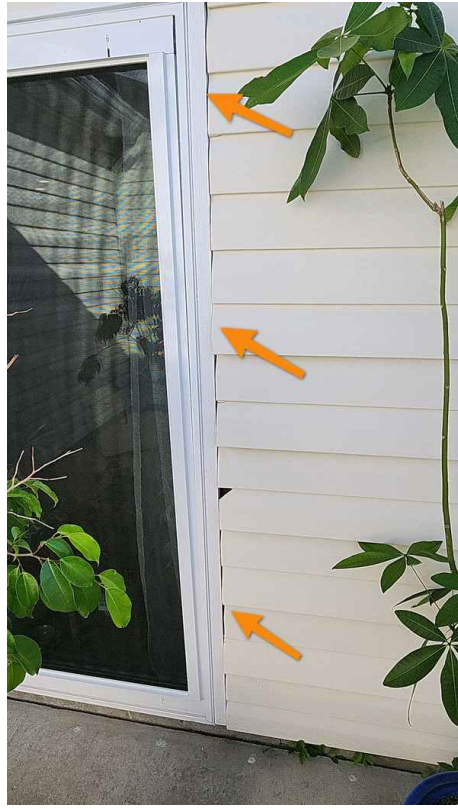
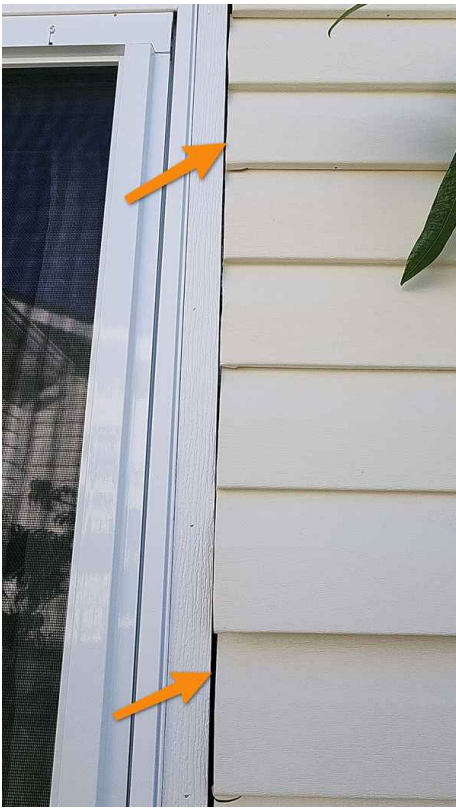
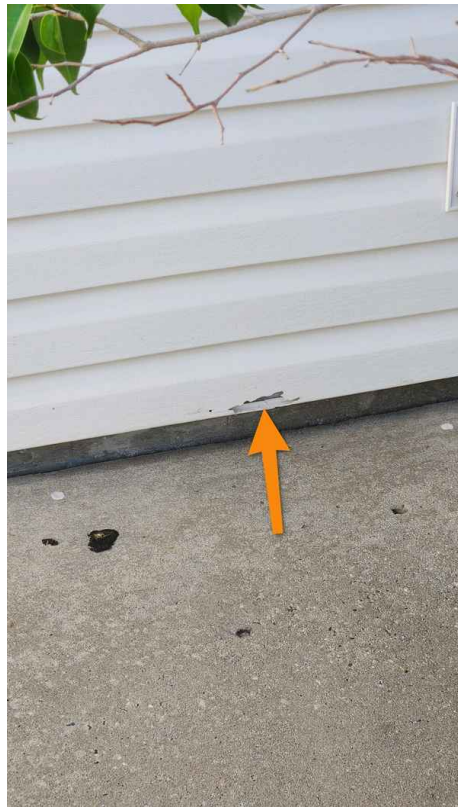
### VINYL SIDING - MULTIPLE CONCERNS

Observed cracked/damaged siding at more than one location. Also observed that there is damaged siding at the right side of the recently installed patio door. This area also needs to have a section of j-channel installed for proper function. Repair all areas as needed to prevent moisture intrusion and further damage to the siding.

Examples...

Repair Requested. Repair before closing.

Contact your local homeowners association

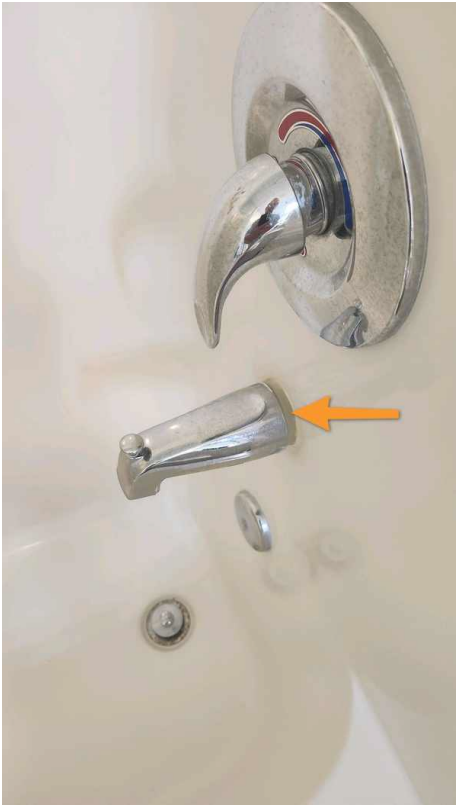
13.11.1 - Bathrooms: Shower / Tub  
**FAUCET - LOOSE FROM ENCLOSURE**

The bath tub faucet is loose from the enclosure. Evidence suggests this condition may cause the plumbing lines to leak. Recommend a licensed plumber evaluate and make the necessary repairs.

Location  
Spare Bathroom

Repair Requested. Repair.

Recommendation  
Contact a qualified plumbing contractor.

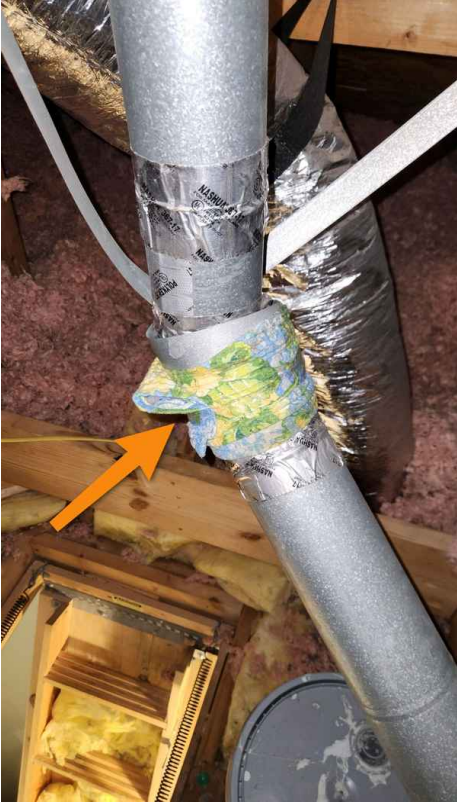
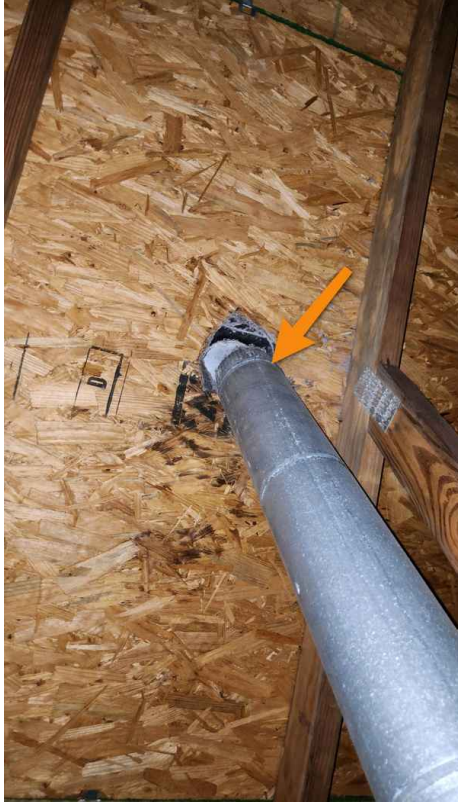
**DRYER EXHAUST - DETACHED VENTING INTO ATTIC**

The clothes dryer exhaust flue is loose/detached and venting into the attic area. The exhaust discharge pipe needs to discharge to the outside of the house in order to remove any moisture from the attic which can lead to wood damage / fungal growth. Recommend a qualified contractor to evaluate and to make the necessary corrections.

Attic

Repair Requested. Repair and clean up accumulated lint in the attic.

Contact a qualified professional.
