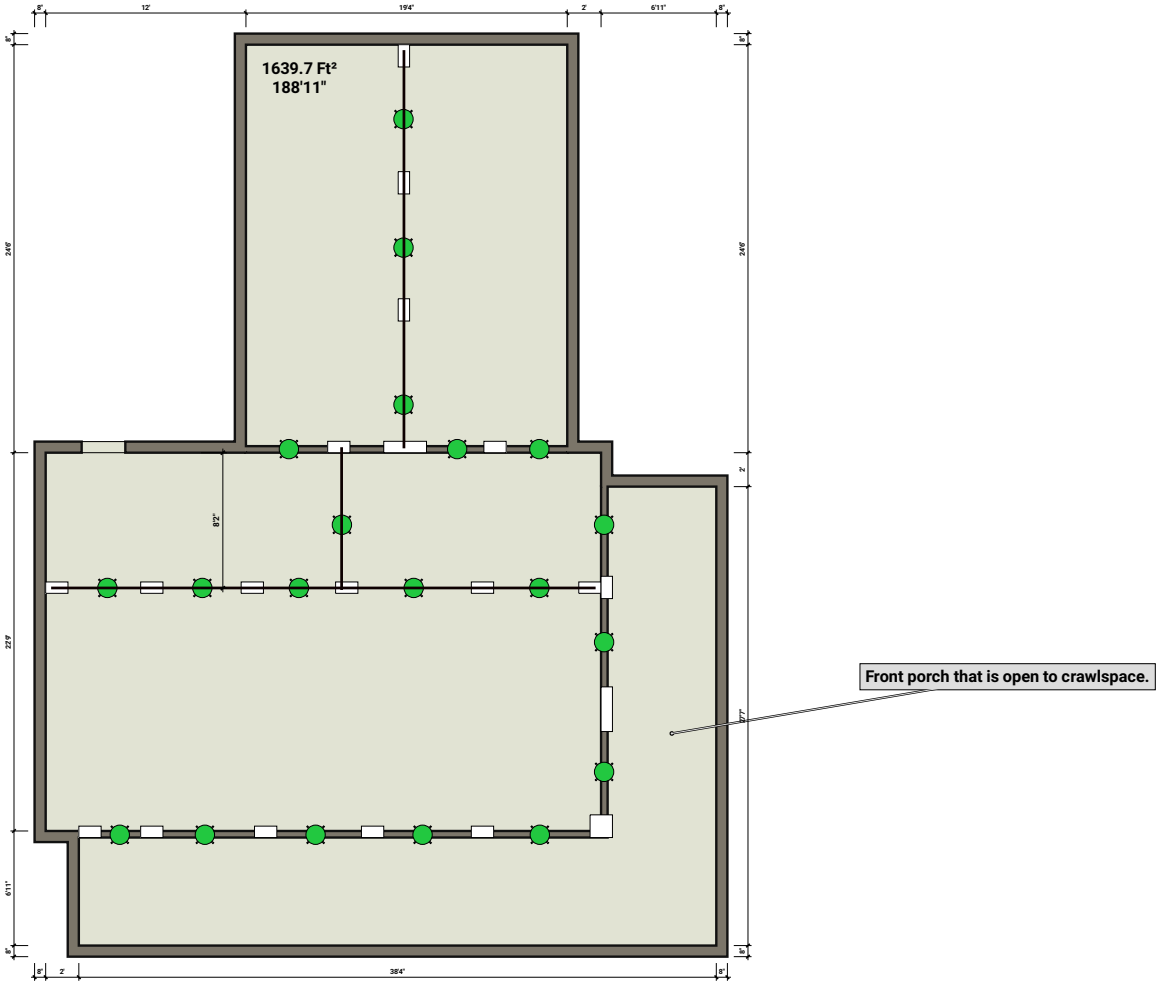
1639.7 Ft²
188'11"
Front porch that is open to crawlspace.
- Failing brick pier due to mortar degredation.
- PowerPost Jack to support load bearing members.
- Drop girder.
Front
