# ATLANTIC COAST SEPTIC SOLUTIONS

## SEPTIC REPORT

10 Alease Dr  
Zebulon, NC 27597

12/03/2025

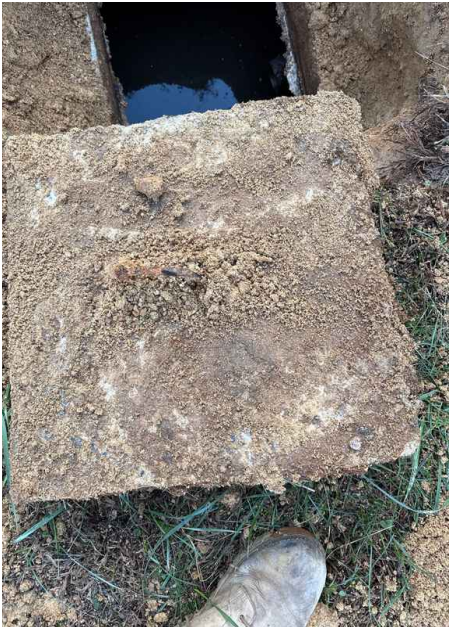
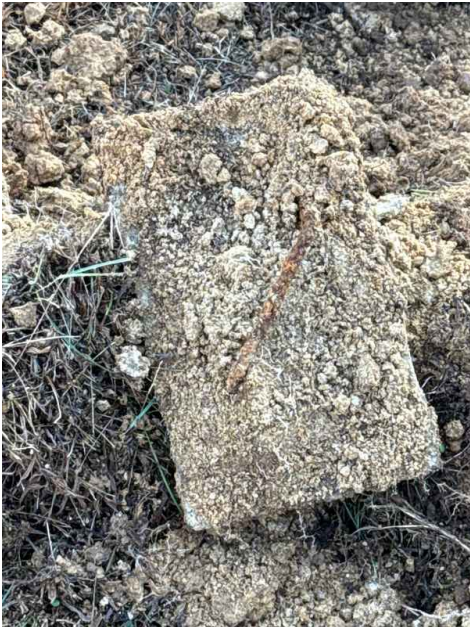
**Tank Assessment: Lids in good condition?**  
Yes
