## Norwood Plumbing - NC: Septic System Inspection

May 20, 2026

4107 Maynard Circle , Franklinton,  
NC

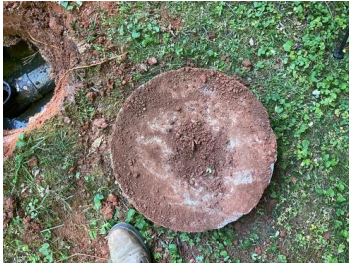
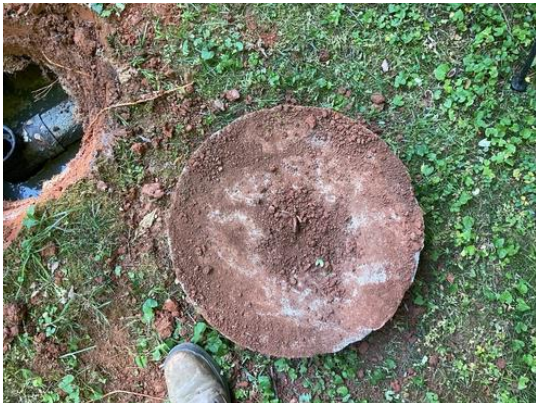
Photo 9

**Condition of septic tank baffle wall (visibility limited)**

Component was not visible or inspected

**Water level in septic tank at time of inspection**

Water level was normal (relative to the outlet)
