# SOUNDVIEW HOME INSPECTION LLC

## SOUNDVIEW HOME INSPECTION REPORT

104 Elm Ct  
Pine Knoll Shores, NC 28512

01/30/2026

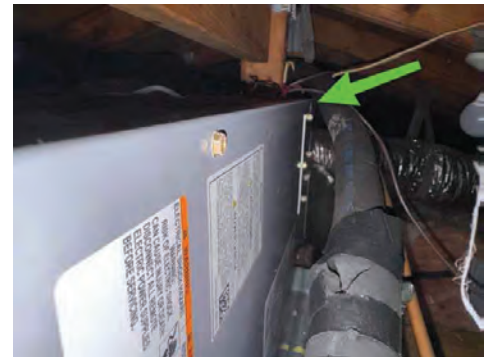
Attic Air Handler

#### **READILY OPENABLE ACCESS PANEL(S) COULD NOT BE REMOVED BY THE INSPECTOR**

Due to installation methods, the access panel could not be removed from the Attic Air Handler.

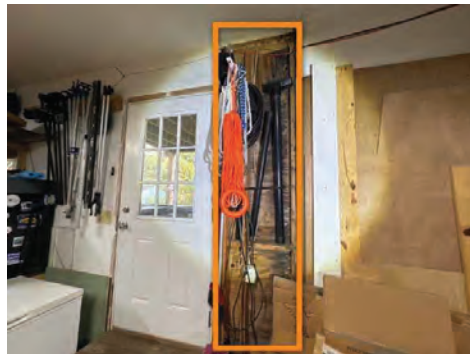
Garage

There was evidence of moisture intrusion. There may be additional concealed damage. Recommend evaluation and repairs.

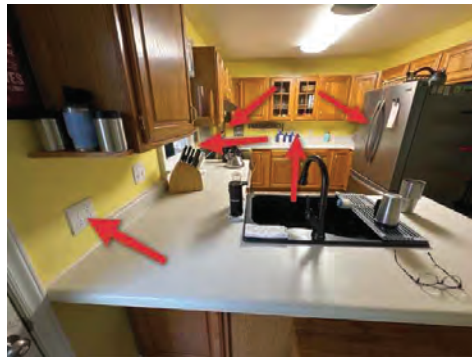
1st Floor Kitchen

There was no GFCI protection installed/functioning on the indicated receptacles. This is a safety hazard. Recommend installation.

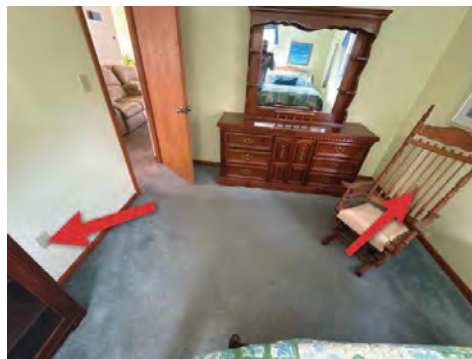
2nd Floor Rear Right Bedroom

A receptacle had an open ground. This is a safety issue and could result in electrical shock and/or fire. Recommend repairs

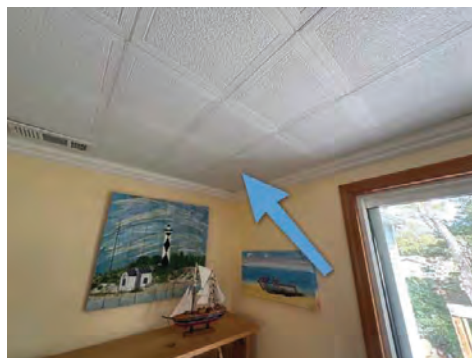
2nd Floor Living Room

There was an area of staining on the ceiling. This could result in damage to the area. Recommend repairs and monitoring.

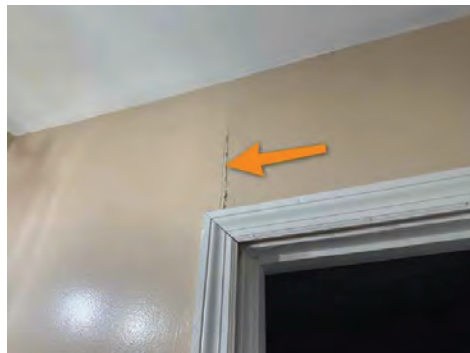
1st Floor Left Bathroom

There was a crack in the wall. This may be a symptom of structural movement or failure of a surrounding component. Recommend evaluation and repairs.

Note: These cracks were adjacent each other in separate rooms

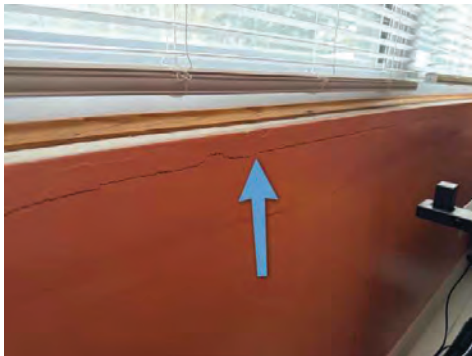
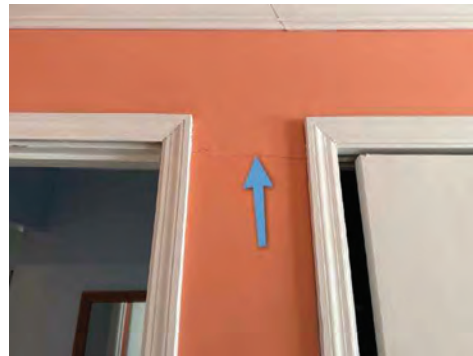
There is what appears to be a typical crack in the wall. This crack could worsen and cause further damage. Recommend repairing and monitoring.

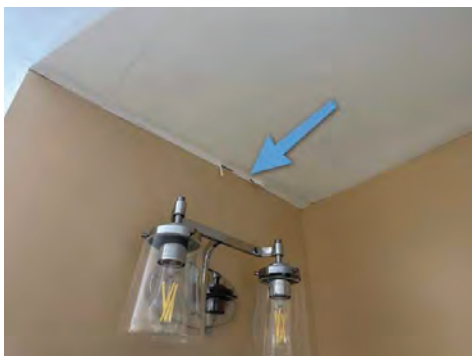
1st Floor Left Bathroom

An area of the wall was damaged. This could result in further damage and/or detachment of materials. Recommend repairs

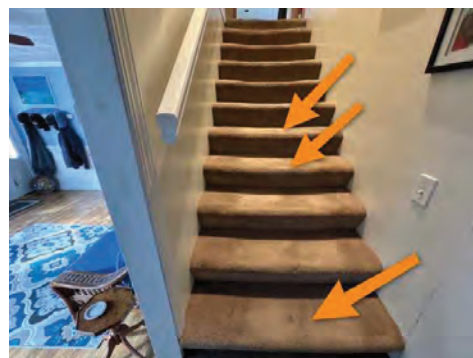
Stairs 1st to 2nd Floor

The treads on a set of stairs were loose/detaching. This could result in detachment of the treads and lead to falls. Recommend repairs.

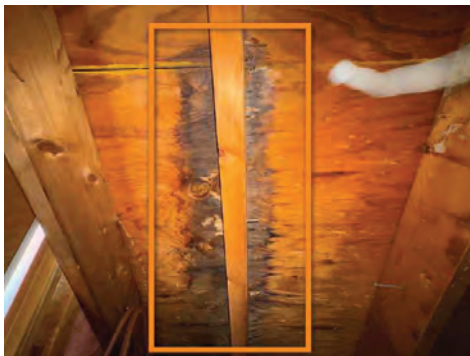
Front Right Eaves Storage

There was evidence of moisture intrusion. This may lead to further damage and deterioration of materials. Recommend repair.

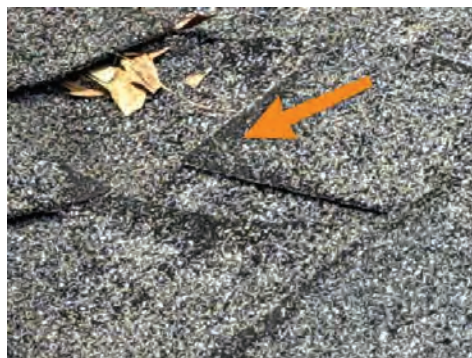
Front Right

The coverings for the roof were weathered. The fiberglass underlayment is showing through, major granule loss has occurred, and the coverings are brittle. Moisture intrusion may occur. Symptoms of moisture intrusion are already present. Recommend replacement.

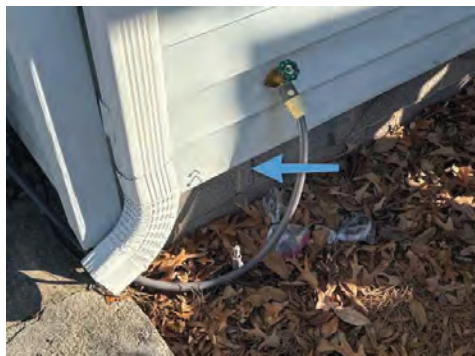
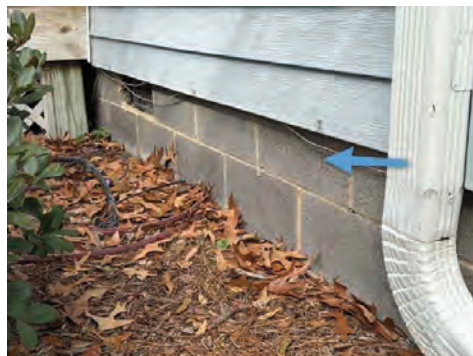
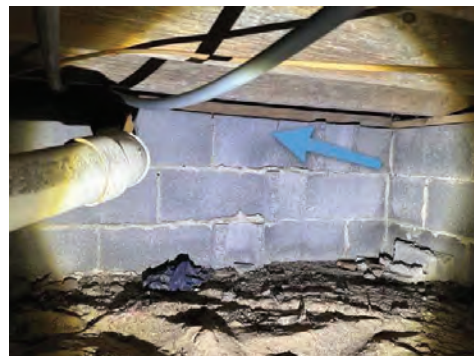
Minor cracking was noted at the foundation. This could lead to further damage. Recommend repairing and monitoring.

Recommendation  
Recommend monitoring.

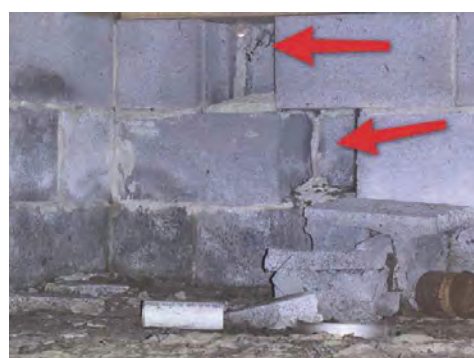
Rear Right Corner

Improper construction practices were present. This could lead to failure of one or more portions of the floor system. Recommend repairs.

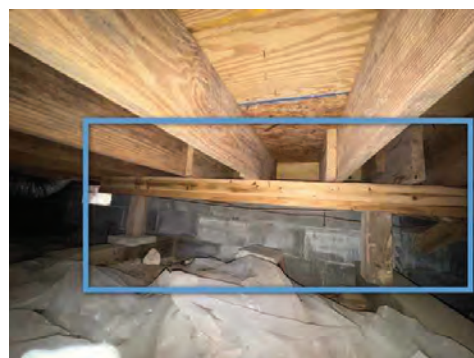
Front Right

There is an area of noticeable repair on the foundation. This could be concealing further damage. Recommend monitoring the area.

Recommend monitoring.

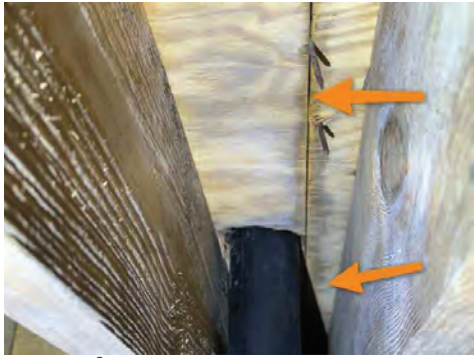
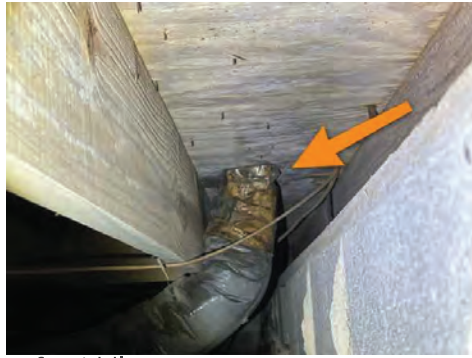
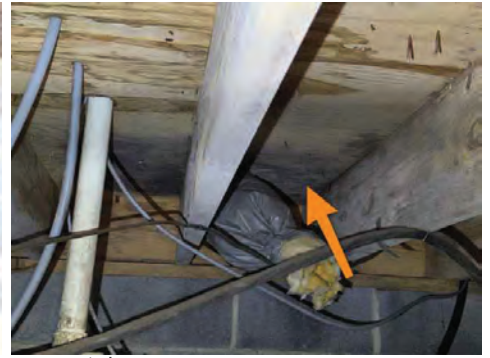
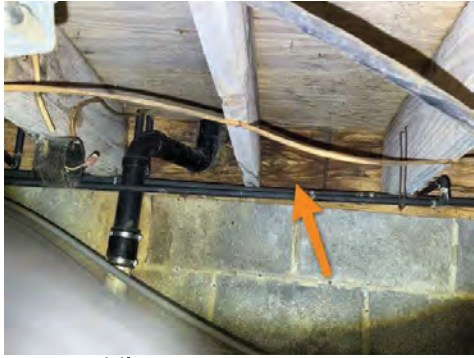
There is evidence of moisture intrusion. This could cause failure of the sub-floor. Recommend repairs

Contact a foundation contractor.

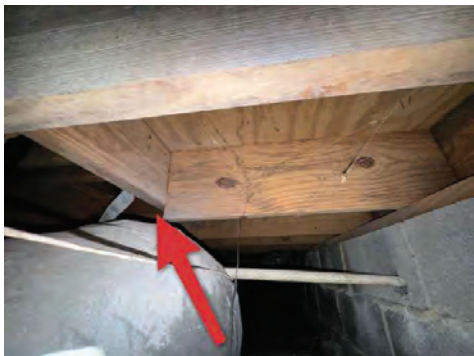
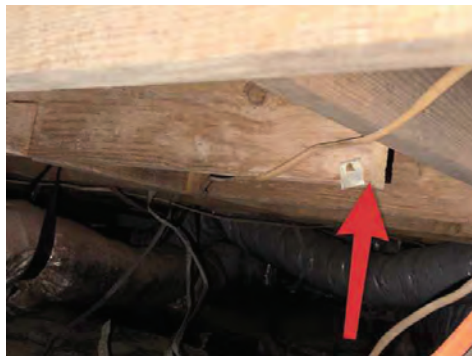
Improper construction practices were noted. A floor joist was cut. This could result in failed flooring in this area. Recommend evaluation and repairs

Contact a qualified general contractor.

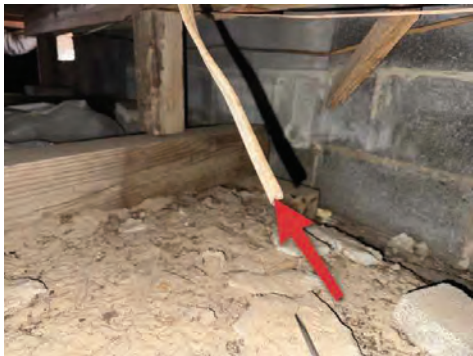
Front Right

There were exposed wires present. This is a safety hazard. Recommend repairs.

Contact a qualified licensed electrician

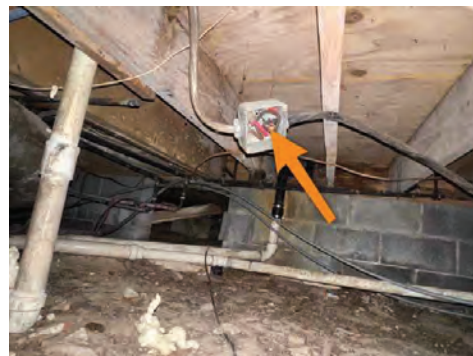
Rear Middle

Medium**COVER PLATE MISSING**

A junction box was missing a cover plate. This leaves the component unprotected. Recommend installation.

Contact a qualified licensed electrician
