3/2/2026

I was recently asked to examine the trees on a lot just south of 176 Flamingo Ln, Sneads Ferry, NC 28460 (between 176 and the small cemetery). On 2/27/2026 I visited the site and found the following nine trees:

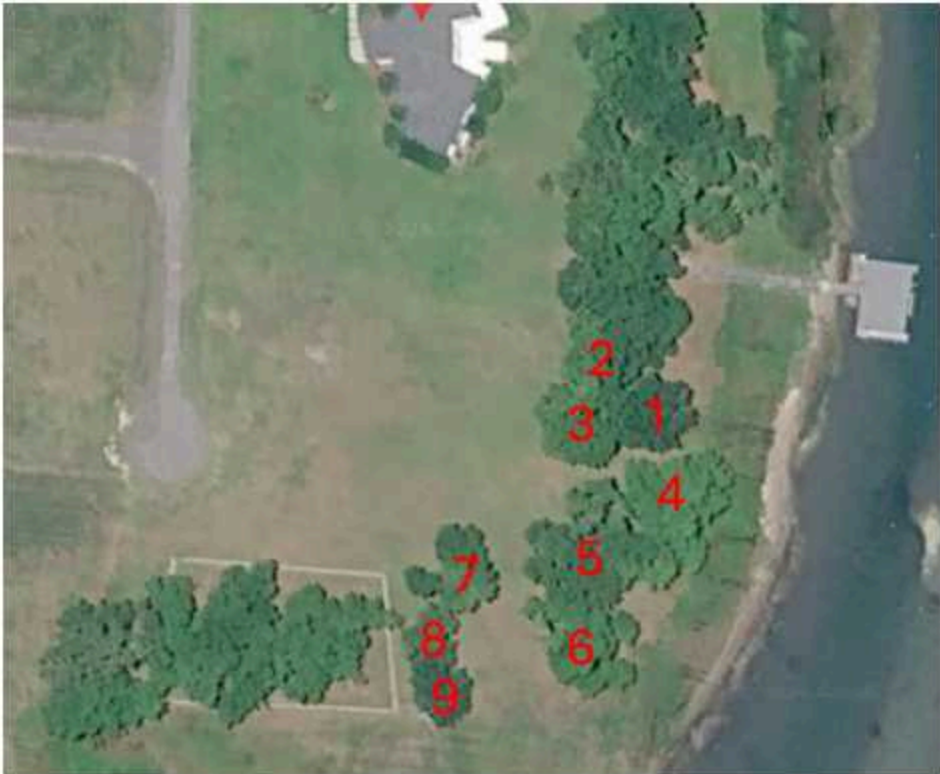
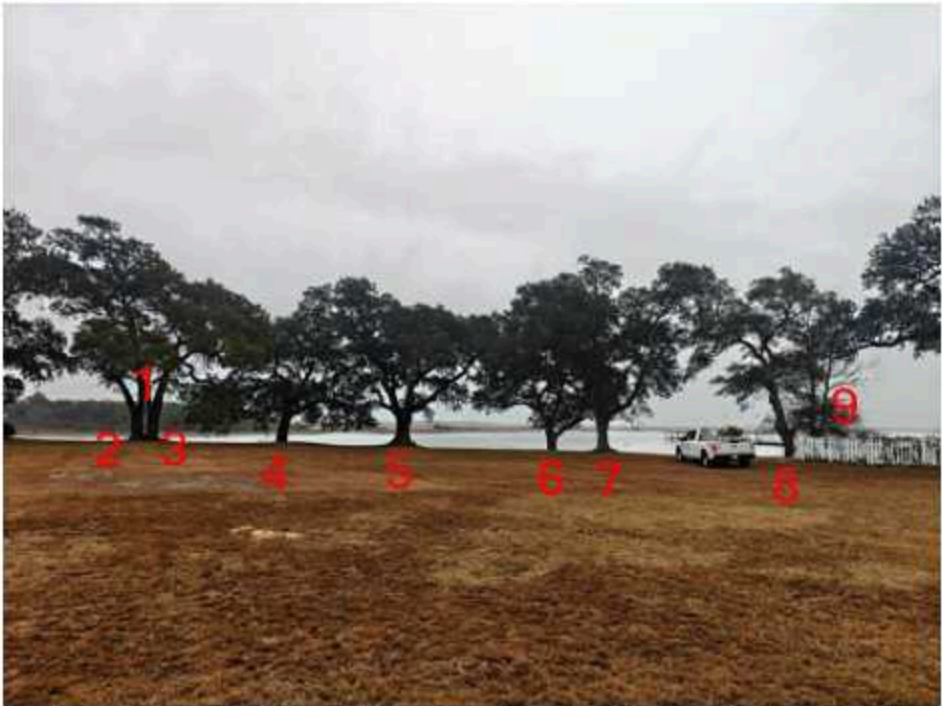
Overview: The seven live oaks are all large, mature trees in relatively good health and stable condition. The two hickories are not as healthy, but they are stable at this time, and #1 is providing wind-protection for #2 & #3.
