Property Inspection Report

Report Number: 2967

106 Dukes Lake Circle
Richlands, North Carolina 28574

Date of Inspection: Thursday, March 6, 2025

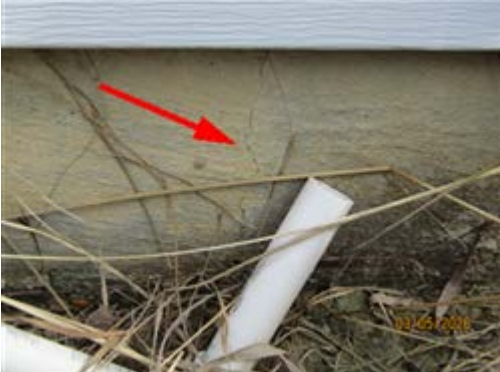
(A1 - 1.1) All Accessible Areas

Where visible, cracks were noted in the concrete slab foundation of the home. Cracks in the foundation can indicate a deficiency in the foundation, footing, or supporting soil that can change and worsen if it progresses over the life of the home. At this time these cracks pose no structural concern but need to be repaired/sealed. A masonry contractor should be consulted to determine the significance/cause of the cracks and outline any necessary repairs.

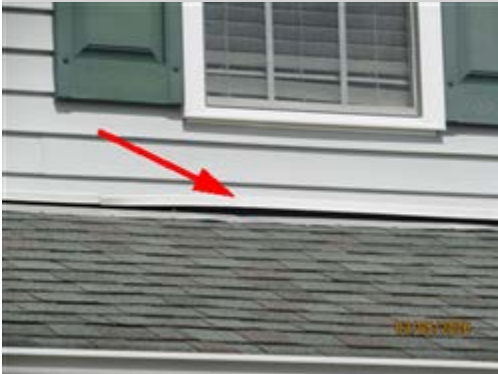
(B1 - 1.1) Main House: All Accessible Areas

On the front of the home, a loose and/or bowed section of siding and trim are in need of repair. A siding installation company or general contractor should be consulted to evaluate and repair the siding to ensure the integrity of the cladding system.

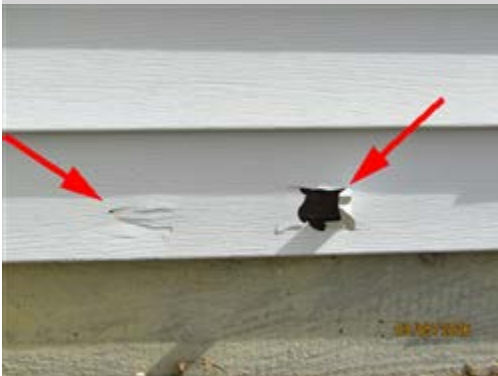
(B1 - 1.3) Main House: All Accessible Areas

On the left side of the home, several damaged or cracked pieces of siding are in need of repair or repair. A siding installation company or general contractor should be consulted to evaluate and repair the siding to ensure the integrity of the cladding system.

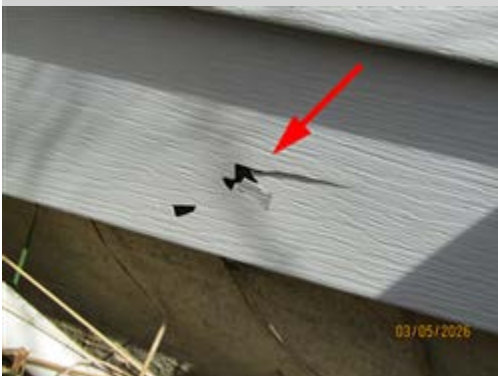
(B1 - 1.4) Main House: All Accessible Areas

On the left side of the home, several damaged or cracked pieces of siding are in need of repair or replacement. A siding installation company or general contractor should be consulted to evaluate and repair the siding to ensure the integrity of the cladding system.

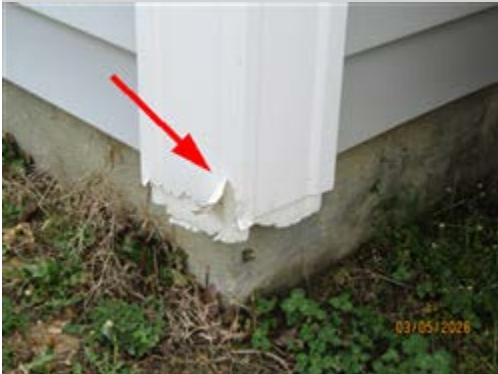
(B1 - 1.6) Main House: All Accessible Areas

The vinyl corner trim was noted to be damaged in several locations around the home. A siding installation company or general contractor should be consulted to evaluate and repair the siding to ensure the integrity of the cladding system.

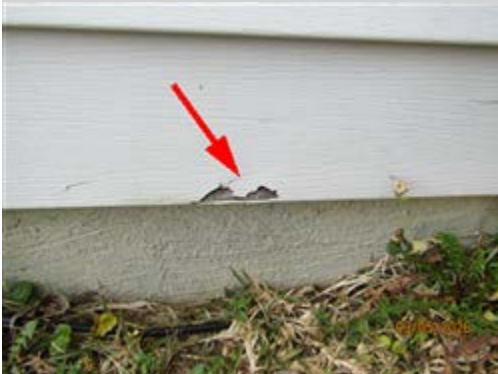
(B1 - 1.7) Main House: All Accessible Areas

On the right side of the home, several damaged or cracked pieces of siding are in need of repair or repair. A siding installation company or general contractor should be consulted to evaluate and repair the siding to ensure the integrity of the cladding system.

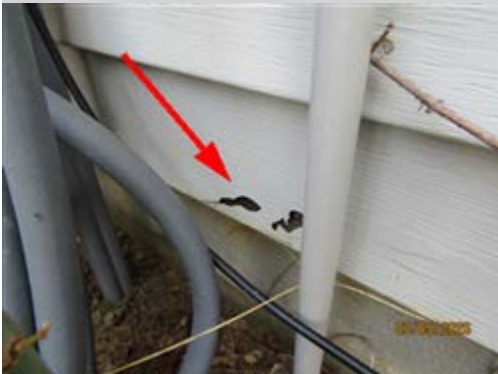
(B1 - 1.8) Main House: All Accessible Areas

On the right side of the home, several damaged or cracked pieces of siding are in need of repair. A siding installation company or general contractor should be consulted to evaluate and repair the siding to ensure the integrity of the cladding system.

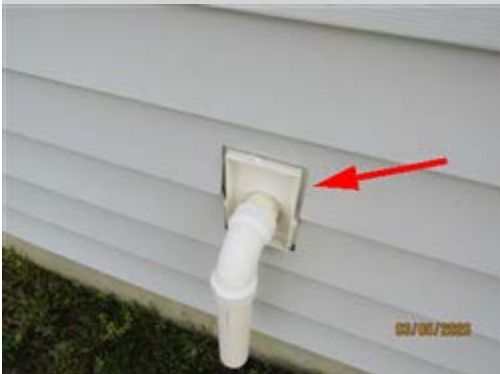
(B1 - 1.11) Main House: All Accessible Areas

The rear trim piece for the washing machine drain exit is missing. Further evaluation and repair by a qualified contractor is recommended.

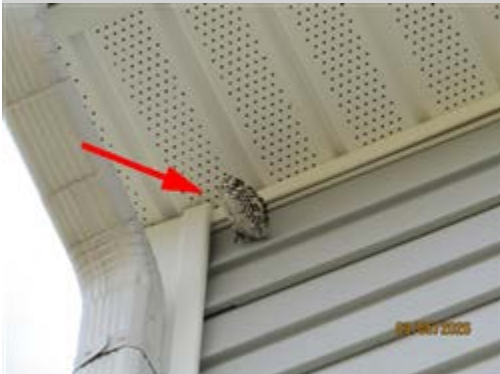
(B1 - 1.12) Main House: All Accessible Areas

Flying insect nests were noted in several locations around the home. Further evaluation and removal by a qualified contractor is suggested.

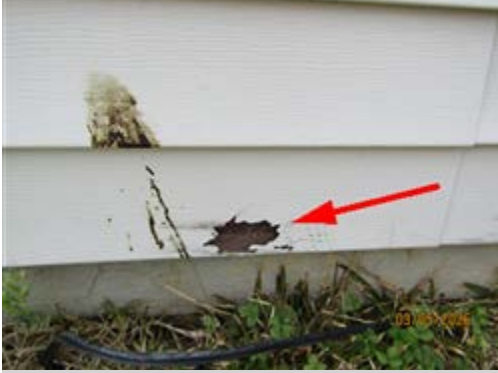
(B1 - 1.13) Main House: All Accessible Areas

On the right side of the home, several damaged or cracked pieces of siding are in need of repair. A siding installation company or general contractor should be consulted to evaluate and repair the siding to ensure the integrity of the cladding system.

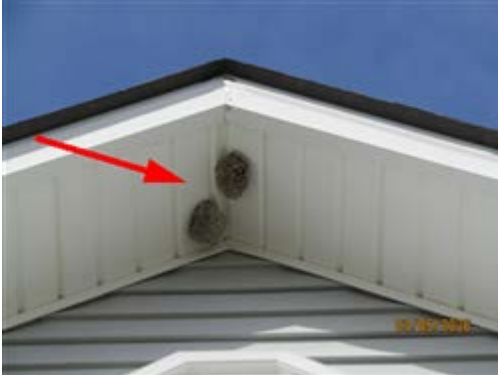
(B1 - 1.14) Main House: All Accessible Areas

Flying insect nests were noted in several locations around the home. Further evaluation and removal by a qualified contractor is suggested.

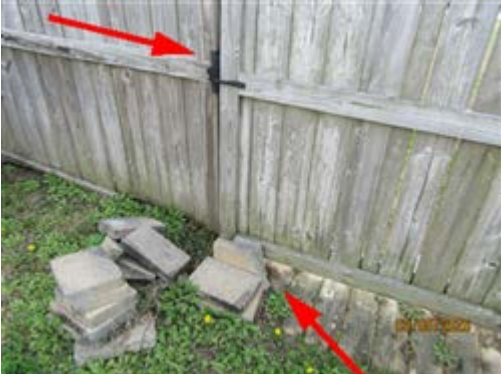
(B3 - 2.1) Backyard Fence Areas

The left side backyard wood fence gate assembly is damaged and does not open and close as intended. Further evaluation and repair by a qualified contractor is advised to ensure proper function.

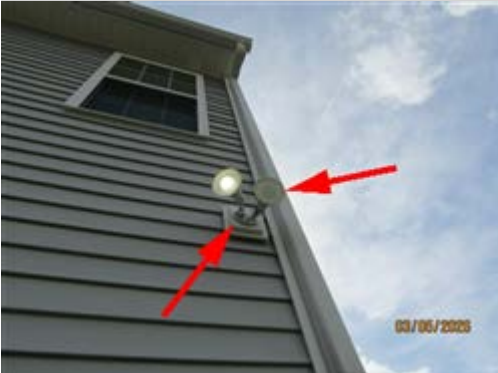
(E5 - 1.1) Exterior Light Fixtures and Receptacles

The rear light fixture is damaged and partly not operational. Damaged fixtures could result in improper operation and electrical hazards. An electrical contractor should be consulted for further evaluation and repair.

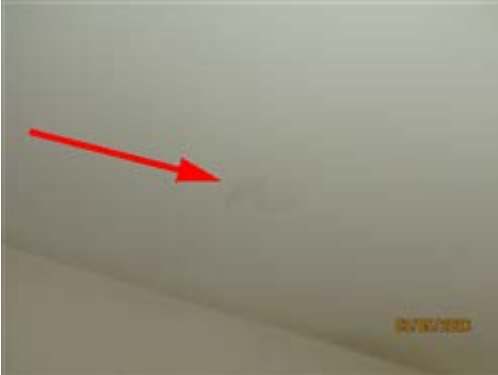
(H1 - 1.1) General Rooms

Several stains on the family room area ceilings indicate a history of a leak. At the time of the inspection it was not possible to determine if the condition was due to an active or past occurrence. Further investigation by a general contractor and seller disclosure is advised.

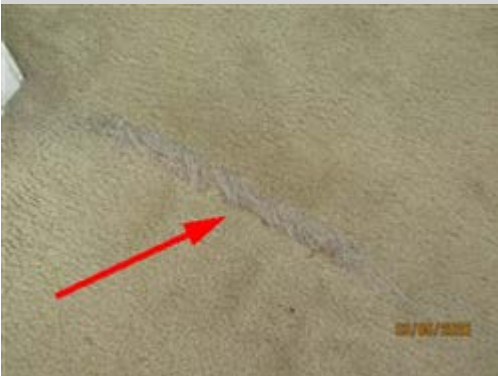
(H1 - 1.3) General Rooms

The carpet floor surface was noted to be damaged and stained in several locations throughout the home. Further evaluation and repair by a flooring specialist is recommended.

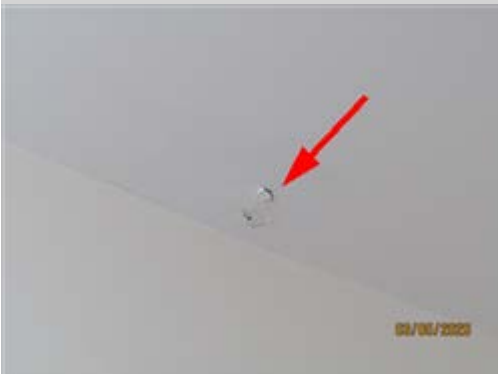
(H1 - 1.4) General Rooms

Nail pops and other drywall imperfections were noted in multiple locations throughout the home. Further evaluation and repair by a drywall or painting contractor is suggested.

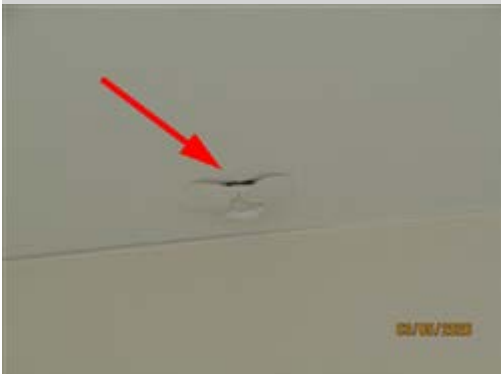
(H1 - 1.7) General Rooms

Nail pops and other drywall imperfections were noted in multiple locations throughout the home. Further evaluation and repair by a drywall or painting contractor is suggested.

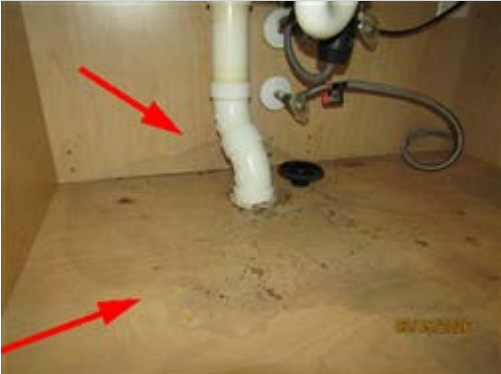
(H2 - 1.1) Kitchen Areas

The kitchen sink cabinet has visible areas of water stains/damage. The seller should be asked for disclosure related to the damage and history of any leaks. The cabinet needs to be repaired and the adjacent plumbing systems evaluated. A plumbing contractor should be consulted for evaluation and repair to ensure proper service.

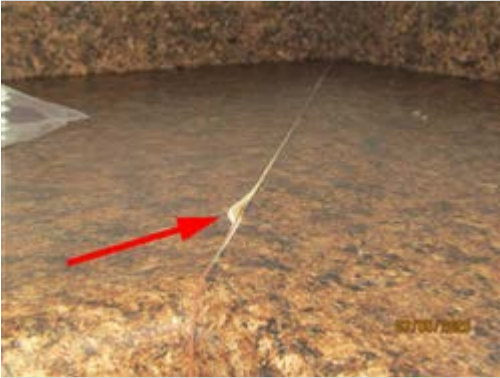
(H2 - 1.4) Kitchen Areas

The laminate counter top has moisture damage at seam locations. The counter edge is swollen and has displaced the countertop surface. A general repair specialist should be consulted to determine the source of the moisture and make necessary repairs.

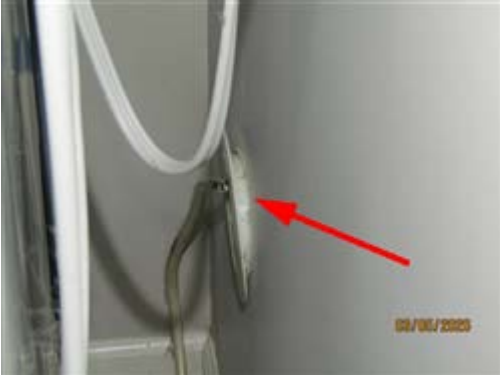
(H2 - 1.5) Kitchen Areas

The refrigerator water supply line assembly cover is not secured properly. Further evaluation and repair by a qualified contractor is advised to ensure no other concerns are present.

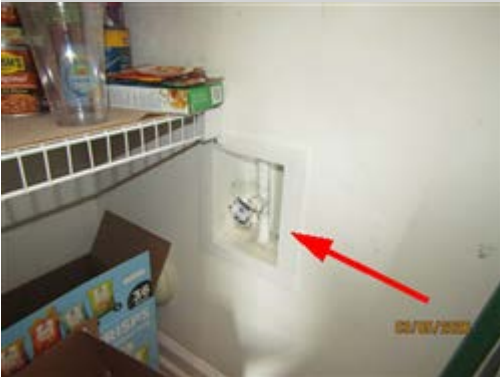
(H2 - 1.6) Kitchen Areas

In the kitchen pantry, a water shutoff valve was noted. This is likely the interior water shutoff for the home. This is noted for awareness to the buyer. A qualified contractor should be consulted to label the shutoff valve and ensure proper function.

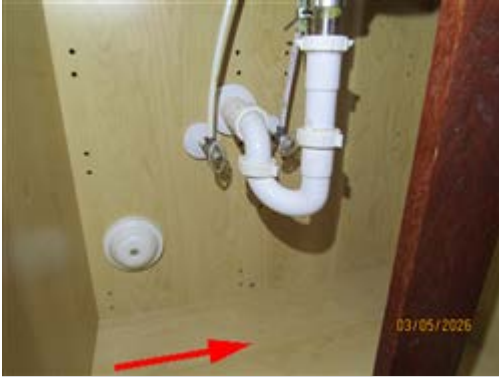
(H3 - 1.1) Downstairs Half Bathroom

The vanity sink cabinet is stained in areas. The seller should be asked for disclosure related to the stains and history of any leaks. The cabinet needs to be repaired and the adjacent plumbing systems evaluated. A plumbing contractor should be consulted for evaluation and repair to ensure proper service.

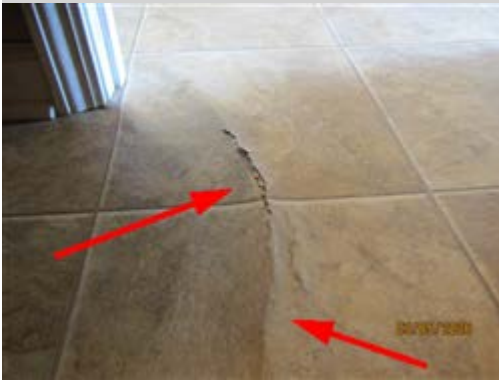
(H3 - 1.2) Downstairs Half Bathroom

The vinyl floor surface was noted to be damaged and loose in several locations throughout the home. The loose and buckled floor surface poses potential trip/fall hazards. Further evaluation and repair by a flooring contractor is recommended.

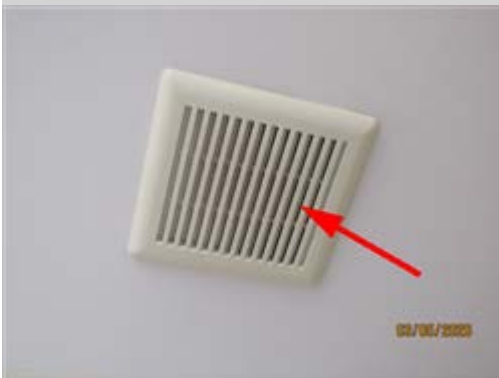
(H3 - 2.1) Upstairs En Suite Bathroom

The ventilation fan has lint in the grill area and on the exterior exit. The fan needs to be cleaned and evaluated to ensure proper operation. A general repair person should be consulted for corrections.

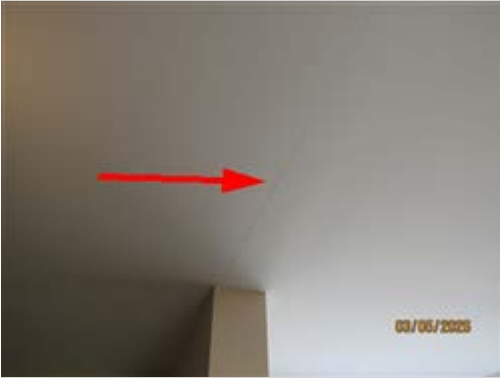
(H3 - 2.2) Upstairs En Suite Bathroom

Nail pops and cracks along tape joints were noted in several locations of the bathroom ceiling. Further evaluation and repair by a drywall or painting contractor is recommended.

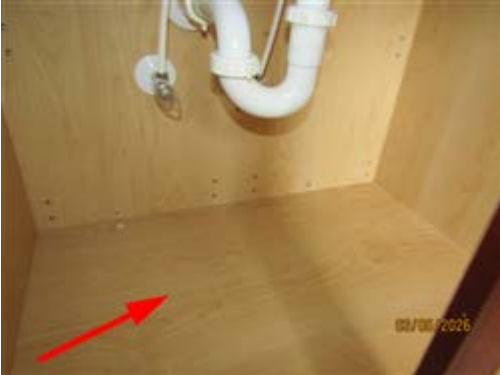
(H3 - 2.3) Upstairs En Suite Bathroom

The vanity sink cabinet is stained in areas. The seller should be asked for disclosure related to the stains and history of any leaks. The cabinet needs to be repaired and the adjacent plumbing systems evaluated. A plumbing contractor should be consulted for evaluation and repair to ensure proper service.

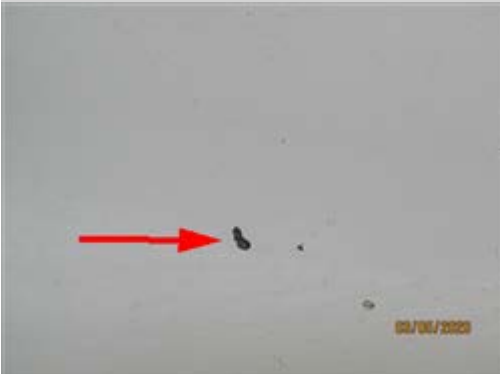
(H3 - 2.4) Upstairs En Suite Bathroom

The tub base has several chips in the surface that expose the structural matt. The chips could allow water to penetrate under the surface and possibly result in leaks. A surface specialist or general contractor should be consulted to make necessary repairs.

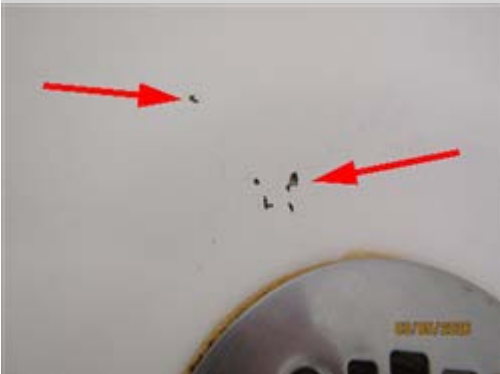
(H3 - 2.5) Upstairs En Suite Bathroom

The shower base has several chips in the surface that expose the structural matt. The chips could allow water to penetrate under the surface and possibly result in leaks. A surface specialist or general contractor should be consulted to make necessary repairs.

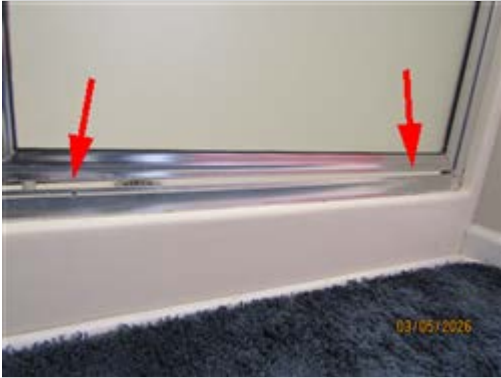
(H3 - 2.6) Upstairs En Suite Bathroom

The shower door bottom seal and/or weather stripping is missing or not functional. Further evaluation and repair by a qualified contractor is advised.

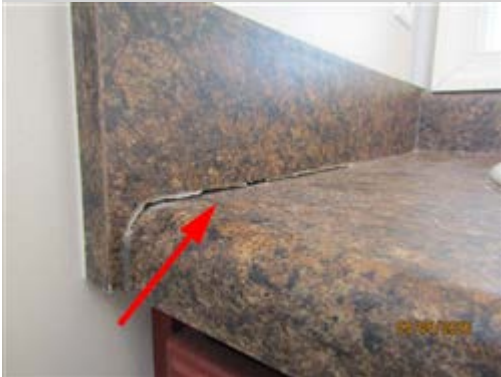
(H3 - 2.7) Upstairs En Suite Bathroom

The vanity sink top and side splash have visible gaps present. Further evaluation and repair by a qualified contractor is advised.

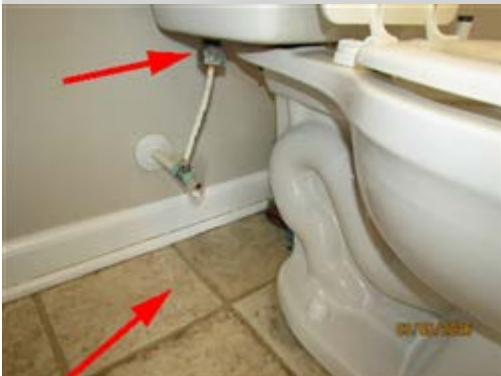
(H3 - 2.8) Upstairs En Suite Bathroom

The floor area around the toilet is discolored, possibly indicating a history of a leak or a seeping leak. The supply line connection also has corrosion present. The toilet installation needs to be checked to ensure that the toilet is not leaking. A licensed plumbing contractor should be consulted for evaluation and repair.

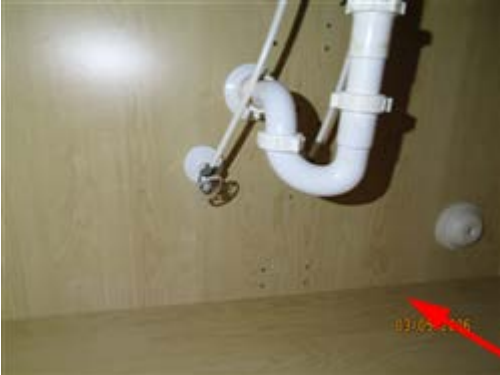
(H3 - 3.1) Upstairs Hallway Bathroom

The vanity sink cabinet is stained in areas. The seller should be asked for disclosure related to the stains and history of any leaks. The cabinet needs to be repaired and the adjacent plumbing systems evaluated. A plumbing contractor should be consulted for evaluation and repair to ensure proper service.

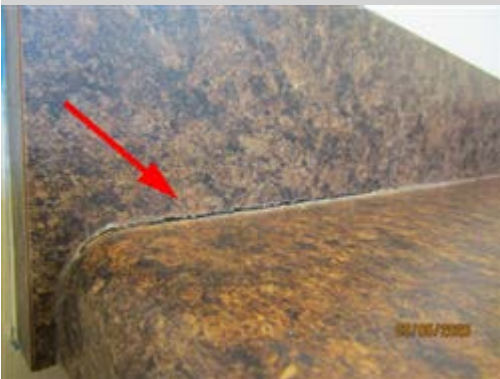
(H3 - 3.2) Upstairs Hallway Bathroom

The vanity sink top and side splash have visible gaps present. Further evaluation and repair by a qualified contractor is advised.

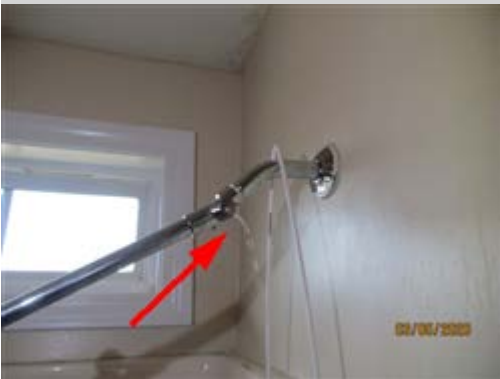
(H3 - 3.3) Upstairs Hallway Bathroom

The shower head assembly leaks when water service is turned on. Further evaluation and repair by a plumbing contractor is advised to ensure efficient, proper service.

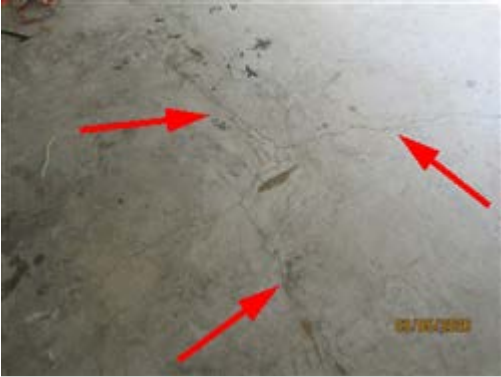
(H4 - 1.1) Garage Areas

The garage floor concrete pad is cracked in several areas. Further evaluation and repair by a masonry contractor is recommended.

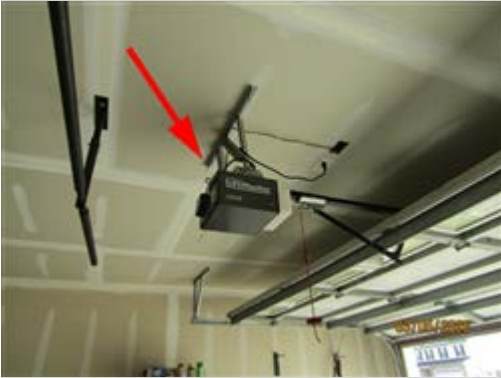
(H4 - 1.2) Garage Areas

The garage door needs adjustment and repair. The door lift motor assembly was loud and/or noisy as it raised and lowered the door. A garage door installation company should be consulted for evaluation and repair to ensure that the door operates safely and properly.

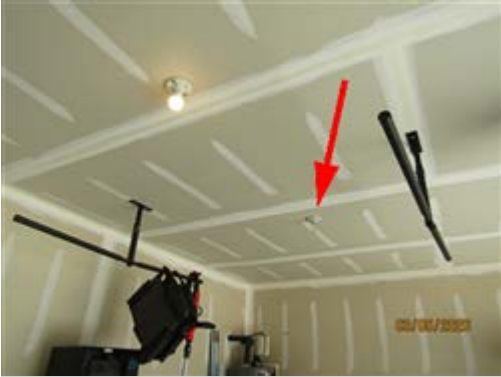
(H4 - 1.3) Garage Areas

The noted garage light fixture was not functional when tested. This could indicate a defective bulb or other more serious problem, further evaluation is needed. An electrical contractor should be consulted for further evaluation and repair.

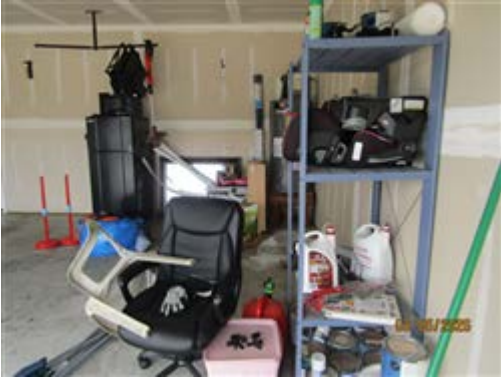
(H4 - 1.4) Garage Areas

The inspection of the garage was limited in areas due to storage and personal items. Once accessible, further evaluation by a general contractor is advised to ensure all items are in good, working order.

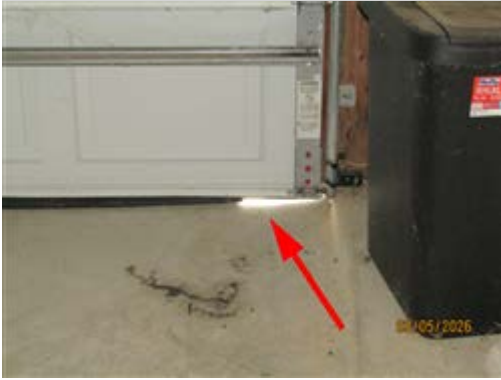
(H4 - 1.5) Garage Areas

The garage door weather stripping is damaged and not effective in areas. A garage door installation company or general contractor should be consulted for evaluation and repair to ensure that the door operates safely and properly.

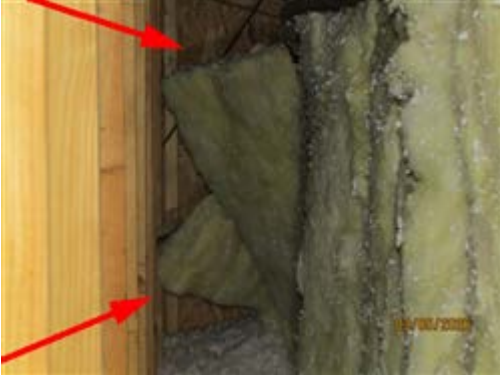
(I1 - 1.1) Attic: All Accessible Areas

Where visible, several sections of insulation in the attic are missing, displaced and/or have fallen down. Improper insulation installation could result in condensation, over heating of the building components, and inadequate conditioning of the living areas. A general contractor should be consulted for repair/replacement.

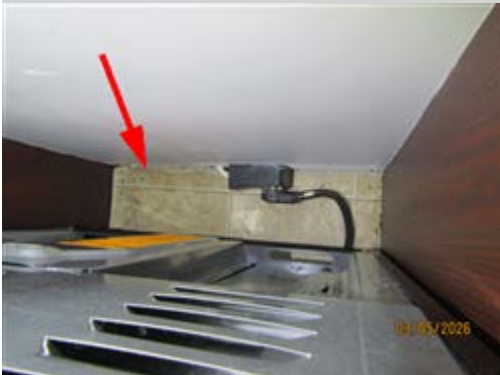
(J1 - 1.1) Range: Electric

The oven/range moves forward when the door is opened. The oven needs to be secured or anchored with an anti-tip bracket to prevent the unit from turning over when weight is applied to the door. An appliance repair specialist or general contractor should be consulted for further evaluation and repair.

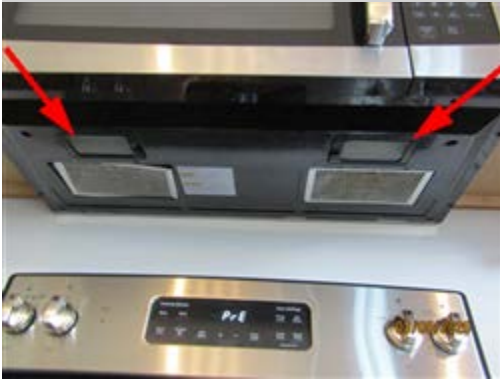
(J1 - 3.1) Microwave: Over Range
--

The surface lights for the microwave did not function. An appliance repair specialist should be consulted for further evaluation and repair to ensure proper operation of the appliance.
