Jan 20th, 2026

208 White Street, Williamston, NC, 27892

Home Inspection Report

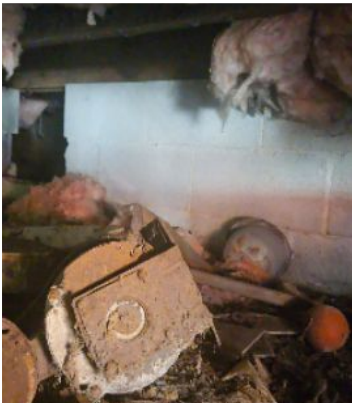
4.2 FOUNDATION

Hole in foundation wall.-
This is allowing animals to enter the crawlspace.-
This is a functional issue. It is recommend that further evaluation, repair, and or replacement of this and all other foundation and foundation wall be completed by a foundation contractor.

Recommend further evaluation of the foundation and the foundation wall. This is to be completed by a qualified or licensed foundation contractor or a licensed general contractor for proper function and safety.

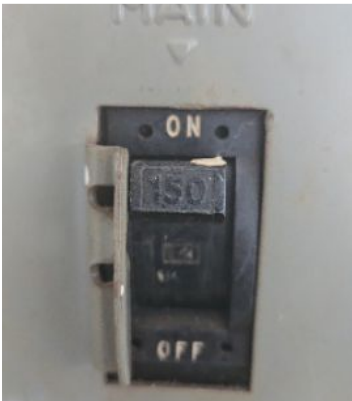
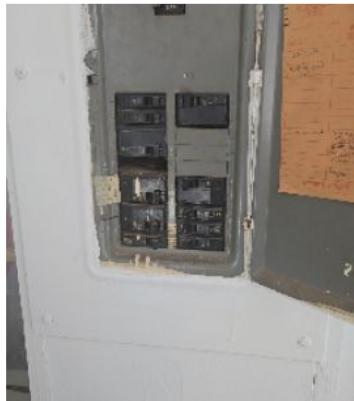
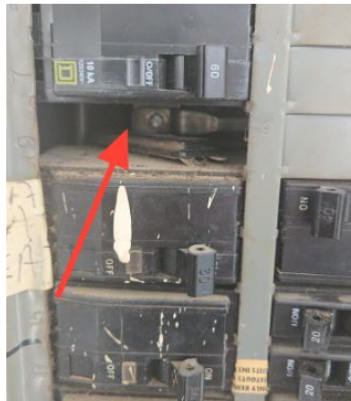
open knock out

arrows are pointing at 3 wires that have been cut and are not capped with a wire nut inside the panel box. The wire with 2 arrows, 1 at the bottom and 1 midway, is a solid aluminum wire. Recommend all electrical be evaluated by a licensed electrician.

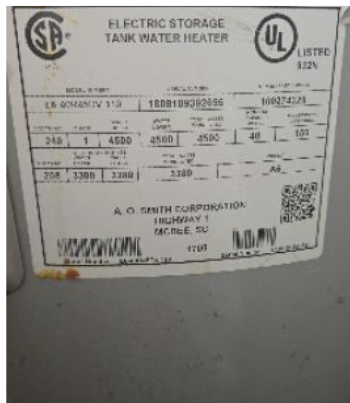
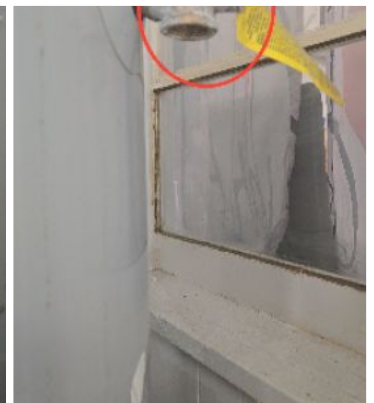
TPR Overflow Pipe

The water heater is missing the TPR Overflow pipe. This is a safety concern. Recommend further evaluation, repair, or replacement as necessary of this and all plumbing be completed by a licensed plumber for proper function and safety.
