Property Inspection Report

Report Number: 2402

2402 Carey Rd.
Kinston, North Carolina 28504

Date of Inspection: Thursday, May 29, 2025

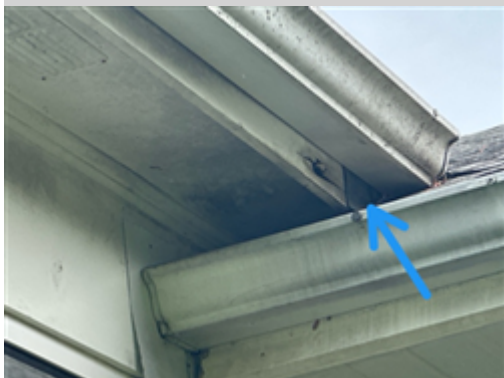
(A6 - 1.3) Main House

The soffit is decayed on the rear of the home where the screened porch roof ties into the main roof on both the left and right sides as well in the area above the screen door. No other surrounding areas showed any evidence of damage. A licensed roofing contractor and/or licensed general contractor should be consulted to perform an invasive inspection to determine the source of the water that has caused the decay and of the surrounding areas and to make any necessary repairs.

Example picture for 1-2

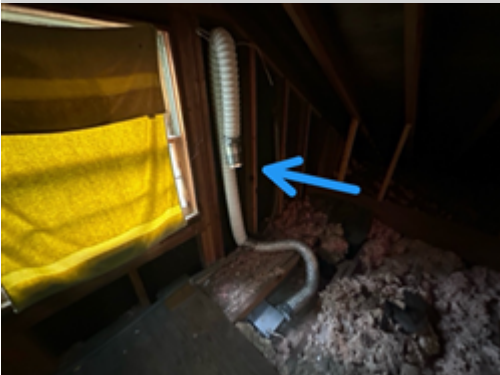
(I1 - 1.1) Attic: All Accessible

The bathroom ventilation fan exhaust duct does not exit to the exterior of the home. The fan exits to the attic space which will add undesirable moisture to the area. A general repair specialist or licensed general contractor should be consulted for review and repair.

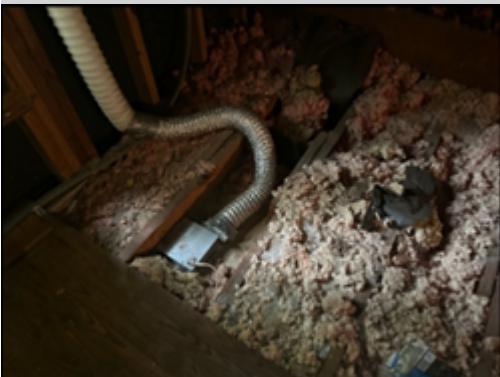
(I1 - 1.2) Attic: All Accessible

The insulation in the attic is missing and/or compressed in some areas. Improper installation could result in condensation, over heating of the building components, and inadequate conditioning of the living areas. A licensed general contractor or professional insulation company should be consulted for repair/ replacement.

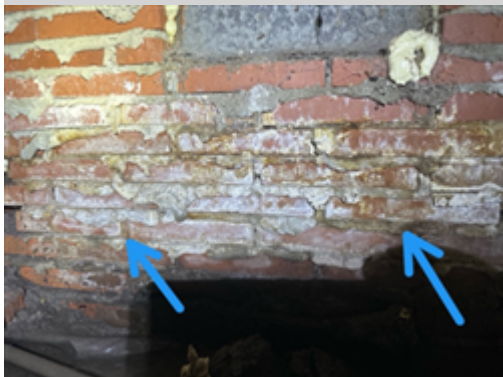
(I1 - 2.1) Crawl Space

Efflorescence (salt stains) were noted on the foundation walls. The stains indicate that the foundation was been cyclically wet and dry. Water penetration into the foundation area can result in structural damage and undesirable environmental conditions. Water in the foundation area indicates an absent or damaged waterproofing and foundation drain systems. Repairs are needed to prevent water penetration. A general contractor should be consulted for further evaluation to determine the source of the moisture and to make necessary repairs.

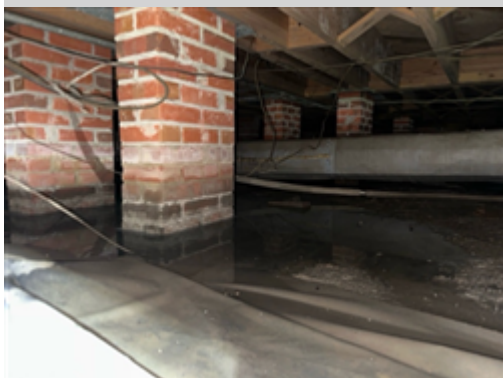
(I1 - 2.2) Crawl Space

Areas of standing water were present in the crawl space. Direct water penetration can damage the foundation, the wood structure, and creates an undesirable environment in the crawl space areas that encourages insect and fungal growth such as mold/mildew. Water in the crawl space indicates an absent or damaged waterproofing and foundation drain system, and/or is the result of a leak. A licensed general contractor should be consulted for further evaluation to determine the source of the moisture and to make necessary repairs.

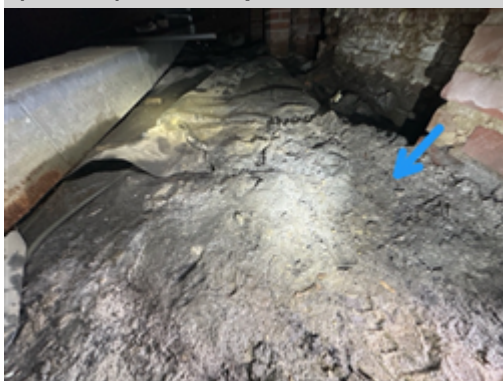
(I1 - 2.3) Crawl Space

The vapor barrier does not completely cover the ground in the crawl space. The completion of the vapor barrier would help reduce the moisture in the space. If desired, a crawl space specialist or licensed general contractor can be consulted for review.

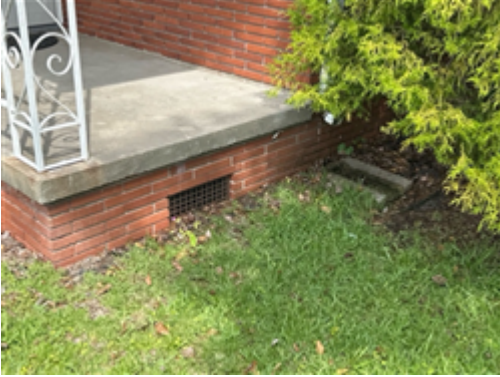
(I1 - 2.4) Crawl Space

The foundation vents are at grade (ground level) on the front of the home. This can allow water to enter the crawl space area. A licensed general contractor can be consulted to review the configuration to ensure that water can't penetrate into the crawl space.

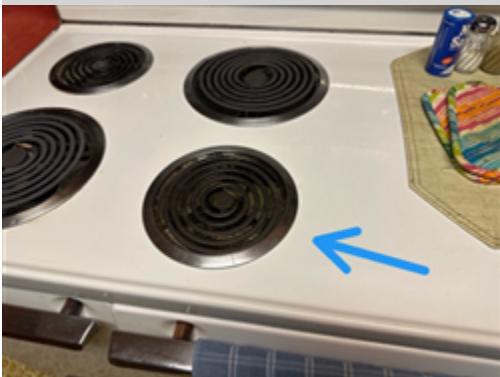
(J1 - 1.1) Range / Oven: Electric

The front right burner for the stove top did not operate to produce heat or respond to the control panel when it was requested to heat. An appliance repair person should be consulted for further evaluation and repair to ensure proper operation of the appliance.

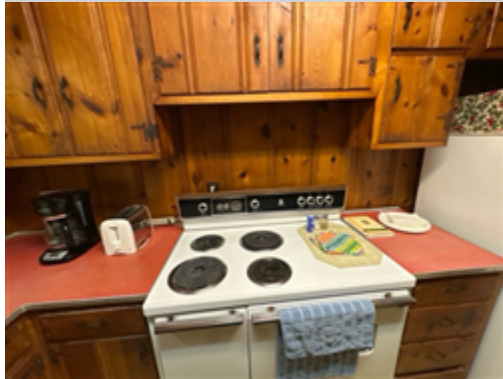
(J1 - 2.1) Range Hood: Recirculating

There is not a hood over the stove. The hood removes airborne grease, combustion products, fumes, smoke, odors, heat, and steam from the air. An appliance repair person or general repair specialist should be consulted for placement.
