## Property Inspection Report

May 16, 2026 (11:00 AM)

HI57-051626-509Bascom  
509 Walnut St Wilmington, NC

Steel Magnolia Home Inspections

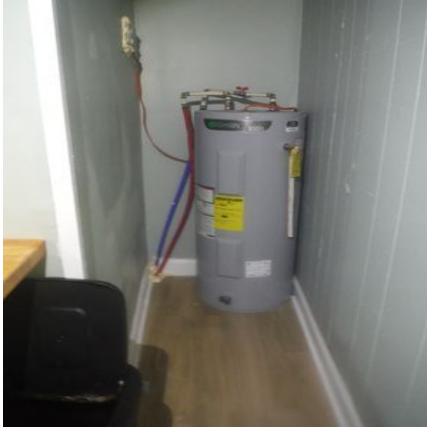
**(D4-1.1) Unit 1**

Manufacturer: AO Smith  
Serial Number: 2313133504892  
Model Number: E6-30H45DV 100  
Date: 2023

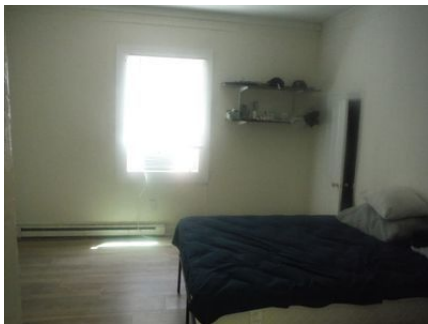
(H1-1.1) Bedroom 1 Apt.1

When windows are not opened, the inspector cannot complete the home inspection process to locate related areas of concern and or possible decay. The window inspection should be completed when operation is restored. The interior inspection was limited to visible areas and was restricted by furnishings, storage, rugs, and drapery.

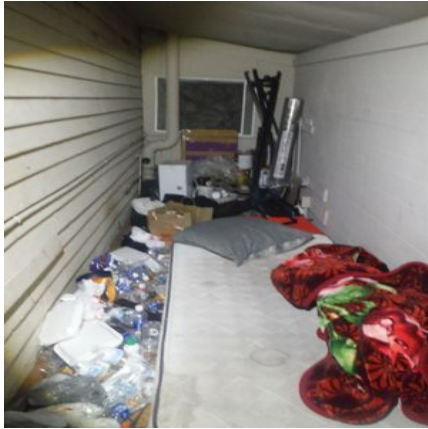
(H1-4.1) Enclosed Porch Apt.2

This area was not inspected fully, not accessible.

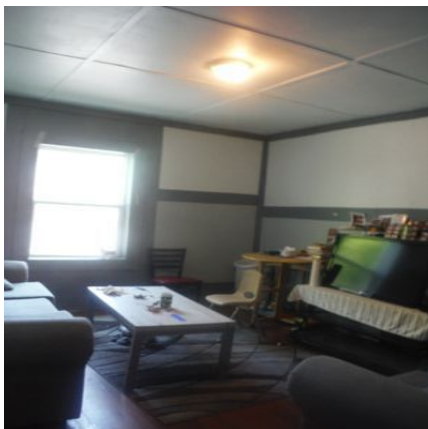
(H1-5.1) Living Room Apt. 2

The interior inspection was limited to visible areas and was restricted by furnishings, storage, rugs, and drapery.

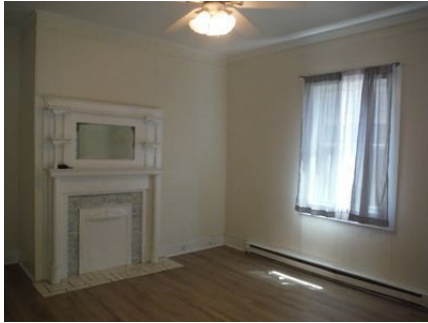
(H1-6.1) Living Room Apt.1

The interior inspection was limited to visible areas and was restricted by furnishings, storage, rugs, and drapery.

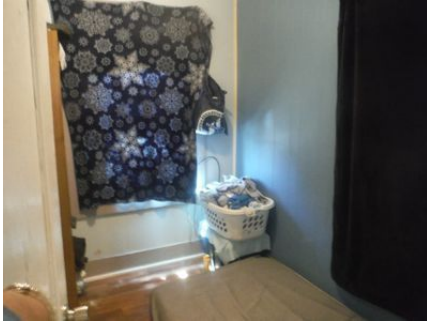
**(H1-7.1) Office**

The interior inspection was limited to visible areas and was restricted by furnishings, storage, rugs, and drapery.

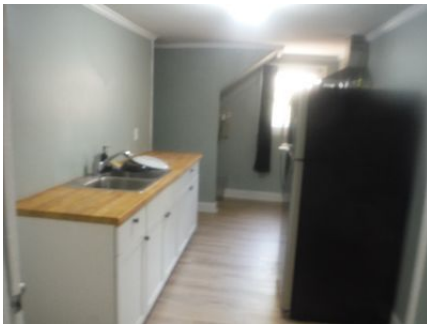
**(H2-1.1) Kitchen Apt. 1**

The interior inspection was limited to visible areas and was restricted by furnishings, storage, rugs, and drapery.

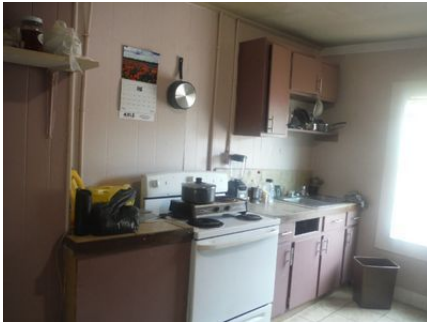
#### (H2-2.1) Kitchen Apt. 2

The interior inspection was limited to visible areas and was restricted by furnishings, storage, rugs, and drapery.
