Worldwide ERC® Relocation Property Assessment

Transferee Property Address: 605 Ravenswood Road

City/State/Postal Code: Hampstead, NC 28443

Date: 07/09/2025 Time: 10:00 AM Weather: Cloudy Temp: 80 Estimated Age of Main Dwelling (yrs.): 38

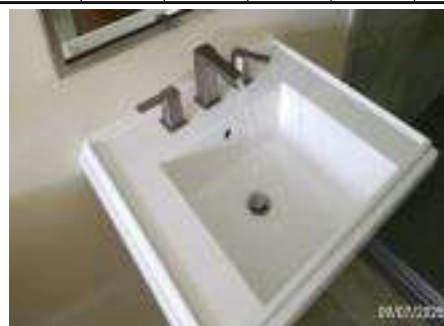
Inoperable Drain Stopper at Master Right Sink

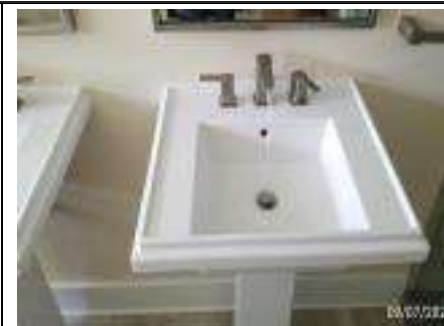
Inoperable Drain Stopper at Master Right Sink

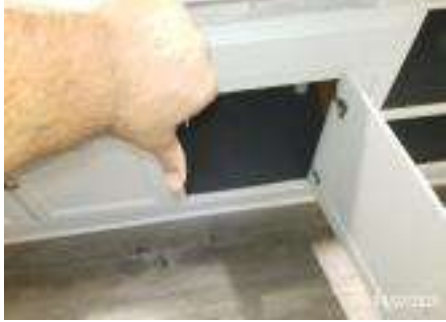
Lower Disposal is Inoperable

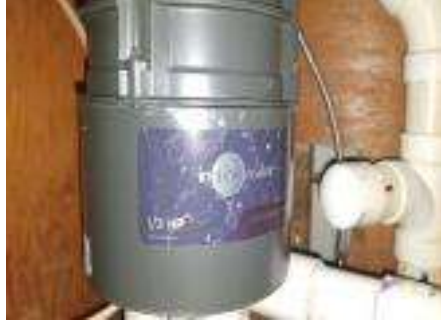
Lower Disposal is Inoperable

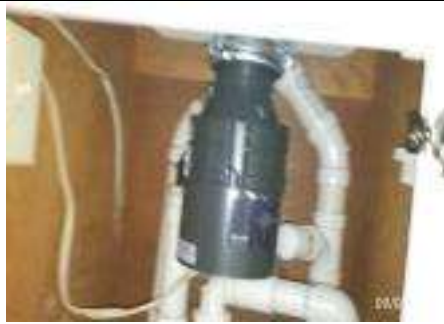
Lower Disposal is Inoperable

Corrective Action: Plumber to replace the lower kitchenette disposal.

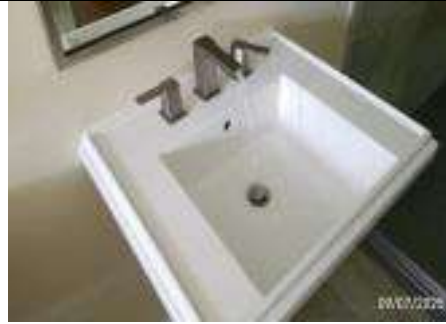
Inoperable Drain Stopper at Master Right Sink

Corrective Action: Plumber to replace the master bathroom right sink stopper.
