Property Inspection Report

February 08, 2024 (9:00 AM)

100288JS
221 W Main St Wallace, NC

Prepared By:
Jon Strout (#3338)
True North Inspection Services

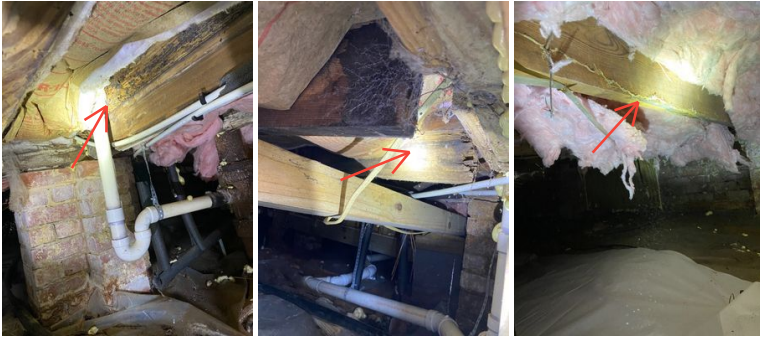
(B3-1.1) Additional Photos

The subflooring under the 1/2 bath toilet and left side structure joists/girder support was noted to be soft and decayed. Evidence suggests direct water penetration. Some areas on center and right also suggest evidence of unwanted pest concerns. A licensed general contractor should be consulted for an invasive investigation to determine the source of the water penetration or noted damaged areas and the extent of the decay to prevent further damage and undesirable conditions.

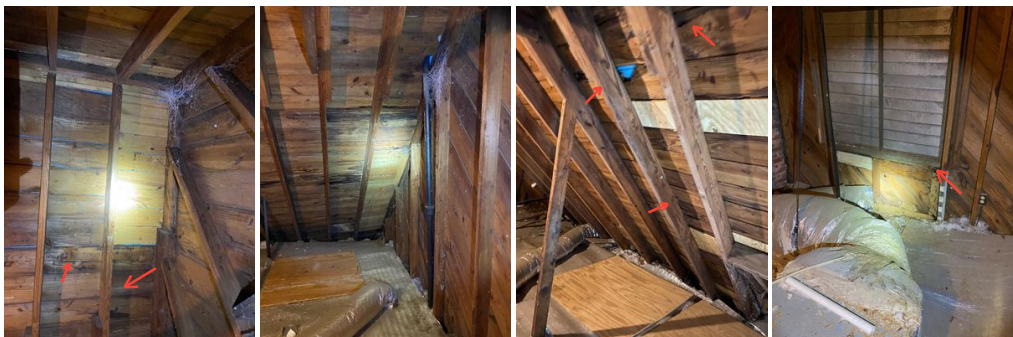
(B6-1.1) Additional Photos

From the attic, the wood framing components located near vents/chimney and rear are discolored, decayed, cracked, and select areas of replaced. The level of decay indicates a history of a long term leak that could involve hidden areas of damage, the flashing, and the roof covering systems. A licensed general contractor should be consulted for further evaluation and repair to determine the source of the leak and extent of the damage to ensure the stability of the home and prevent additional damage.

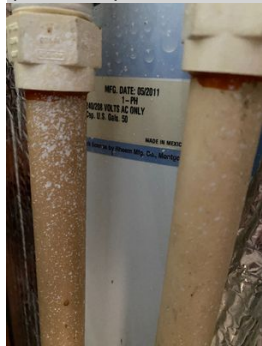
(D4-1.5) Water Heater

There is an approved discharge pipe connected to the temperature/pressure relief valve. The pipe is installed to prevent someone from being sprayed with hot water in the event that the valve discharges. Discharging of a valve is uncommon and usually indicates that the water heater is in need of service or the relief valve is in need of replacing.

GE 2011

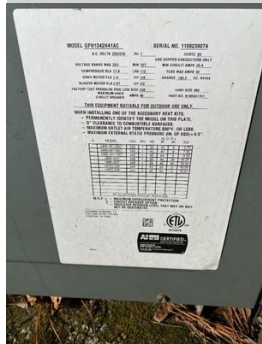
(F1-1.3) Heating system(s)

There were no visible service records for the unit. Recommend check with seller in this regard. Contacting a qualified HVAC contractor for further evaluation, an annual service check-up & cleaning prior to the close of escrow is recommended. Most manufacturers recommend an annual service evaluation and cleaning as a preventive maintenance measure.

Goodman 2011

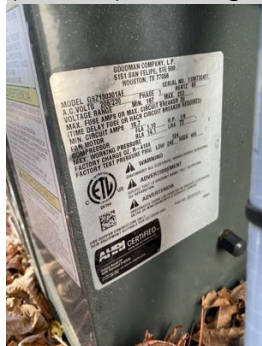
(G1-1.3) Cooling System(s)

An on-off test was not performed. The inspector could not override the programmed control system, or the system was shut down as the ambient outside temperature was LOWER than the recommended operating COOLING temperature. Recommend questioning seller in this regard and see service notes for details.

Goodman 2011

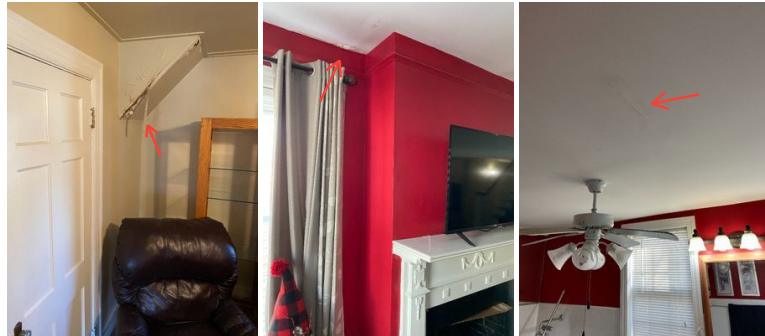
(H1-1.2) Additional Photos

Stains, cracking, damage on the ceilings in bedrooms indicate a history of a leak. At the time of the inspection it was not possible to determine if the condition was due to an active or past occurrence. Further investigation by a repair specialist and owner disclosure is recommended. Refer to the Attic section of the report.

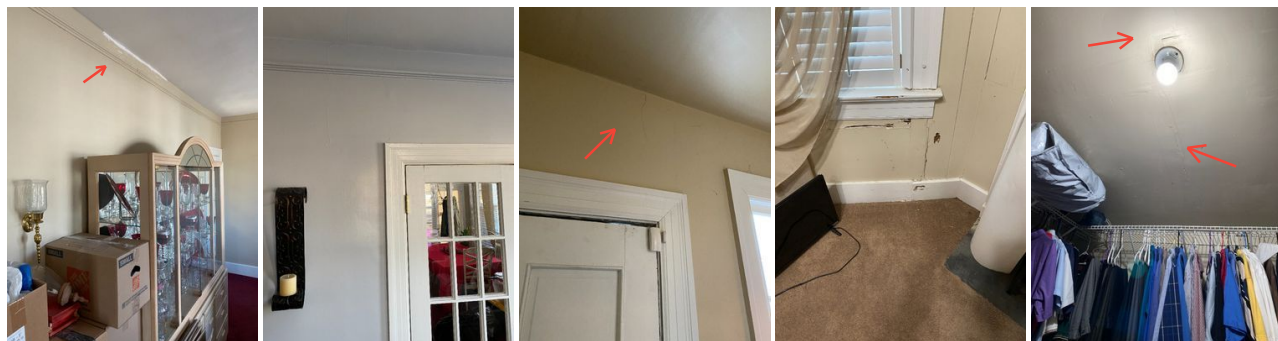
(H1-1.3) Additional Photos

Some of the cracks are present in a way the size and length were more than would be typically expected other than plasterboard cracks. Multiple areas of the flooring were found uneven. An engineer should be consulted to evaluate the structure of the home to determine the significance of this concern and if repairs are necessary.
