Inspection Report

Property Address:
101 Grant St.
Sneads Ferry NC

Seaside Home Inspections, Inc.

Date: 5/14/2026	Time: 09:00 AM	Report ID: 052614
Property: 101 Grant St. Sneads Ferry NC	Customer: Danielle Rivenbark	Real Estate Professional:

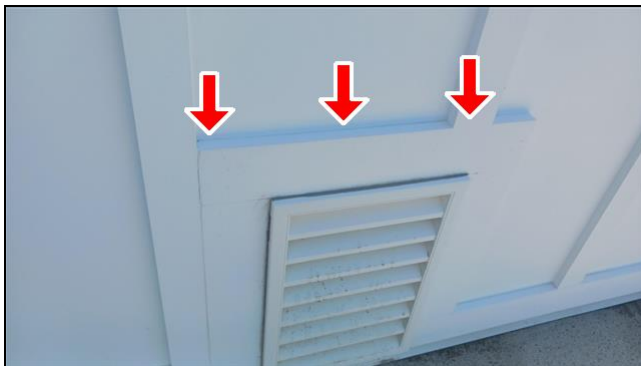
2.1 Picture 3

(1) There is no 'drip cap' flashing over the horizontal trim above the windows and doors on the exterior of the home. 'Drip cap' flashing is typically required over horizontal trim above windows and doors to prevent potential water intrusion. Recommend further evaluation and repair by a qualified tradesman.

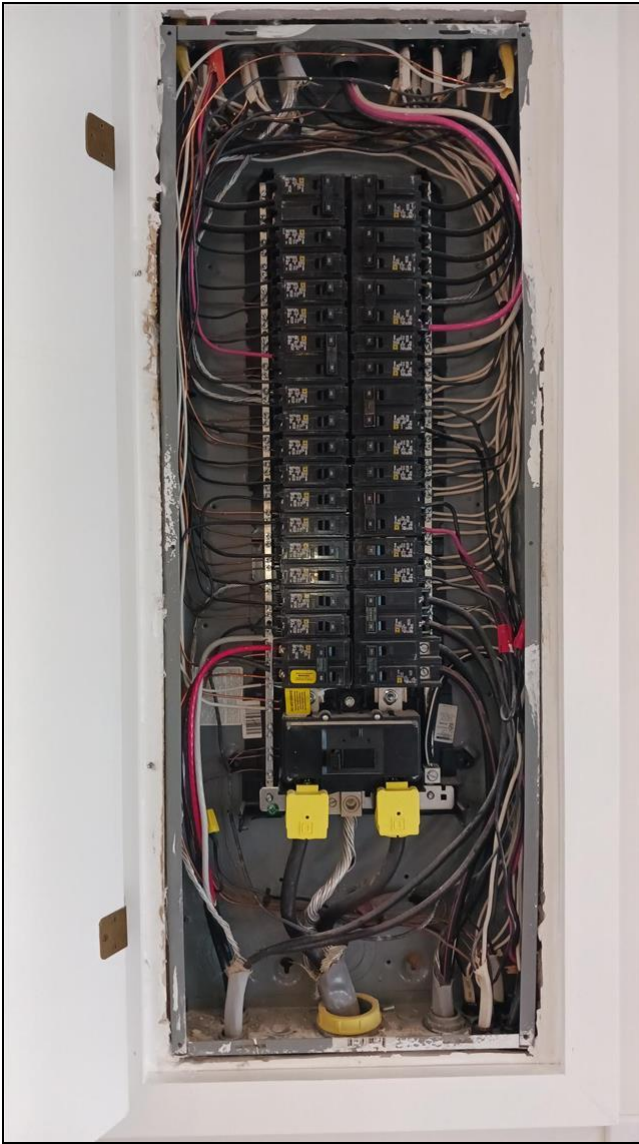
8.2 Picture 1

The main electrical panel is located on the left side of the kitchen. There's a sub panel located near the bottom of the stairs on the ground floor.

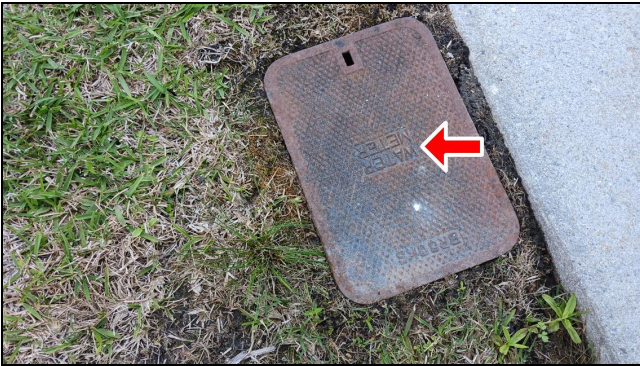
10.3 Picture 1

The main water shut-off valve is located at the meter near the front left corner of the home.

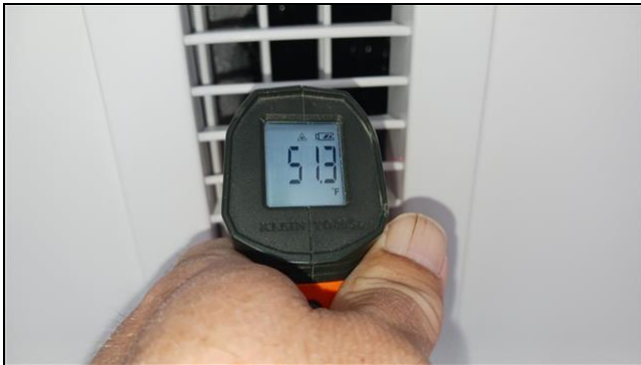
12.0 Picture 5

(3) Ambient air test was performed by using thermometers on air handler of Heat pump in cool mode to determine if the difference in temperatures of the supply and return air are between 14 degrees and 22 degrees which indicates unit is cooling as intended. The supply air temperature on your system read 51 degrees, and the return air temperature was 72 degrees. This indicates that the unit is currently cooling as intended. (second floor)
