Property Inspection Report

Report Number: 1540

105 Bryan Pl.
Washington, North Carolina 27889

Date of Inspection: Monday, September 15, 2025

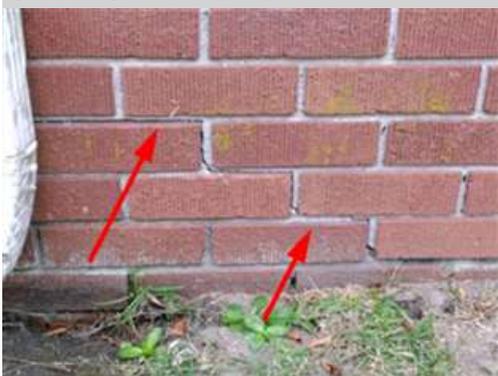
(A1 - 1.2) Main House

Additional photo right front

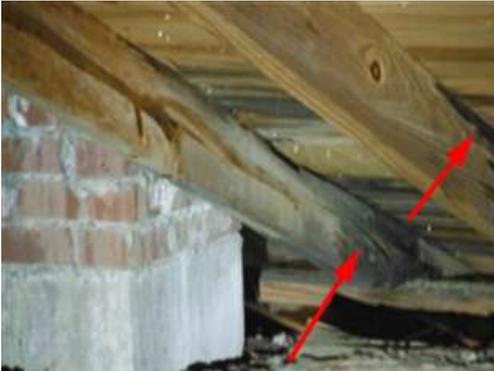
(A6 - 1.1) Main House

A few of the rafters near the chimney are heavily decayed due to water penetration. A licensed general contractor should be consulted to evaluate to roof structure and repair.

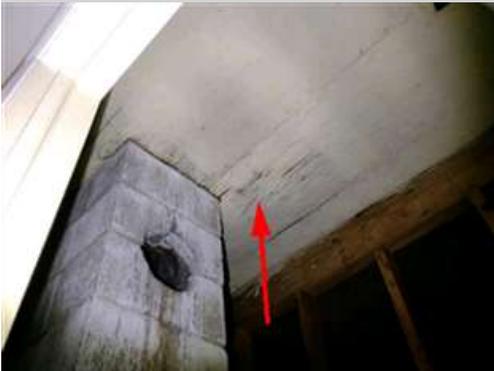
(A6 - 1.2) Main House

The roof sheathing is stained in the utility room and attic areas and evidence suggest a history of a leak. At the time of the inspection, due to attic temperature it could not be determined if the stains were wet or dry indicating a past leak or a possible on going leak., however, the shingles/flashing were noted to be newer and in good condition. A licensed general contractor should be consulted to evaluate the decayed wood and determine if repairs are needed. A roofing contractor may need to be consulted to determine if there are any roof leaks.

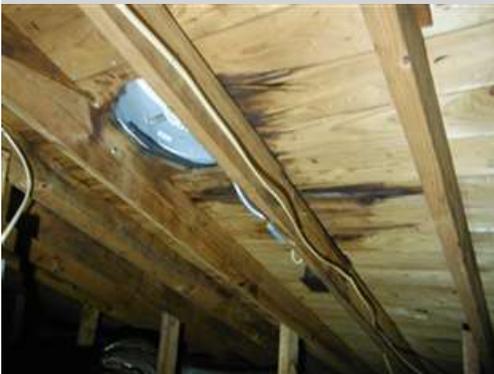
(A6 - 1.3) Main House

Additional photo

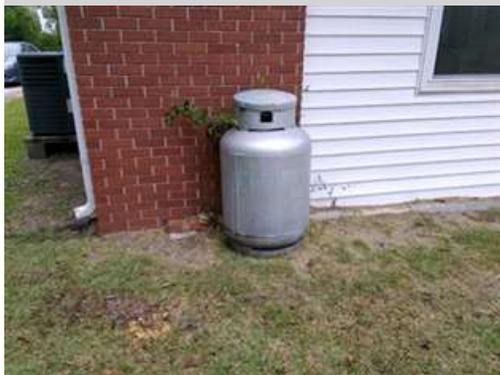
(F3 - 1.1) Exterior

The home has an above ground fuel storage tank; storage tanks are either leased from the fuel supplier or owned by the homeowner. The buyer should request more information concerning the storage tank, service requirements and ownership.

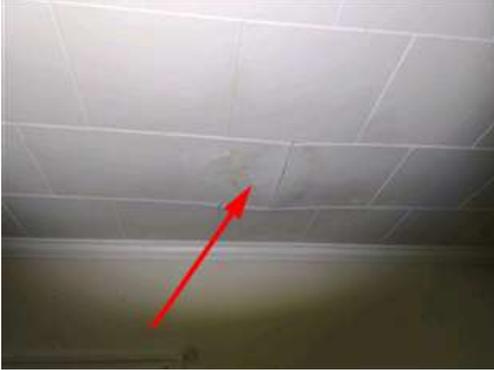
(H1 - 3.1) Family Room Rear

Stains on the ceilings indicate a history of a leak. At the time of the inspection it was not possible to determine if the condition was due to an active or past occurrence. Further investigation by a general contractor is recommended.

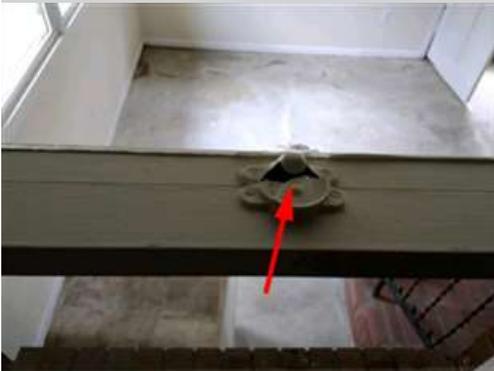
(H1 - 3.3) Family Room Rear

The window latch is broken and should be repaired to ensure the window can be secured as intended. A handyman or general contractor should be consulted.

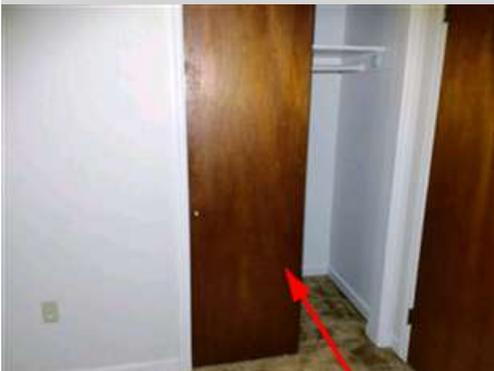
(H1 - 3.4) Family Room Rear

The closet door drags and is difficult to open or close. This condition could indicate improper installation or framing movement. The door needs repair/replacement to ensure that the door closes securely and operates properly. A handyman or licensed general contractor should be consulted for evaluation and repair.

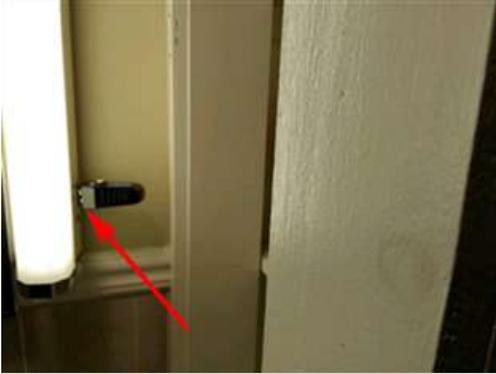
(H3 - 1.3) Bathroom Rear

The home was built before GFCI circuits were required to protect all electrical receptacles located outside or within six feet of water. GFCI circuits add an important safety feature to electrical systems. The buyer should consider upgrading the electrical system to include GFCI protection.

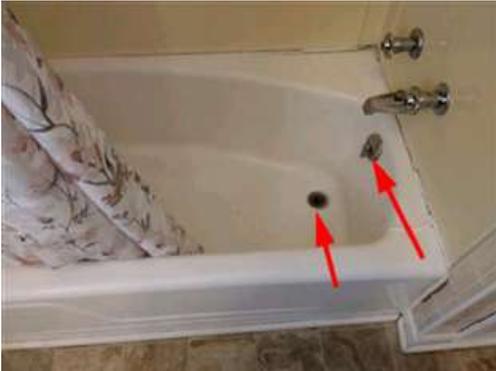
(H3 - 1.4) Bathroom Rear

It was noted that the tub stopper is leaking. The stopper's purpose is to hold water at the desired level. This should be repaired to ensure proper function of the tub. A handyman or licensed plumber should be consulted to evaluate and repair.

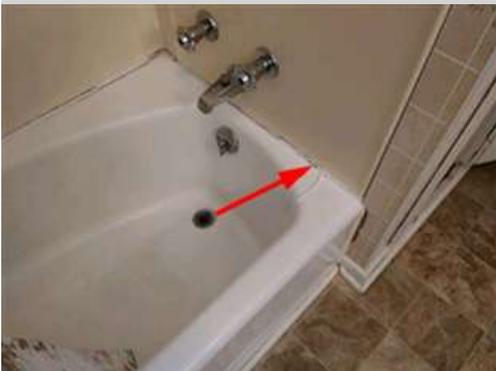
(H3 - 1.5) Bathroom Rear

The caulk at tub to wall transitions was noted to be loose and should be repaired to help prevent water penetration. A handyman should be consulted to evaluate and repair.

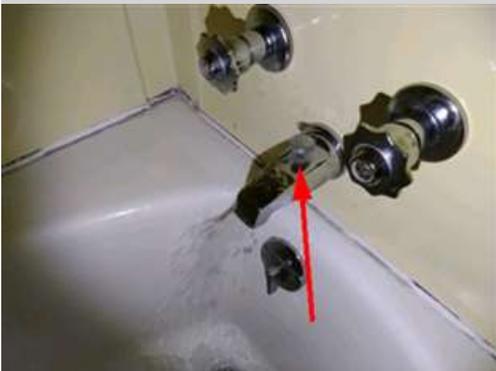
(H3 - 1.6) Bathroom Rear

The diverter valve leaks when the water is on. This should be repaired to prevent water from leaking behind the shower wall. A licensed plumber should be consulted to evaluate and repair.

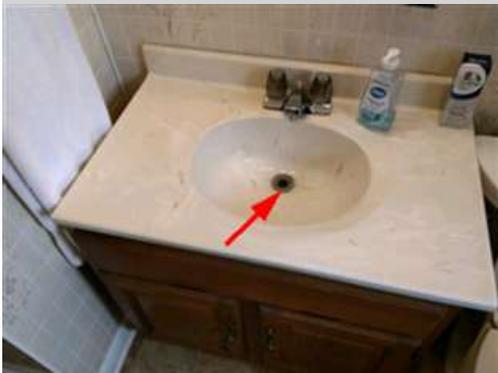
(H3 - 1.7) Bathroom Rear

It was noted that the sink is missing the stopper. The stopper's purpose is to hold water at the desired level. This should be repaired to ensure proper function of the sink. A handyman or licensed plumber should be consulted to evaluate and repair.

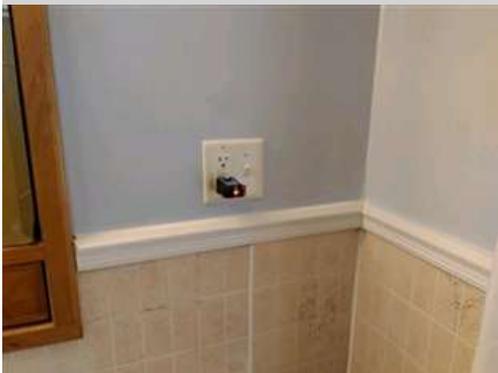
(H3 - 1.8) Bathroom Rear

The receptacle tested as open ground. An equipment ground provides an extra safety feature to prevent electrical shock hazards and property damage. A licensed electrical contractor should be consulted for further evaluation and repair.

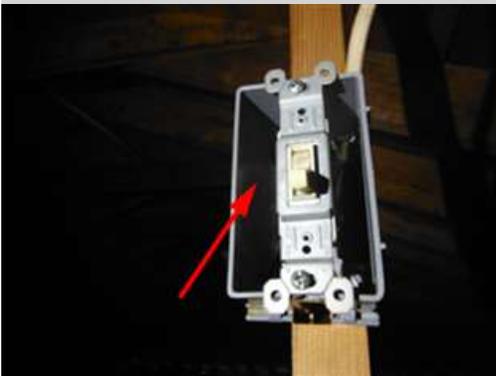
(I1 - 1.1) Attic: All Accessible

The light switch has a missing cover plate. An exposed light switch could result in increased shock and fire hazards. A qualified person should check the light switch and electrical connections for any visible concern and a cover plate should be installed to ensure safe and proper operation and installation.

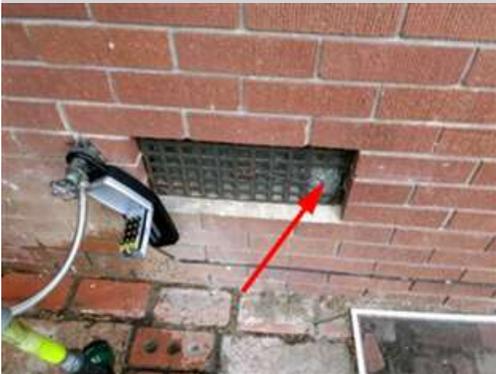
(I1 - 2.1) Crawl Space

The foundation vent grill is damaged on left side of home and should be repaired to help prevent pests from entering the crawl space. A licensed general contractor should be consulted to evaluate and repair.

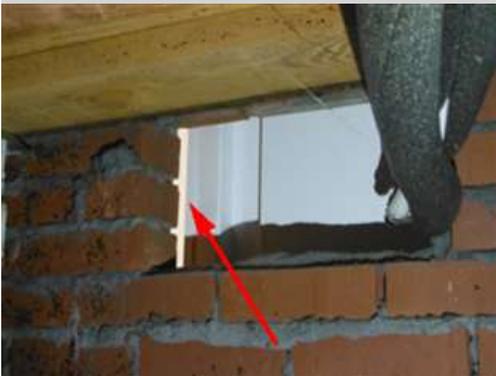
(I1 - 2.2) Crawl Space

The foundation vent on rear left side of home connects to the laundry room. This will allow heat loss/gain and pest entry into the laundry room. A licensed general contractor should be consulted to evaluate and repair.
