# Property Inspection Report

**Report Number: 8629**

778 Alum Springs Rd.  
Mount Olive, North Carolina 28365

Date of Inspection: Monday, July 21, 2025

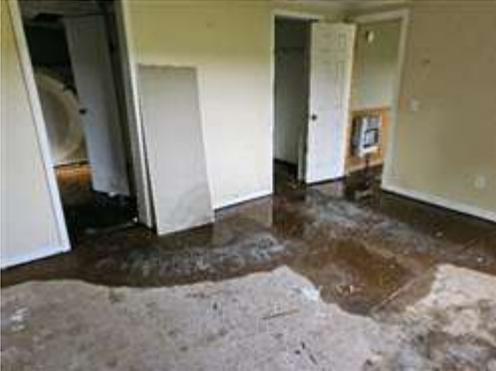
##### (A3 - 1.1) Main House

Due to the leak in the master bathroom, the floors in the master bathroom, master bedroom, master bedroom closet, living room, and laundry room are actively wet with standing water. This can effect the integrity of the flooring system. A licensed general contractor should be consulted for review.

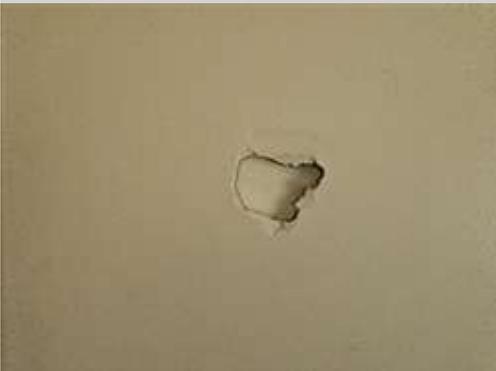
**(H1 - 1.4 ) All Rooms**

The wall next to the door in the master bedroom was noted to be damaged. A general repair specialist or licensed general contractor should be consulted for review.

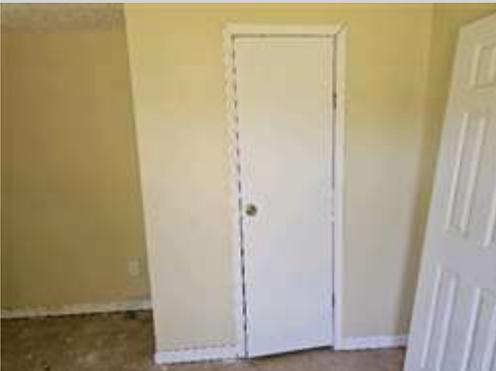
**(H1 - 1.5 ) All Rooms**

The doors in the following locations are not plumb: rear right bedroom closet door (closes by itself), front right bedroom closet door (closes by itself). The doors do not stay in a set position. This can indicate an issue with installation or the hinges. A general repair specialist should be consulted for review.
