Property Inspection Report

Report Number: 1860 - 9/9

1860 Oak Harbor Drive
Ocean Isle Beach, North Carolina 28469

Date of Inspection: Tuesday, September 9, 2025

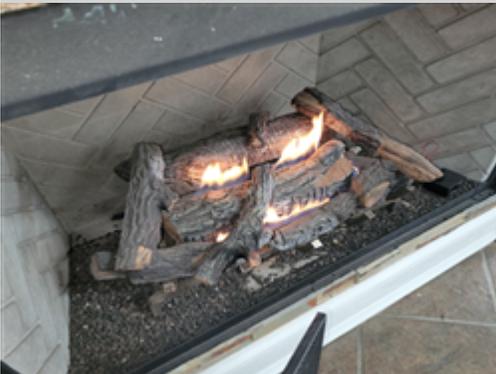
(H6 - 1.1) Fireplace: Pre-Manufactured: Metal: Box: Gas Logs

The fireplace logs were lit and found to function as intended.
