# Structural Building Conditions Assessment Report

## Ocean Point Resort Condominiums

January 12, 2022  
Ardurra #2021-1159-00

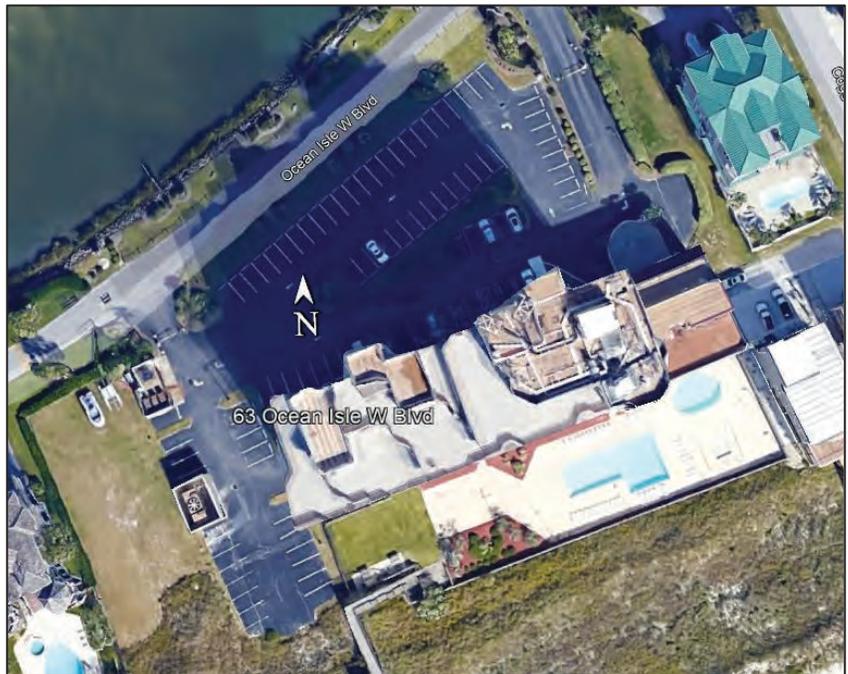
**Photo 1: Aerial Overview**

See **Photo 1** for an aerial overview of the Building and adjacent parking lot.

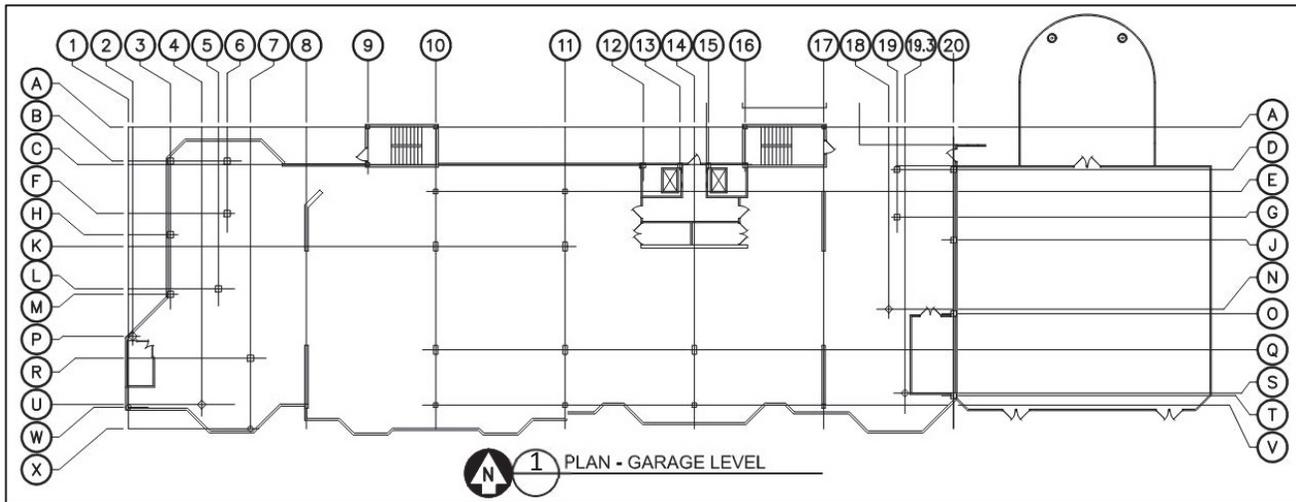
Overall, the exposed columns, slabs, shear walls, and underside of the 1<sup>st</sup> elevated floor appear to be in relatively good condition and coatings are good. Some slight deficiencies were noted on the bottom of the slab and some of the walls. A few columns, located near or at the southern edge of the Building and near the western end of the Building were observed with partial to full delamination of one or more faces and in need of repair as noted below. See **Plan 1 Garage Base Plan** below.
