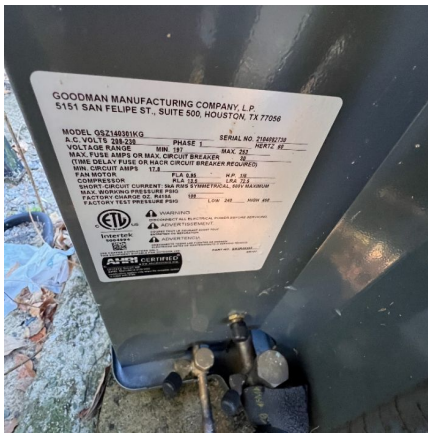
Location: Exterior: Crawl Space
Heating Unit Type: Heat Pump: Split System
Energy Source: Electric
Inspection Method: Operated, Covers Not Removed
 (F1-1.1) Heating Unit 1

The 2021 Goodman electric heat pump system was operated in both the heating and cooling cycles and appeared to function as intended. All system components, including the air handler which is located in the crawlspace, were visually evaluated with no noted defects.

HVAC systems should be regularly serviced to maintain optimal performance. If service is desired, a licensed HVAC contractor should be consulted.

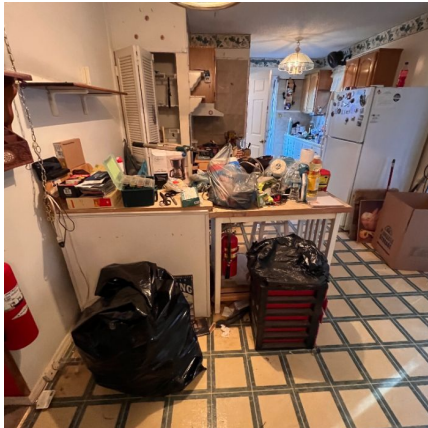
(H1-1.1) All Rooms

Multiple areas contained storage and furniture which impeded the home inspection. Not all closet/cabinet areas, interior electrical receptacles, windows or finished surface components were safely accessible and/or evaluated.
