## Pre-listing Home Inspection Report

242 Black Bear Way, Ellsworth , ME 04605

Friday July 10, 2026

071026

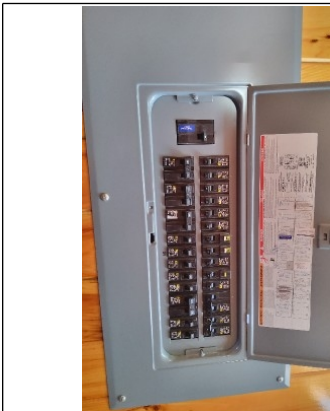
**Comments** Panel size was marginal and may need to be upgraded for future needs.  
Branch breaker distribution appeared normal.  
No signs of overheating were evident at the time of the inspection.  
Outlets were randomly tested and had correct polarity, except as noted.

Main electric panel located in 1st floor hallway

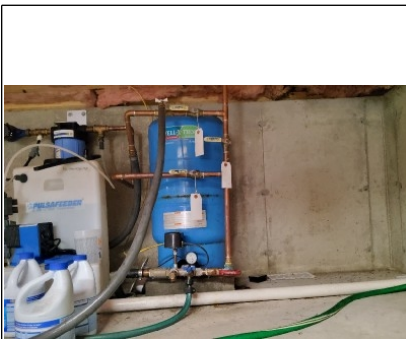
Water entrance along the north side of the basement

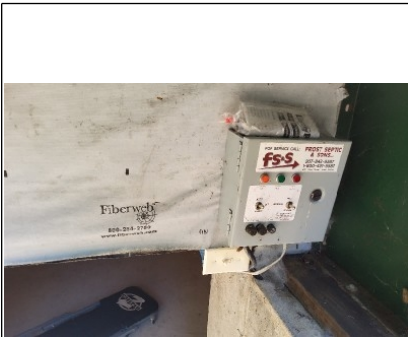
Septic tank high and low water alarm located in the basement bulkhead door

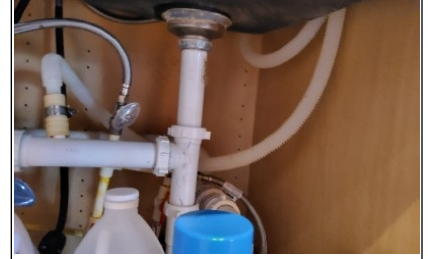
Dishwasher drain line is looped to prevent sink water from back flowing into the dishwasher

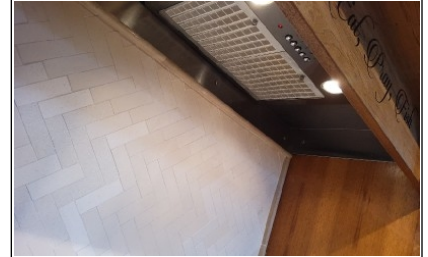
Exhaust fan is noisy

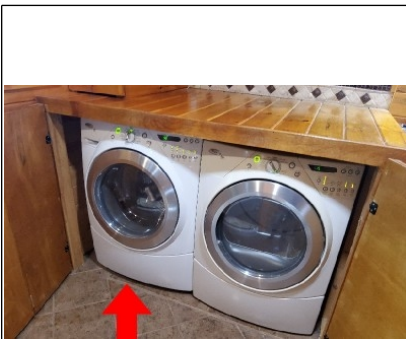
Washer and dryer in 1st floor bathroom
