## **Green Bridge Home Services, LLC Inspection Report**

Prepared for: Katie Hitch & Lee Roe  
Location: 57 Ellsworth Rd, Blue Hill, ME  
Date of Inspection: 6/12/2026

## Inspection Report

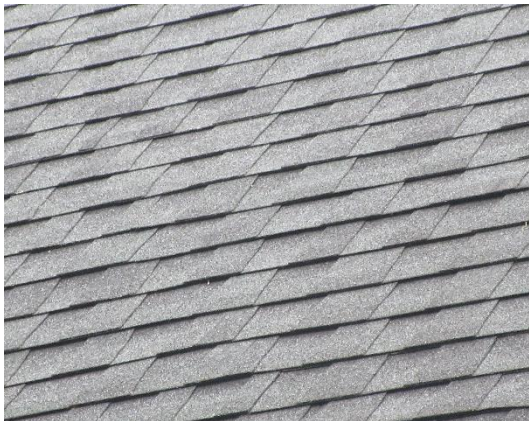
<b>Roof</b>	Rating	Description	Comments
<b>Access</b>			
		eye view	
<b>Covering</b>			
type		arch asphalt shingles	
condition		acceptable	
defects	MI	multiple areas	moss growth; will reduce life of shingles, pressure wash or chemically clean to clear
ridge venting		none observed	
layers observed		single	
<b>Gutters</b>			
need cleaning?	MI	yes	
adequate dispersion?		yes	
<b>Chimney</b>	A		
location/purpose		south	furnace & wood stove
material		brick masonry

**shingles close up**

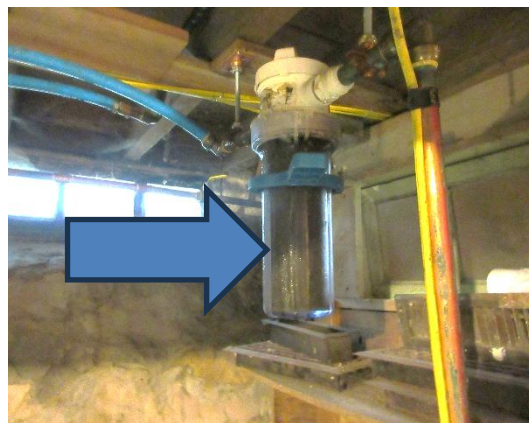
MI	inline filter(s)	filter will need to be occasionally changed.
service provider		unknown

water treatment

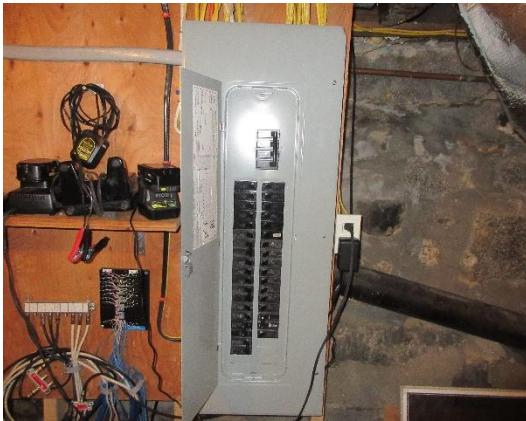
main breaker panel(s)

<b>Electrical</b>	Rating	Description	Comments
<b>Service Entrance</b>			
service wire & support		acceptable	
meter loc & condition		north ext wall	acceptable
main disconn at meter		none at meter	
grounding		visible	
<b>Main Panel</b>			
location		north wall	basement
clearances		acceptable	
amp rating		200 amp	
panel condition	AOC	water in bottom of panel	appears to be entering in from
fuses or breakers		breakers	
avail slots or full?		available	
open (uncoverd) slots?		none	
AFCI breakers		none	AFCI breakers are recommended
double tapped circuits	MI	yes	two
bonding confirmed		yes	
<b>Branch Wiring</b>			
type	A	nm (Romex)	
<b>Switches, Outlets, Other</b>			
location/defects	AOC	basement	uncovered boxes; should be covered
GFCI		acceptable	
tamper resist outlets		partial	
<b>Generator</b>			
	NI	none observed

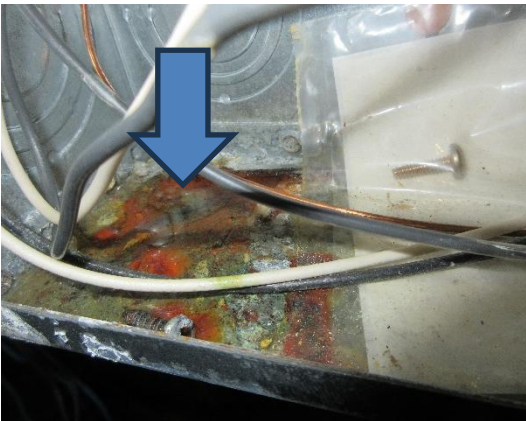
- Electrical:
  - There is a puddle of water in the main electrical panel. This appears to be coming out of the heat pump wire. We recommend contacting the heat pump contractor who installed the system and having a new line installed. The water is entering the panel through the protective sleeve from the heat pump electrical wire. The whole line should be replaced, as there is water inside the protective sleeve, dripping into the panel. The breakers for the heat pump should also be replaced as they are rusty.

water in bottom of main panel

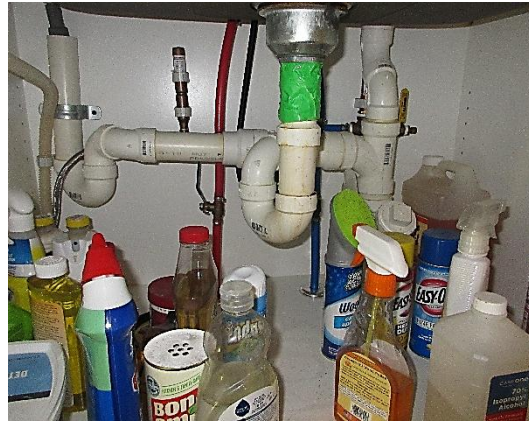
<b>Kitchen(s)</b>	Rating	Description	Comments
<b>LOCATION</b>		first floor	
<b>Outlets</b>	<b>A</b>		
GFCI's		present	
grounded wiring?		yes	
sufficient # of outlets		yes	
<b>Sink</b>			
faucet & sprayer		acceptable	acceptable
shutoffs and trap		observed	
leaks	<b>MI</b>	drain line under sink	tape on drain line, may have had previous leak, recommend plumber to correctly fix leak
<b>Stove</b>	<b>A</b>		
fuel		Propane	
burners		working	
oven(s)		working	
exhaust fan		working	
<b>Refrigerator</b>	<b>A</b>		
		working	
icemaker/water		none observed	
<b>Garbage Disposal(s)</b>	<b>NI</b>		
		none observed	
<b>Dishwasher</b>	<b>A</b>		
		working properly as can be observed	
plumbed properly		acceptable	
<b>Other</b>	<b>A</b>		
acceptable lighting		acceptable	
outlet at island/peninsula		acceptable	
loose countertop?		none observed

**plumbing under kitchen sink**

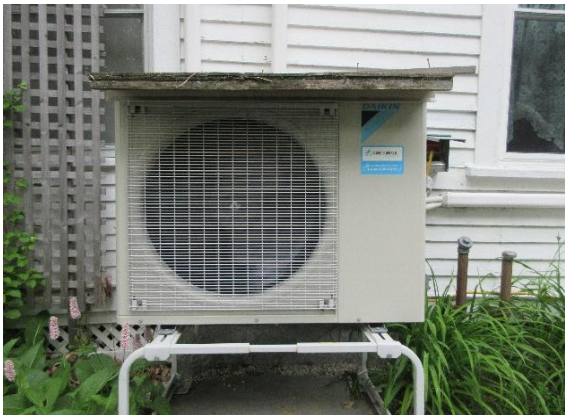
**heat pump**

<b>Fireplace or Alternate Heat</b>	Rating	Description	Comments
Location	A	kitchen, 1st floor bedroom,2nd floor southwest bedroom, primary bedroom	
fuel		electric	
type & brand/model		heat pump	Daikin/4mxl36tvju
operating during insp?		operated on/off	
clearances		acceptable	
dampers, vents working		verified	
chimney conn/lining		n/a	
cleanout		acceptable	
CO level (ppm)		acceptable	
Location	NI	living room	
fuel		wood	
type & brand/model		stove	Hearthstone/Manchester
operating during insp?		not operated	
clearances		acceptable	
dampers, vents working		verified	
chimney conn/lining		acceptable	tile lining observed
cleanout		n/a	
CO level (ppm)		not operated

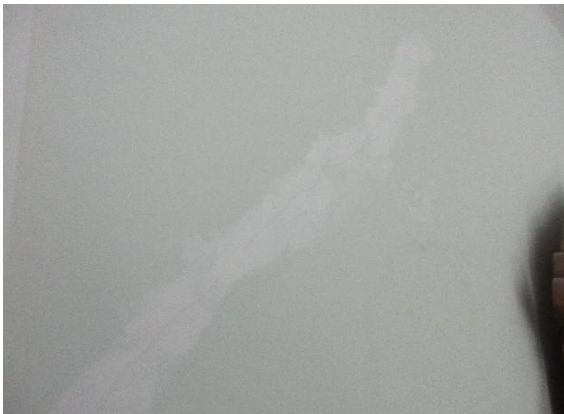
**repair marks**

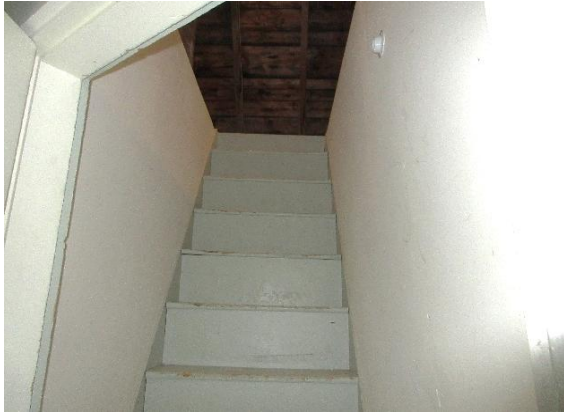
<b>Attic</b>	Rating	Description	Comments
<b>Access</b>			
	AOC	stairway	stairs should have handrail, fall protection around top if stairs
entry		fully entered attic	
insulated at entry		n/a	
<b>Ceiling Insulation</b>			
thickness (in)/type	A	6"	between rafters in areas
<b>Ventilation</b>			
type	A	attic window	no rafter vents observed
<b>Roof Framing</b>			
type & size		rafters	2 x 6
spacing		24"	
sheathing		3/4 to 1" boards	
<b>Other</b>			
chimney		acceptable	
plumbing vent		acceptable	
bath vent (s)		none observed	
poss mold/moisture		none observed	
moisture content		8%	acceptable
evidence of pests		none observed

**attic access**
