**CERTIFIED INSPECTION
SERVICES Inc.**

Home Inspection Report

17 Main Street, Albion, AK 04910

Friday November 8, 2024

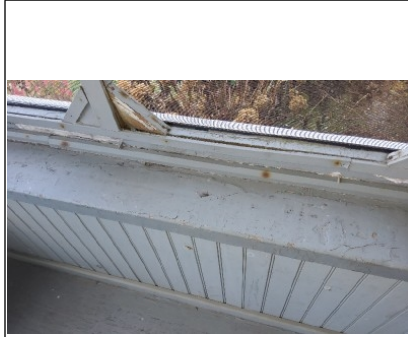
Chipping and peeling paint. Homes of this age may contain lead base paint. Maintain painted surfaces to minimize lead paint exposure

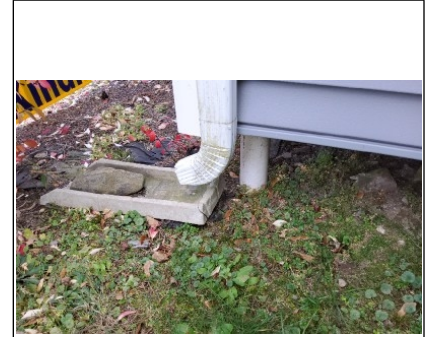
Porch supported by frost free posts

Comments The porch is supported by steel post which can deteriorate overtime. Monitor porch supports periodically for movement.
Underside of porch not visible, no representation is made.

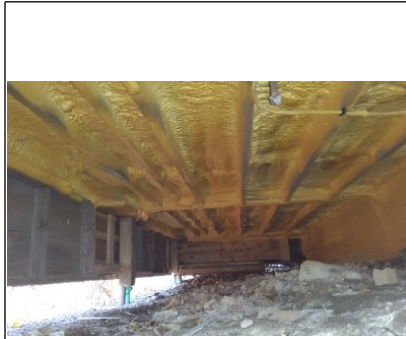
Framing has been covered with foam insulation

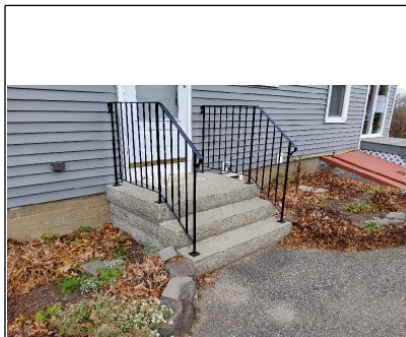
South entrance steps

Comments Step risers are uneven, may present a trip hazard. Recommend repair and/or replacement

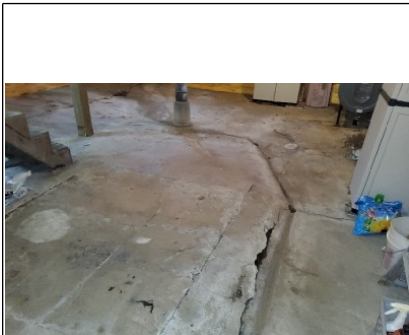
Comments Floor appeared to be in overall satisfactory condition.
Floor had typical cracks.

Concrete slab, hummed in the center to divert water seepage toward the sump pump

8. Filling cracks with a water plug cement along base of southwest and concrete slab of the basement may reduce water seepage. Lowering sump pump may reduce groundwater conditions beneath the concrete slab and reduce water seepage observed in the basement. Install a cover on sump pit.

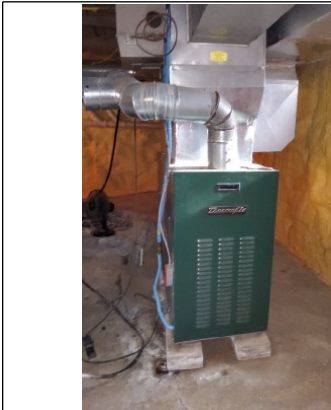
Oil,fired forced hot air furnace

Comments Recommend furnace be cleaned and serviced if not conducted within the last twelve months.
Last date the furnace was serviced is not labeled. Recommend furnace be cleaned and serviced if not conducted within the last twelve months

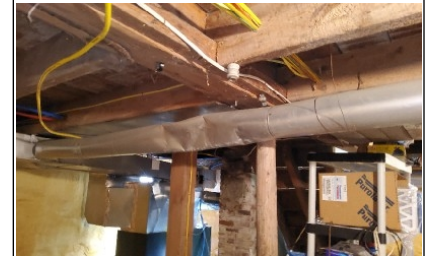
Some ductwork is dented
