Septic Inspection Report

Report Confirmation#: (366)-2025

Conclusion: At the time of this septic inspection, I found this septic system to be functioning but not as designed due to only 1 of 2 drain lines outflowing.

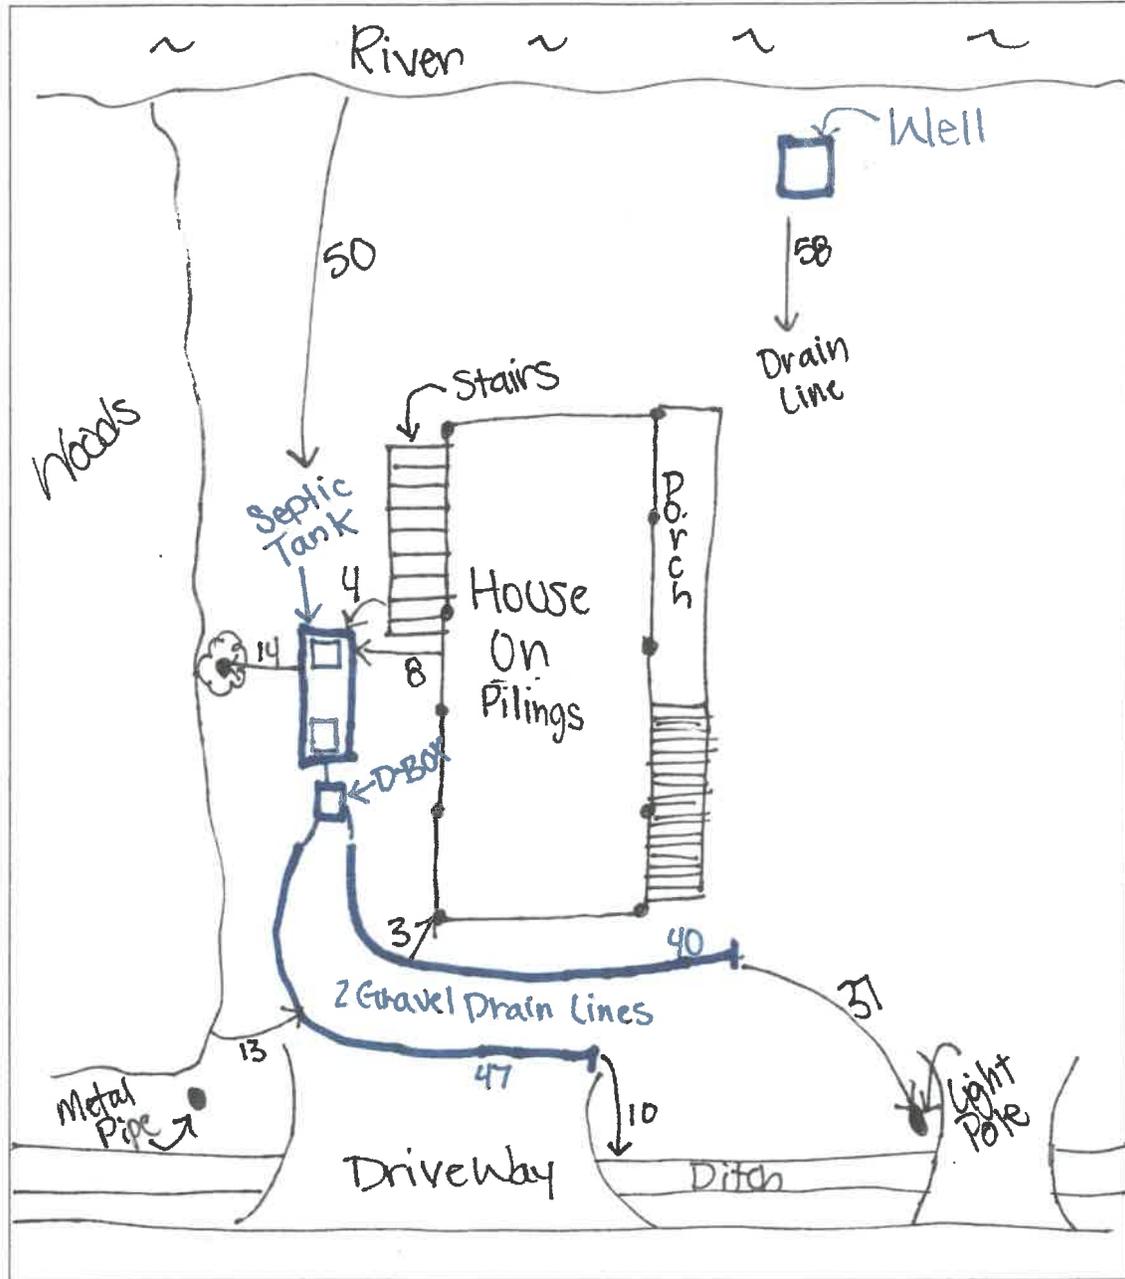
Septic System Location:

****This Diagram Is Not to Scale & Features/Placement Shown may Not Be Exact****

****The Permit(s) should be Reviewed Regarding Location of the Septic Repair Area****
