Reference: Engineering Services  
4 Laurel Circle  
Foxfire, NC 27281  
TE&D Project No.: 2201-020959

As requested by the client, a representative of Tyndall Engineering & Design, PA (TE&D) was on-site to observe the following items for the front and rear home addition:

- 1) Assessment of damaged trusses at the rear left of the home due to a fallen tree.

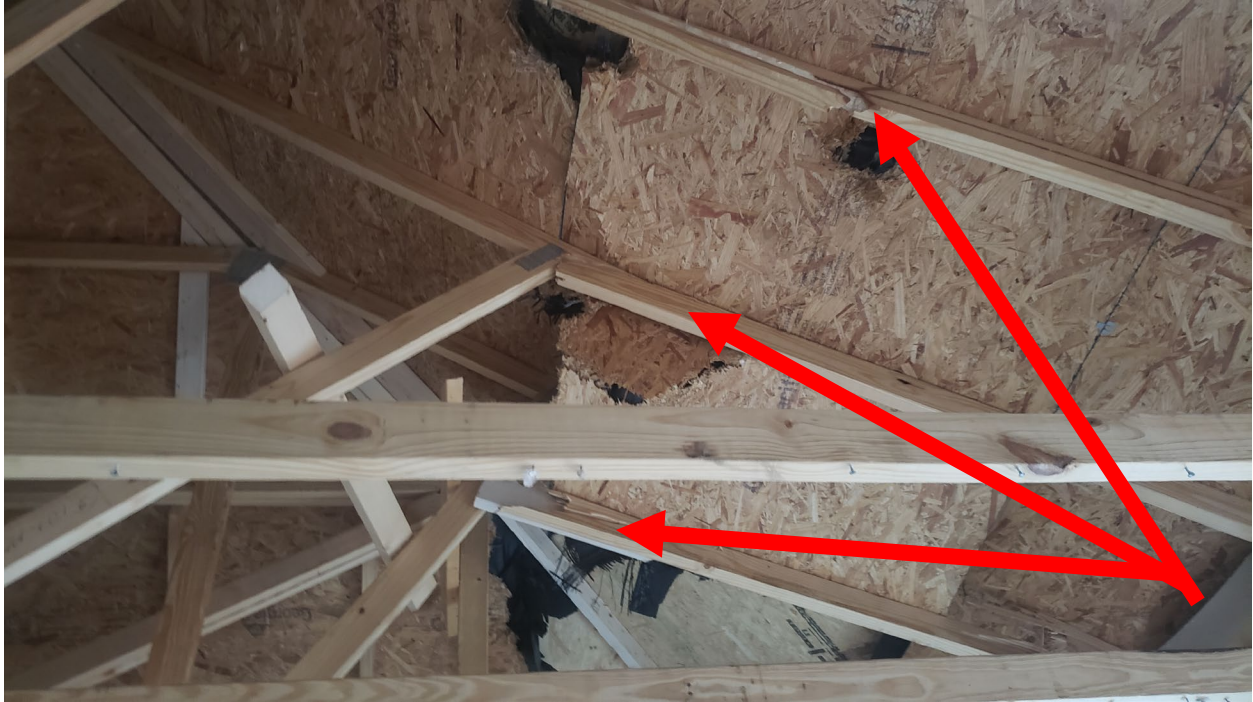
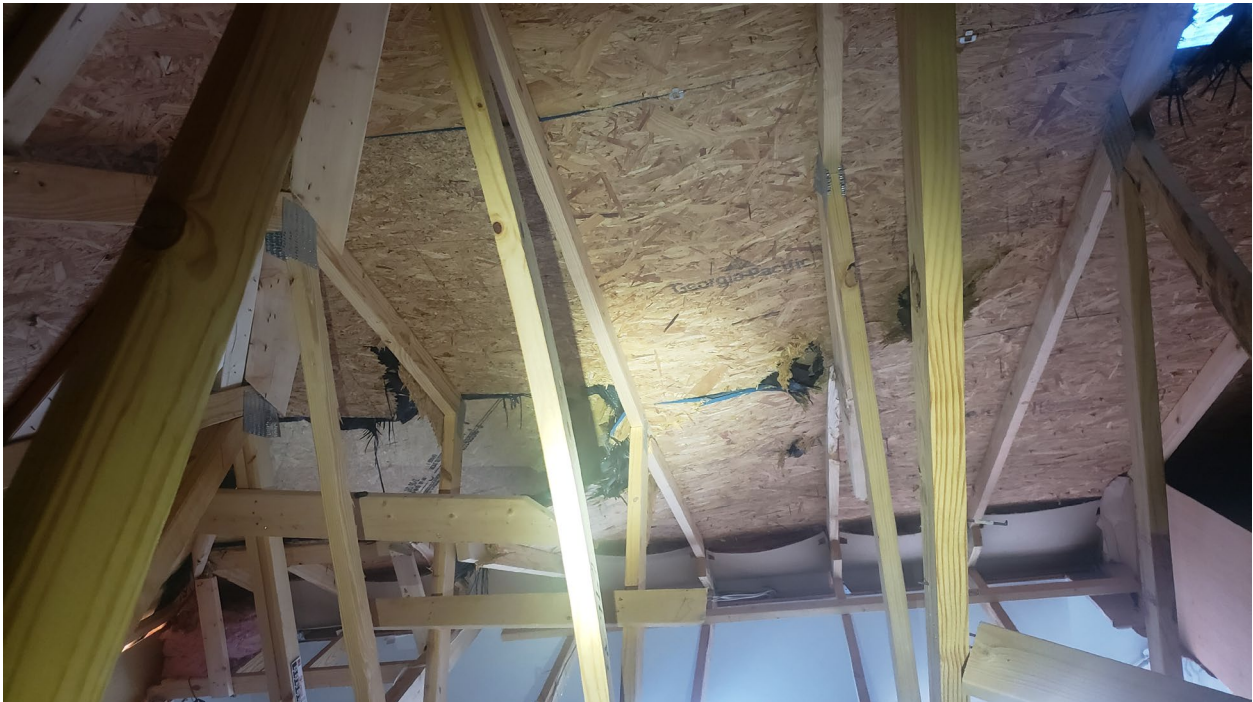
- 1) We observed several trusses that had been damaged due to the fallen tree. Based on our observations and analysis, TE&D recommends the following repairs be made:

**Examples of damaged trusses/areas to be repaired**

- b. We also observed the top chords and webs of several single ply trusses were damaged/missing at the rear left of the home. TE&D recommends installing new full length 2 x 4 members as needed for the damaged/missing top chords and webs of the remaining trusses. 2 x 4 members are to be fastened with (2) 10d toe nails at each end. At all gusset intersections, new 24" x 24" x 23/32" OSB gussets are to be installed at both sides of the truss. Gussets are to be centered at the intersections and fastened to all members with (2) rows of 8d nails at 4" o.c.

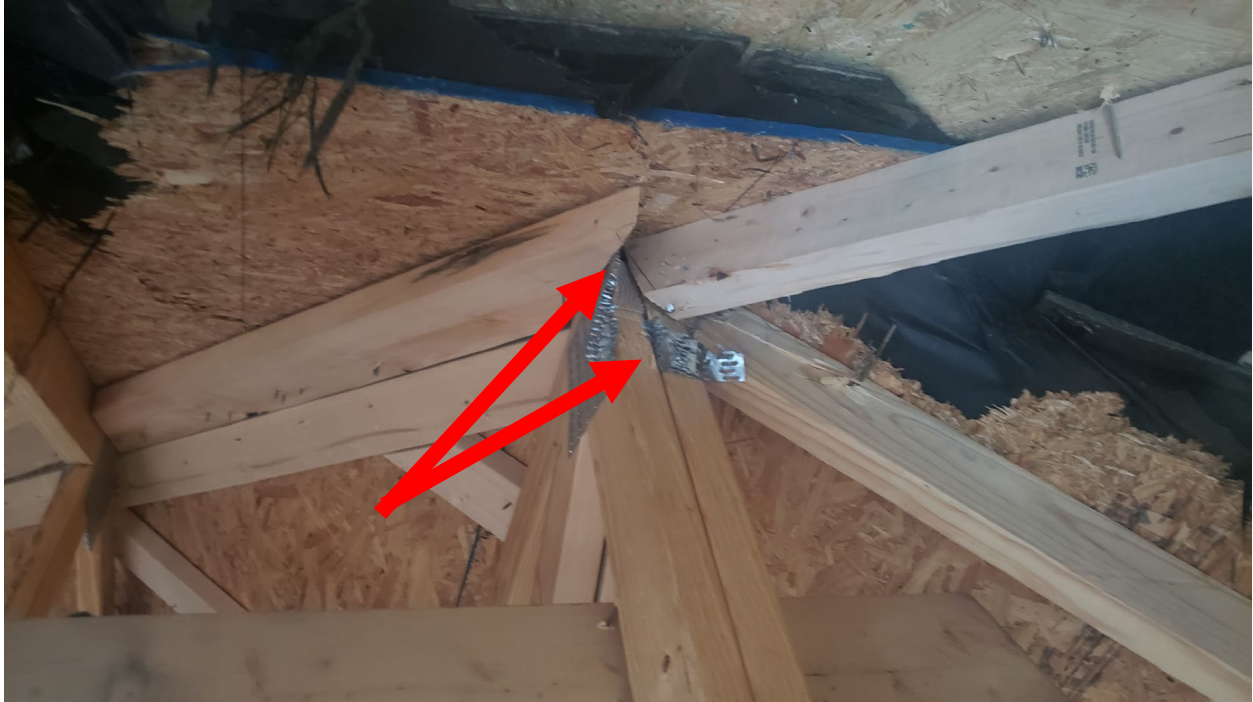
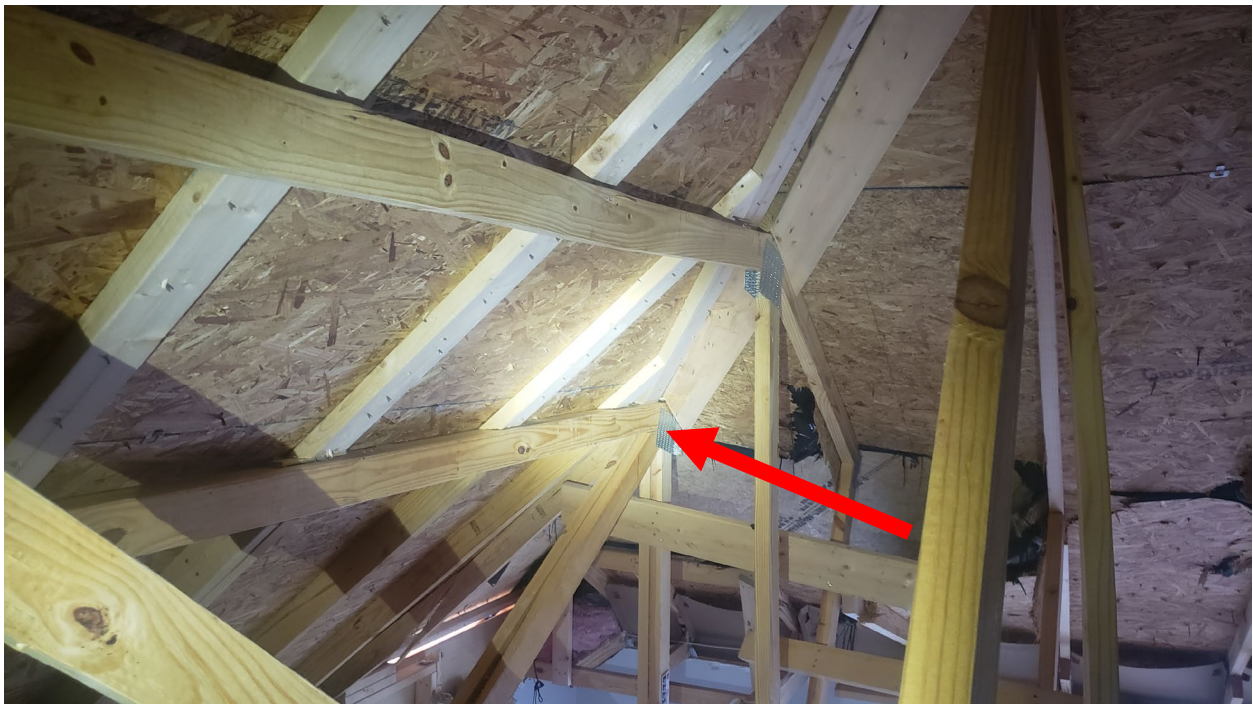
**Item 1a) Girder truss to be repaired**

- a. We observed the top chords/webs of the girder truss were damaged/missing at the rear left of the home. TE&D recommends installing a new full length (2) 2 x 4 members with (4) 10d toe nails at each end and to each other with (2) rows of 10d nails at 4" o.c. At the gusset intersections, new 36" x 36" x 23/32" OSB gussets are to be installed at both sides of the girder truss. Gussets are to be centered at the intersections and fastened to all members with (2) rows of 8d nails at 4" o.c.
