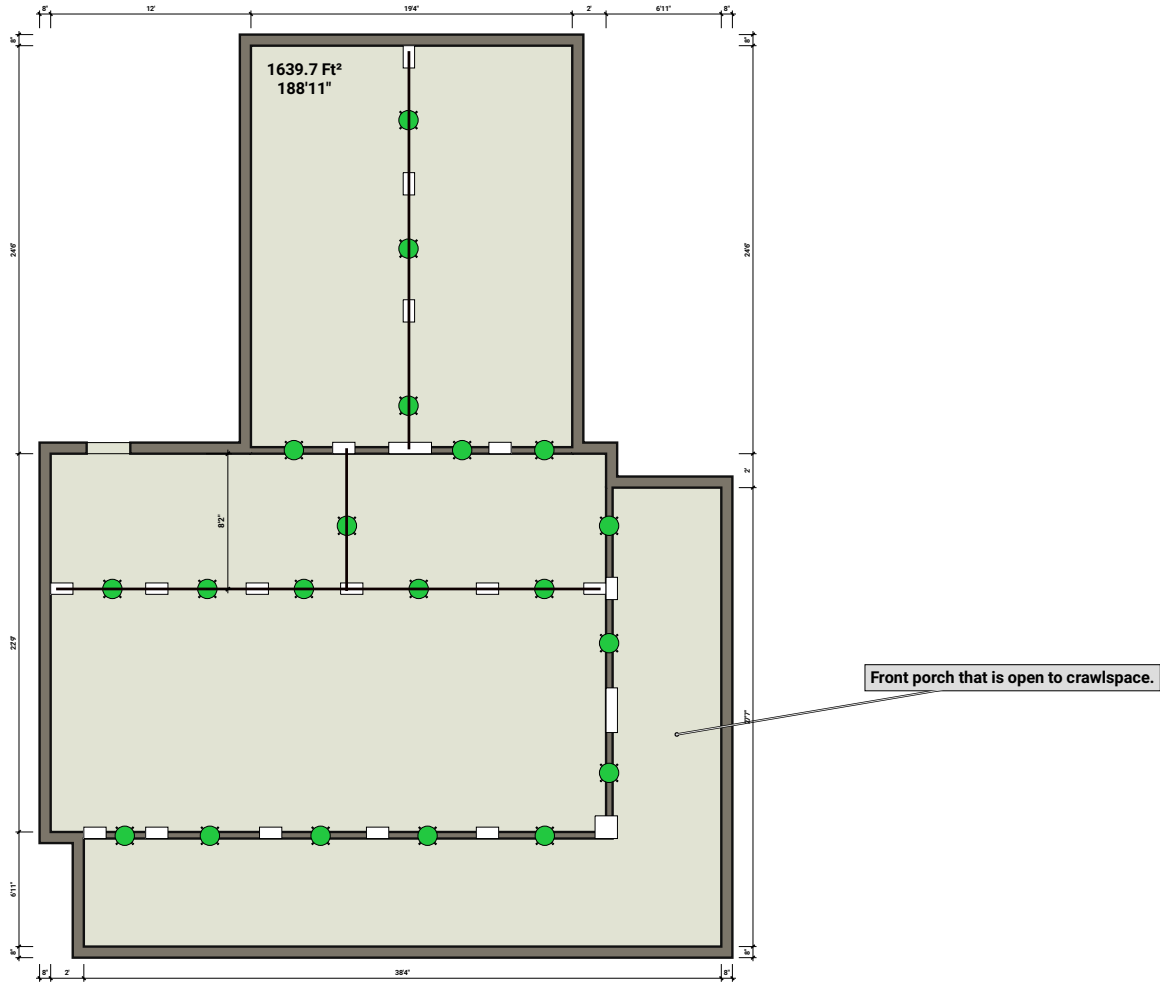
Front porch that is open to crawlspace.

- - Failing brick pier due to mortar degradation.
- - PowerPost Jack to support load bearing members.
- - Drop girder.
