Property Inspection Report

Report Number: 2025058

213 Nine Mile Road
Newport, North Carolina 28570

Date of Inspection: Monday, June 30, 2025

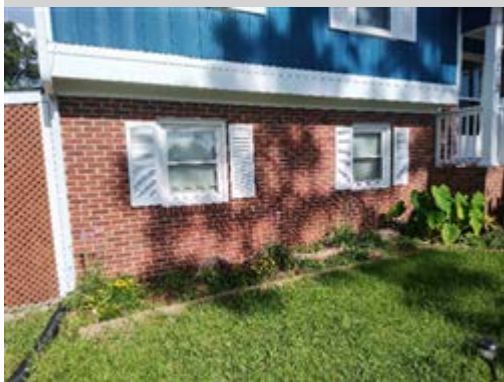
(A1 - 1.4) Main House

The slab is not visible for inspection.

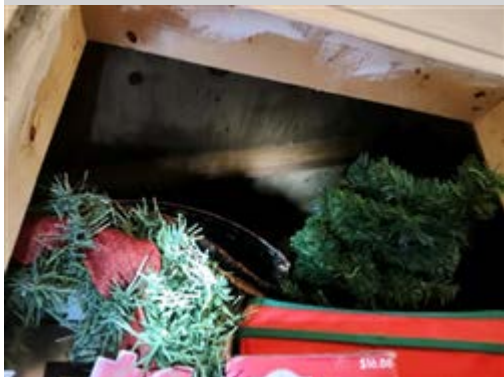
(A6 - 1.7) Main House

Attic over the living room and kitchen were not accessible

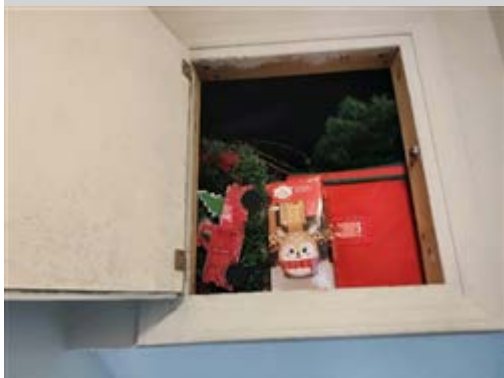
(A6 - 1.8) Main House

Attic over the living room and kitchen were not accessible

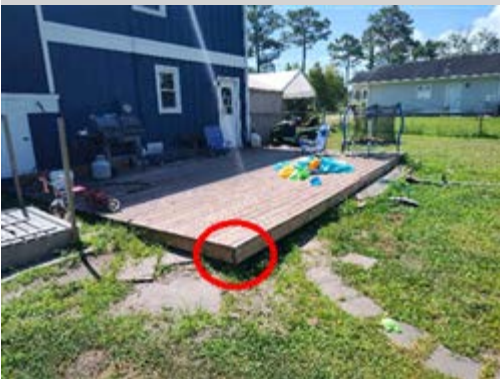
(B3 - 2.2) Deck

A glimpse of the framing below the decking. It appears the bands/girders are attached to the side of the post/4x4 and are not bearing supported. This method of construction (nonbearing supported) requires each connection to be through bolted with 5/8" galvanized bolt nut and washer. (or equal). The joist are also not bearing supported (no ledger or joist hanger). The joist are supported by nails driven through the band into the end of the joist. Joist should be bearing supported. A repairman/carpenter can repair.

The bands and girders are not bearing supported so they should be through bolted with 5/8" galvanized bolts, nuts and washers, or equal.

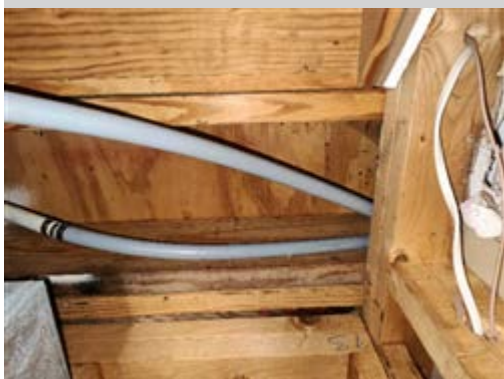
(D1 - 2.2) All Accessible Areas

Where renovations have occurred the piping is PEX, but the main lines in the walls/floors etc is Polybutylene

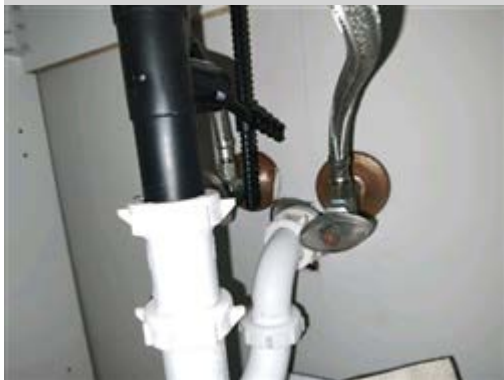
(D1 - 2.3) All Accessible Areas

Polybutylene

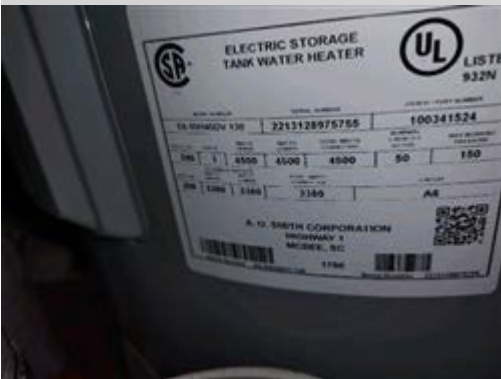
(D3 - 1.2) Unit 1

Manufactured the 13th week of 2022

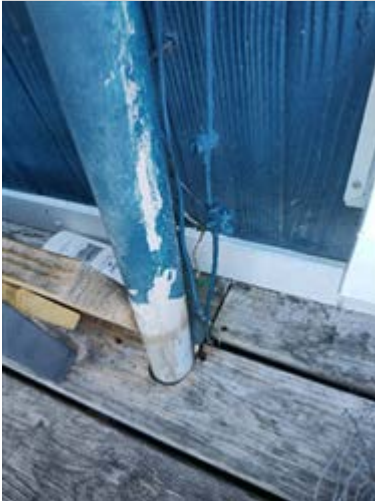
(E1 - 1.2) Underground

I can verify a grounding conductor but the ground rod that is assumed to be there is below the deck

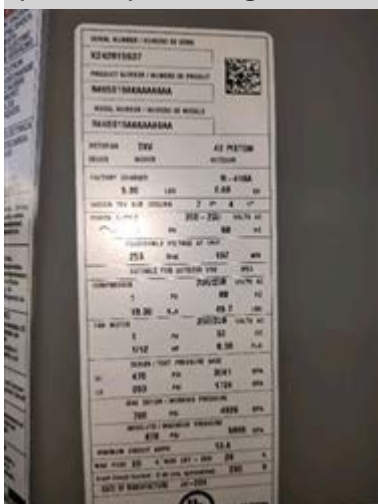
(G1 - 1.2) Cooling Unit 1

Manufactured July 2024

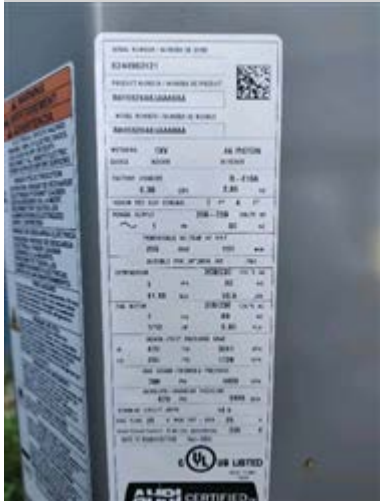
(G1 - 2.2) Cooling Unit 2

Manufactured December 2024

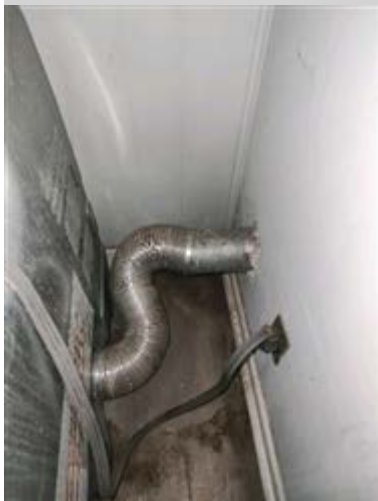
(H1 - 3.2) Laundry

Flex duct and short run through wall

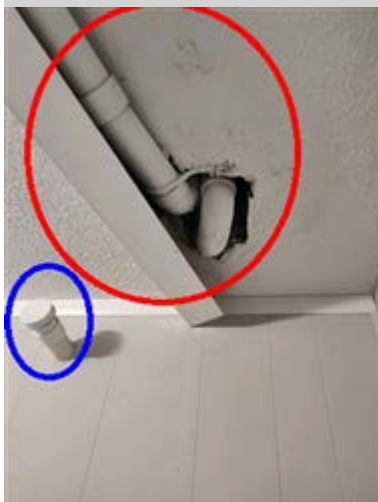
(H1 - 3.3) Laundry

It appears when the upstairs bathroom was renovated the shower drain was installed beneath the ceiling and a visually screening bulkhead was installed to hide the pipe. Not the best practice and workmanship.

Also note air vent (blue circle) that appears to service the 1/2 bath. A second air vent is located on the other side of the bathroom wall near the rear door. Not the best practice and workmanship

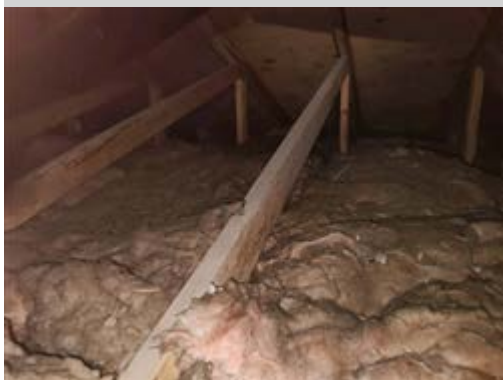
(I1 - 1.2) Attic: All Accessible

Kraft faced batts. R-30

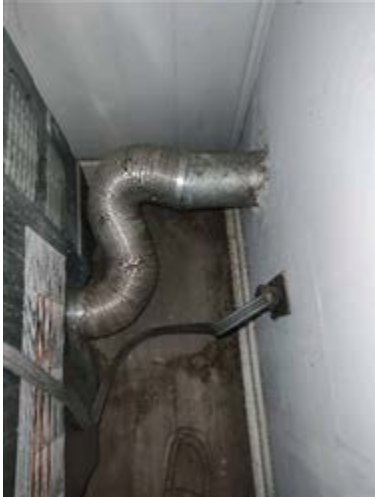
(J1 - 5.1) Vent: Dryer

Location: Attic
