Cabins to Castles Home Inspection, LLC

Property Inspection Report

135 Mimosa , Pine Knoll Shores, NC

Date of Inspection: 9/11/2025 Time: 12PM

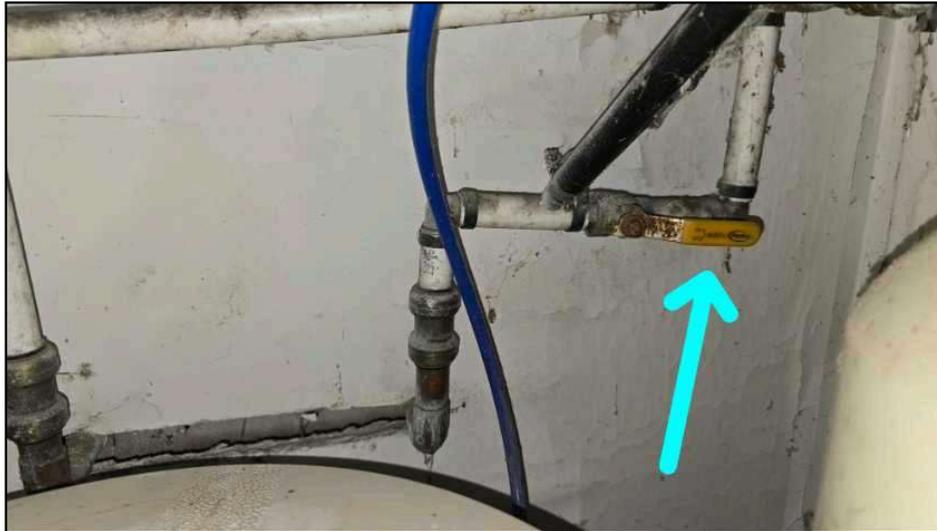
Water shut off valve located in the garage

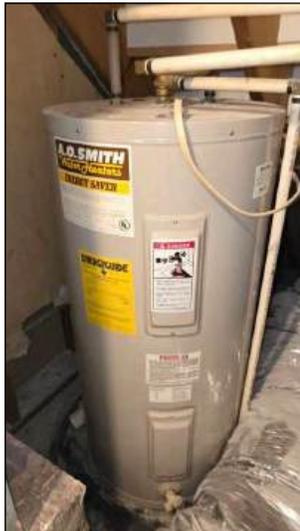
Located under the stairs

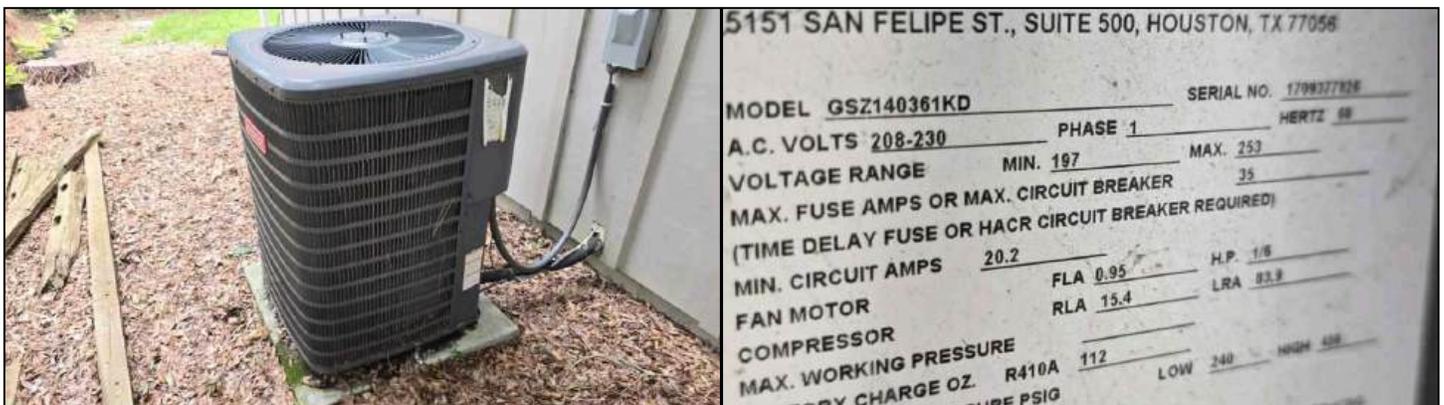
Operating as intended

Manufactured in 2017 year

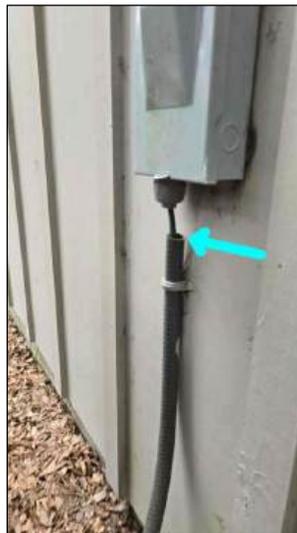
Flexible conduit has slipped off its fitting at the condensing unit electrical disconnect.

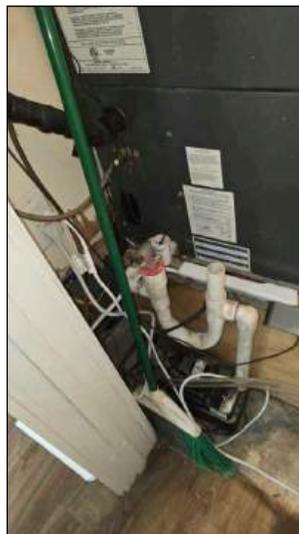
Condensate pump installed. Moisture sensing float switches installed.

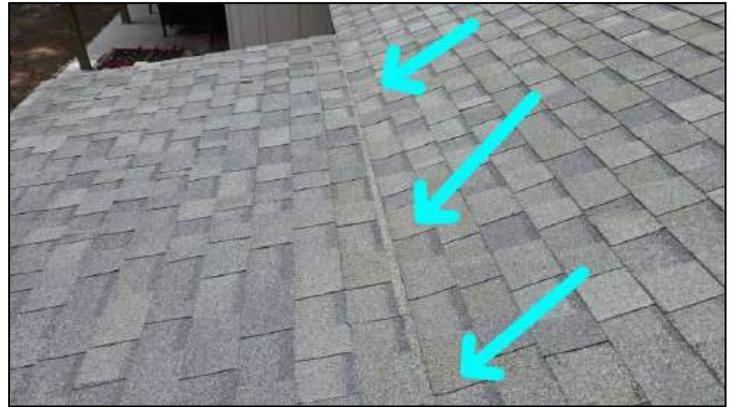
These are the shingles that need to be sealed with roofing sealant to avoid uplift during a major storm.

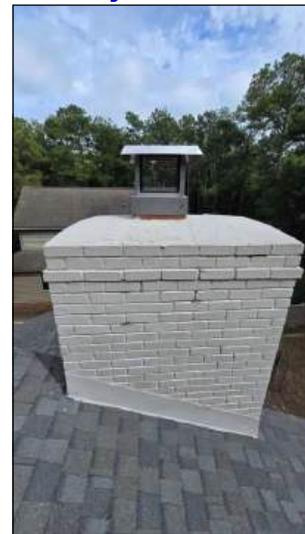
Chimney chase appears in visibly functional condition

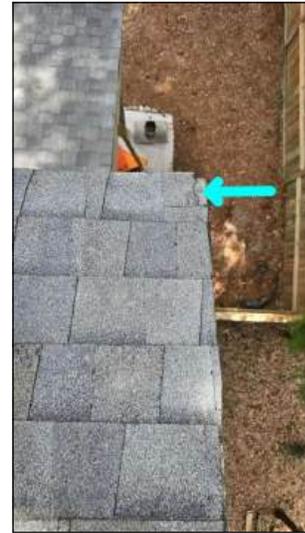
There is also a small area of damage/abrasion from a previous tree limb at the side of the house, which allowed squirrels to access the roof and chew the sewage vent boot flashings, causing damage that needs repair. Refer to the images, especially at the smaller boot flashing that will need replacement.

Previous abrasion of shingle from previous tree limb. Most likely this was the tree limb that allowed the squirrel to access the roof.

Further evaluation and repairs can be completed by a general contractor.

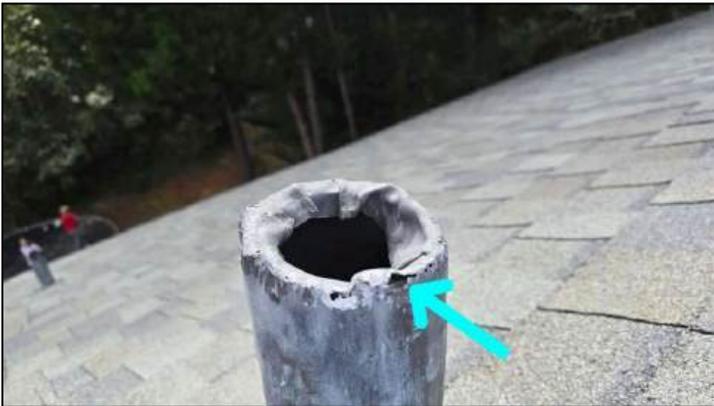
Small chew at the lead boot flashing. But not as much as the other one

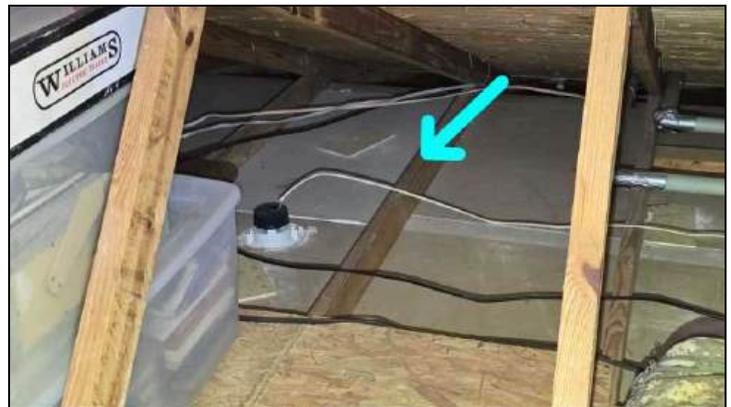
Further evaluation to strap electrical cables is needed to avoid pulling on cables, if storing items in the garage or accessing components in the future, such as over the laundry room as an example.

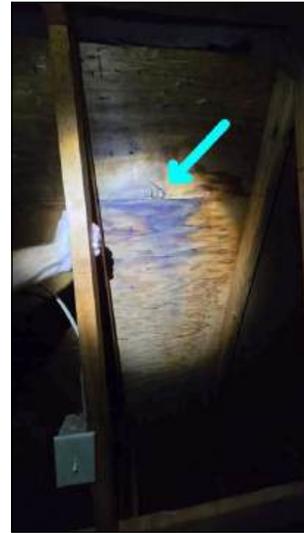
Zoomed out view for reference. This is somewhere in the attic space over the middle bedroom or close to the master bedroom closet area

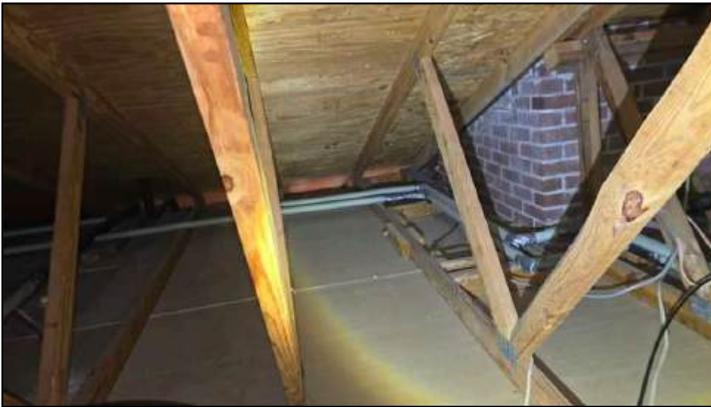
Attic space over the garage

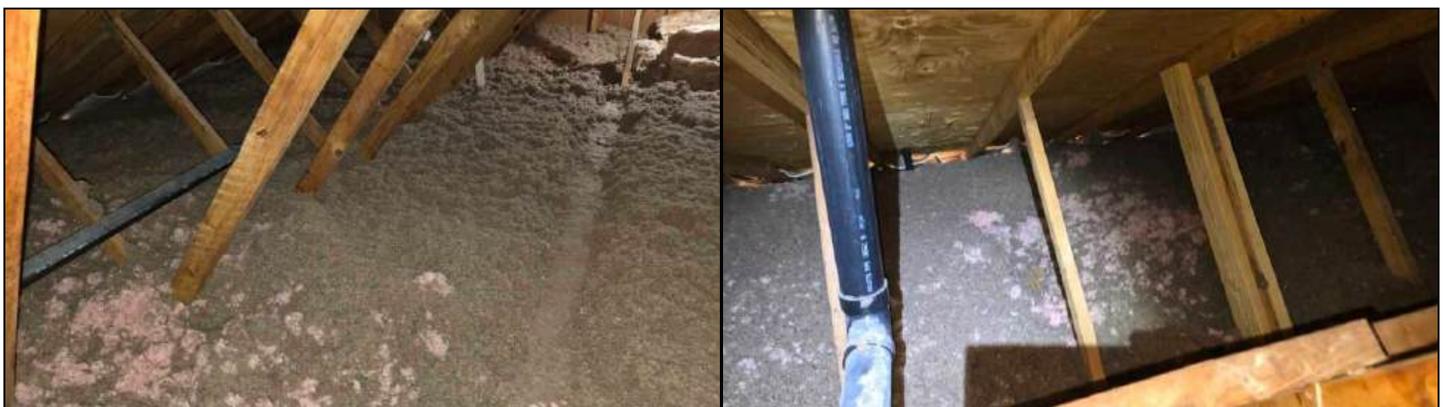
Added insulation above the upstairs area

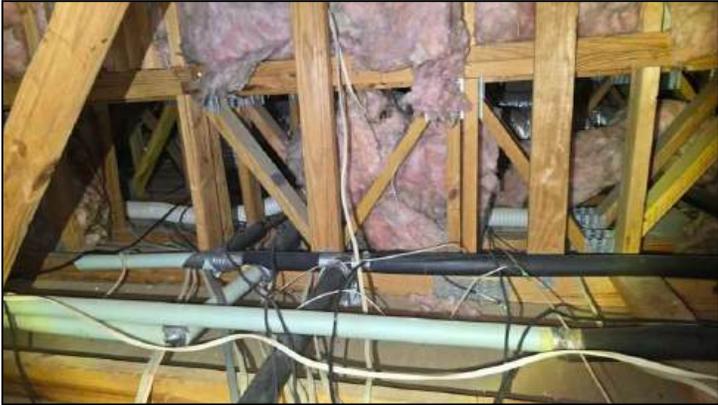
- In the attic space over the garage, the engineered floor trusses of the house were open to view, and the area was not properly insulated. This condition allows heat transfer from the attic into the subfloor system between the first and second levels, which can reduce comfort and efficiency. Over time, it may also contribute to condensation within the floor system.

Not insulated properly at the side of the engineered floor trusses as seen within the attic over the garage

Repairs are needed by a general contractor, insulation contractor, or experienced individual to ensure proper insulation is installed at the sides of the trusses so unconditioned attic air does not enter this assembly.

The insulation repair will be completed by 10/4/25

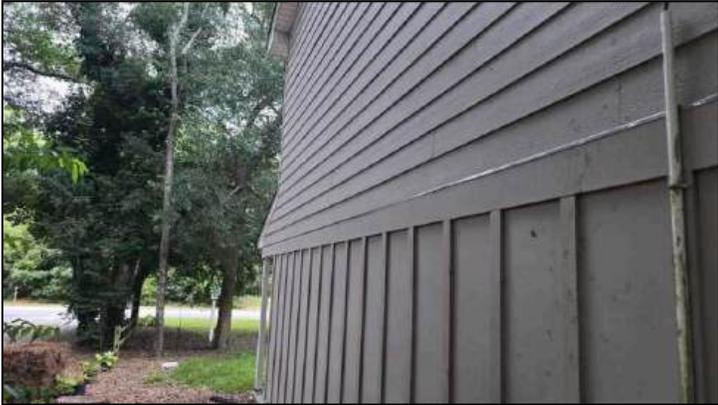
Newer fiber cement wall cladding

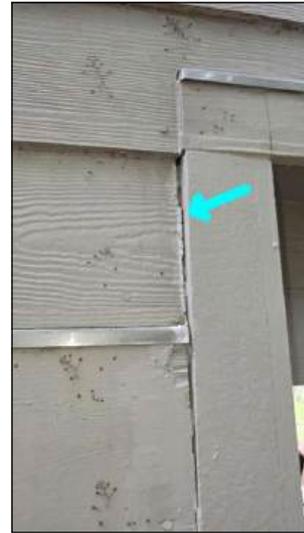
Areas of caulking suggested in the future

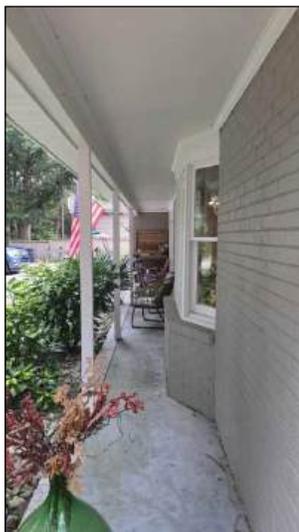
Porches in good condition

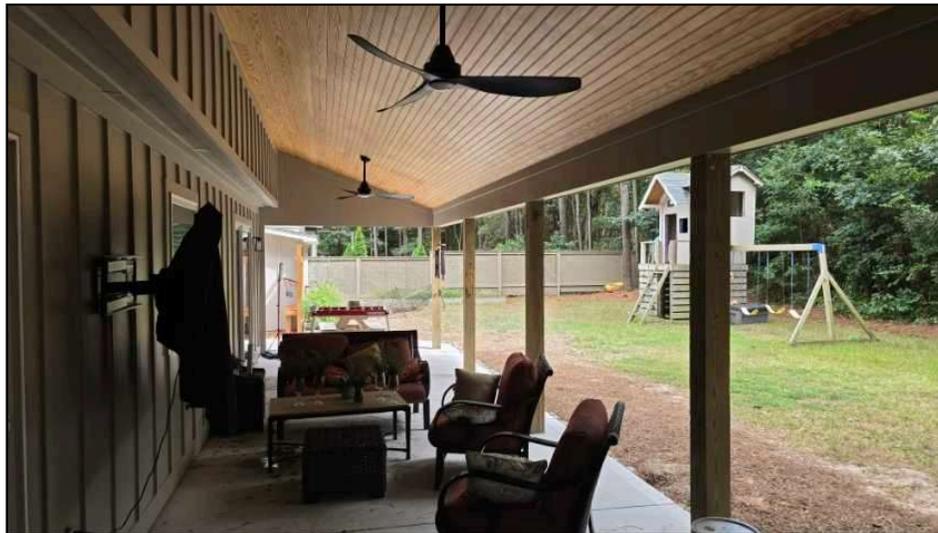
Back porch in good condition with no concerns.

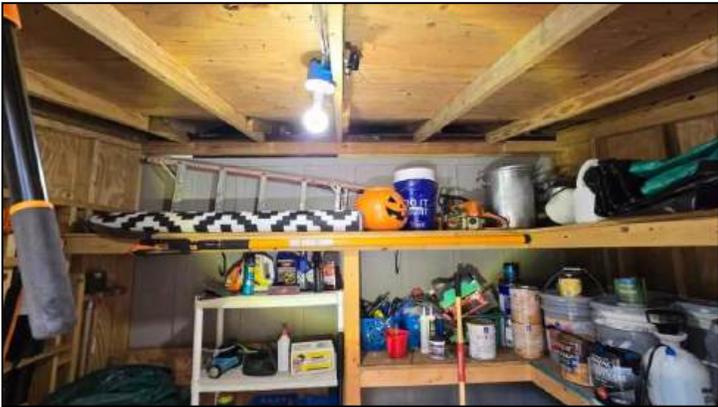
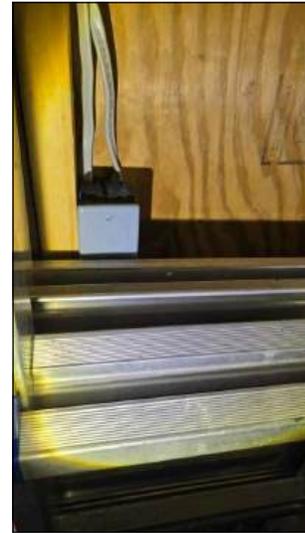
There's no switch for the light at the back exterior storage room attached to the back of the laundry room. It appears that the intended switch has been capped over and you screw and unscrew the light bulb for illumination. However, a pull cord light fixture could also be installed if a switch is not desired.

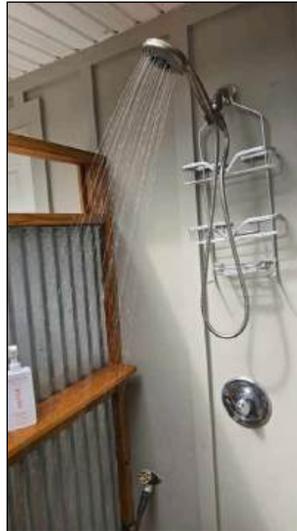
Outdoor shower operates as intended

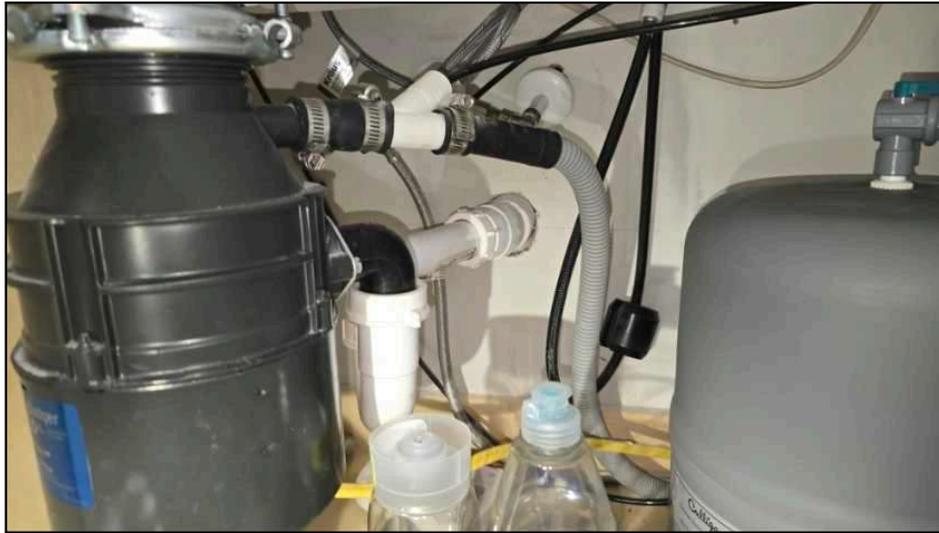
No leaks

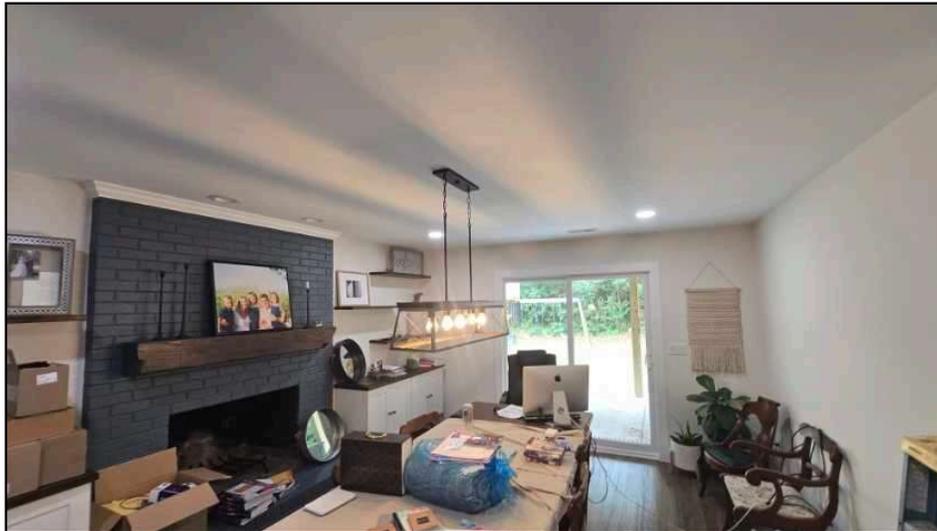
- The recessed light near the fireplace is not operating at this time. Further evaluation is needed to determine the issue. If needed, an electrician can further evaluate if the issue cannot be determined.

This light does operate if the garage lights are on.

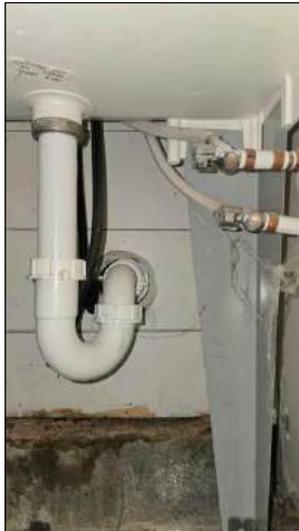
No active leak. Slip joint nut was slightly loose and I tightened it. **Secure legs for additional rigidity if desired.**

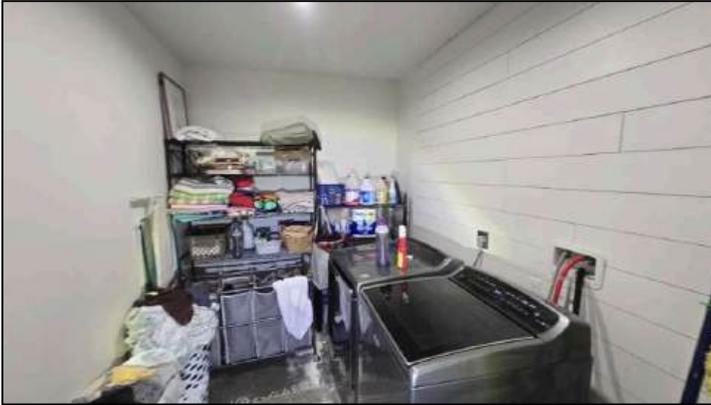
Washer and dryer operated

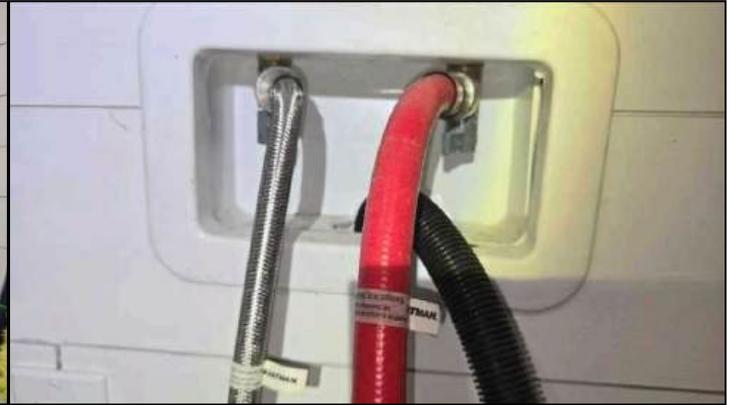
No leaks. Washer and dryer operated

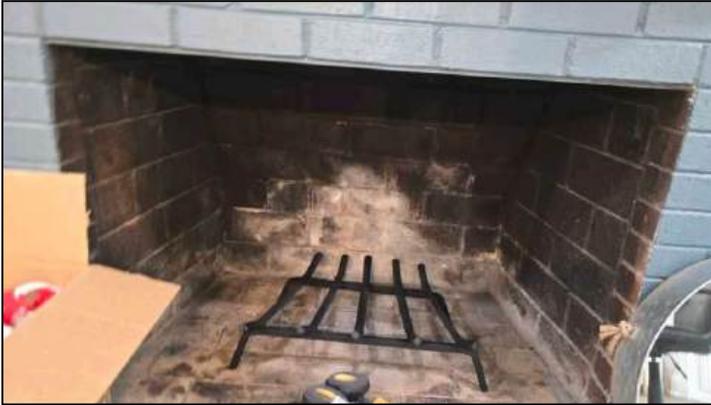
Wood burning fireplace present in the dining room.
No visible major damage at the installation in visible areas.

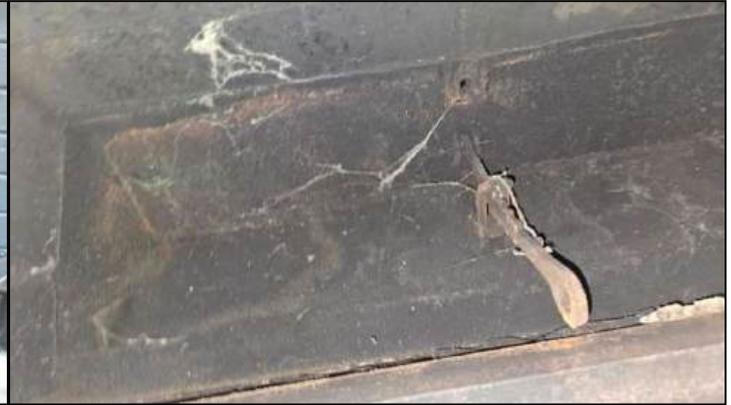
The damper does operate

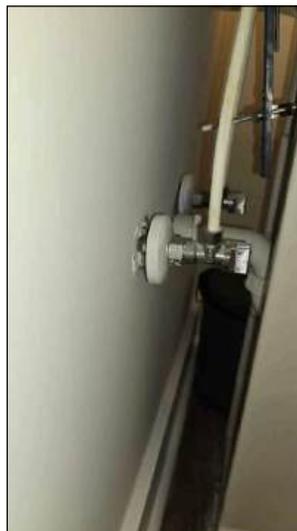
No leaks

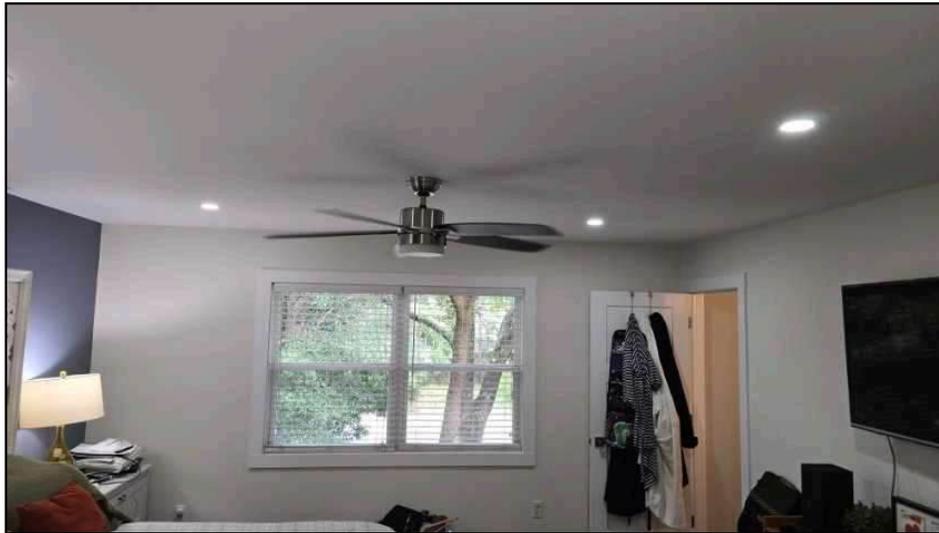
- The light switch and light operates as intended.

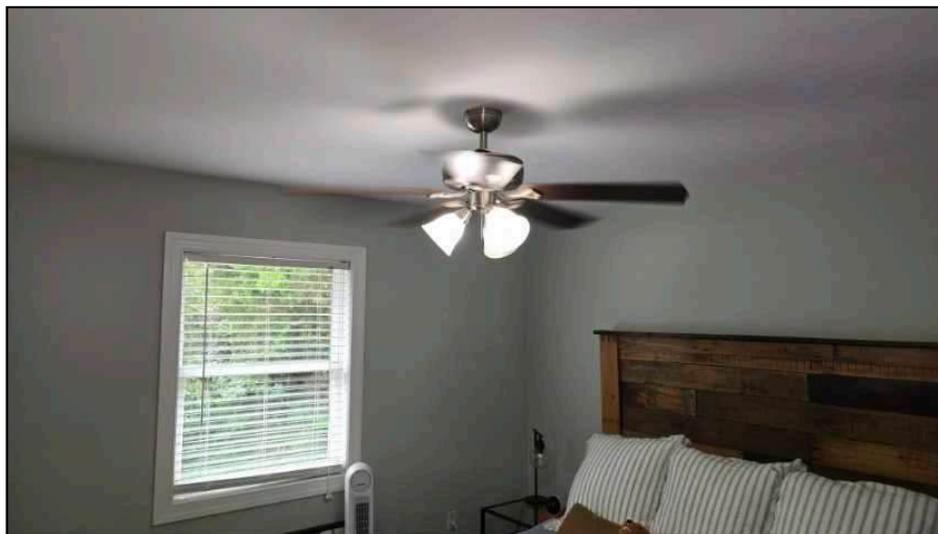
- The light switch and light operates as intended.

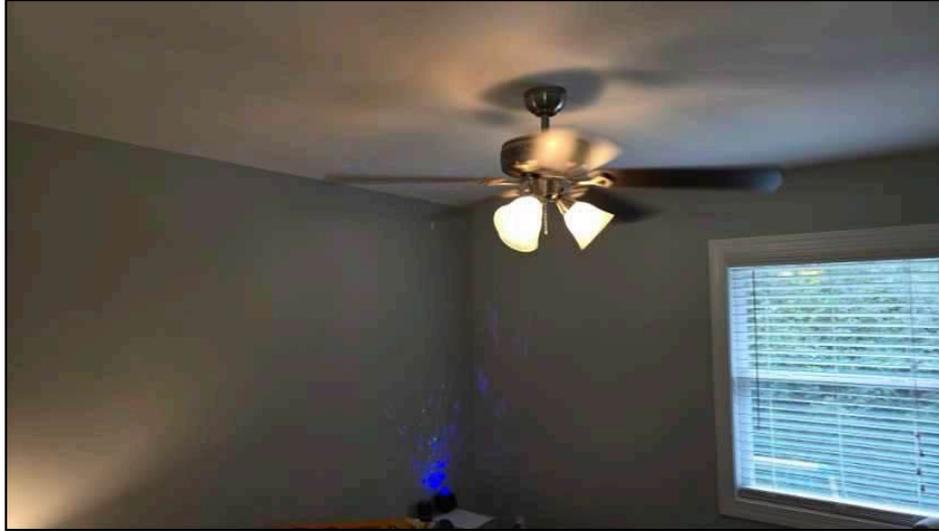
- The light switch and light operates as intended.

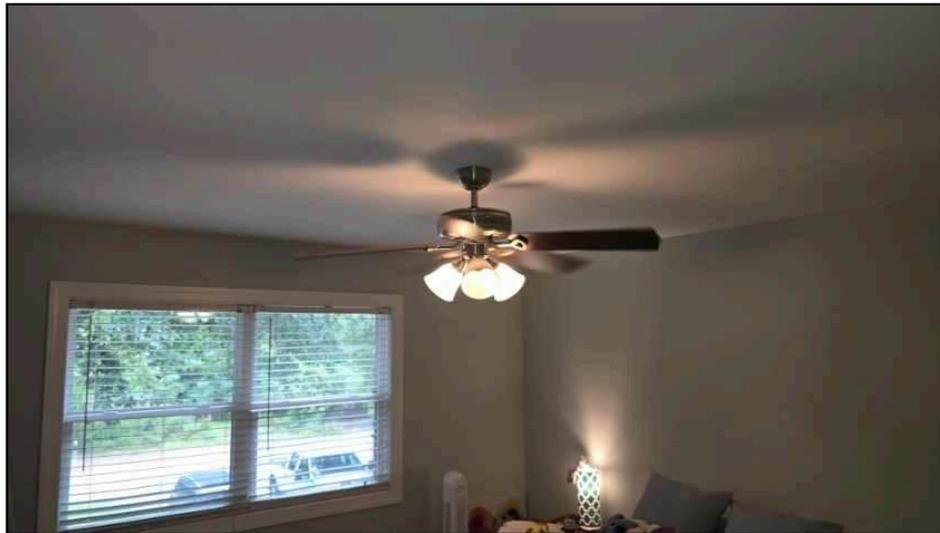
- The light switch and light operates as intended.

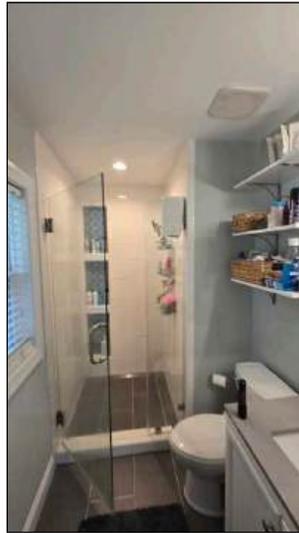
- The light switches in this bathroom operate as intended.

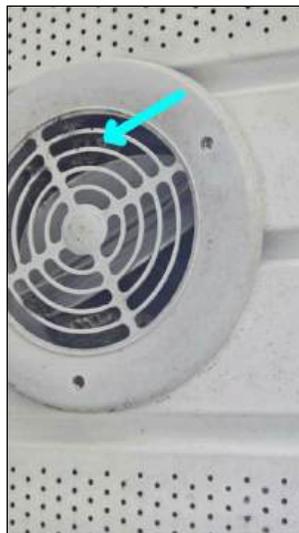
Wasp nest within the master bath exhaust fan exit cover, which may affect the operation of the damper. Removal suggested.

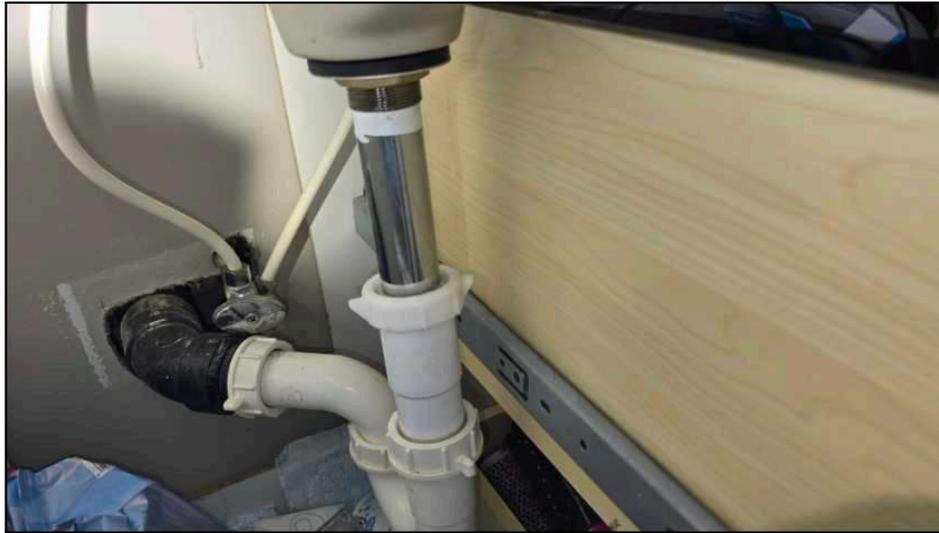
No leaks

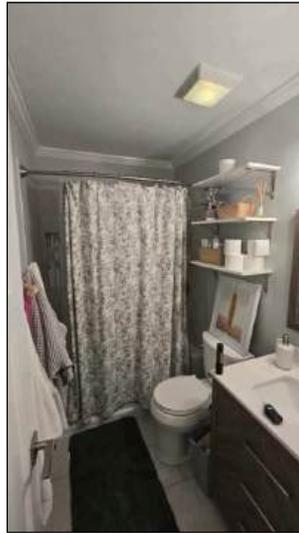
- The light switches in this bathroom operate as intended.

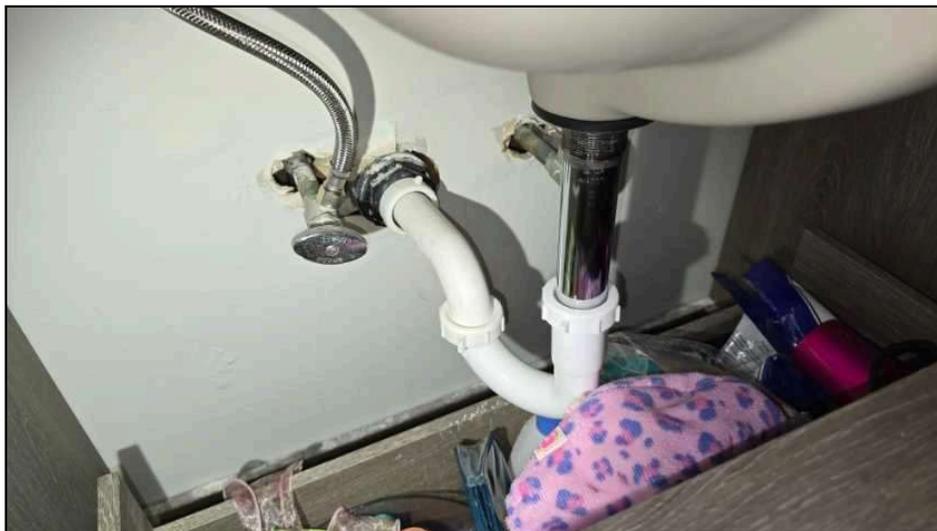
No leak observed
