Home Inspection Report

117 Noyes Ave, Morehead City , NC 28512

Wednesday July 16, 2025

288

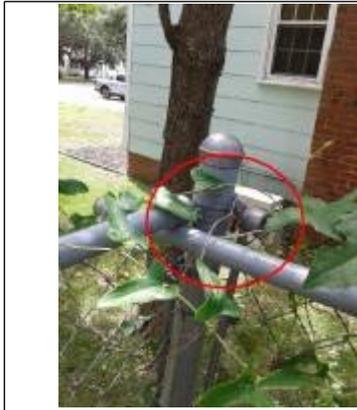
Disconnected railing.

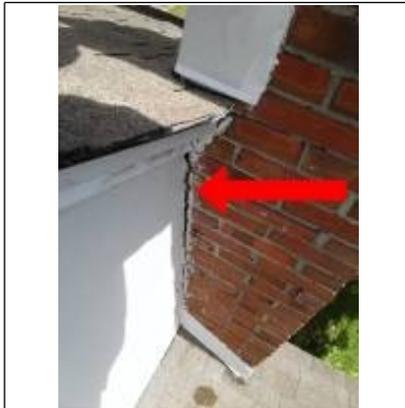
There is a large crack on the NW corner of the chimney. This will allow water penetration. I recommend a handyman fill this seam to prevent water penetration and further damage damaged. All monitor for further movement.

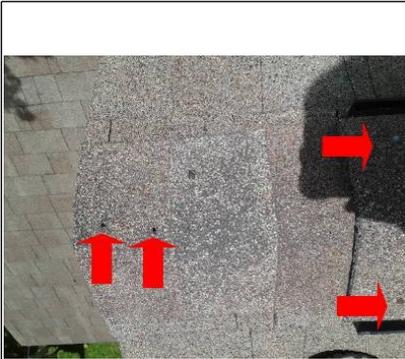
Two right arrows show nails that haven't been tarred over . The two up arrows show two small holes. Both can be taken care of of by a competent handyman with flashing cement. (Tar).

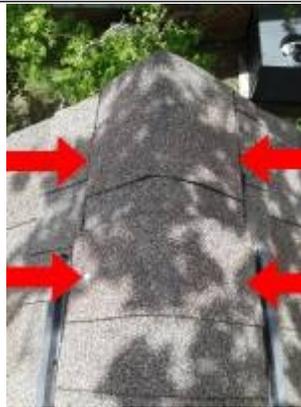
Four exposed nails here also. Flashing cement should be applied.

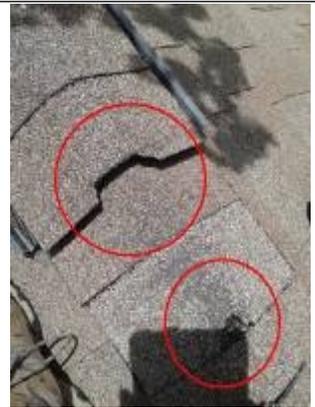
Flashing cement here also

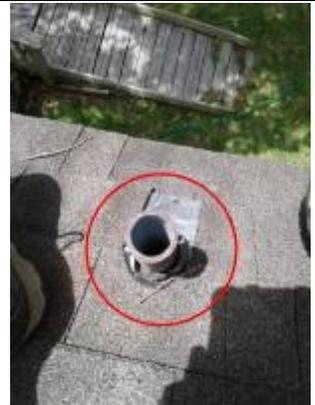
These both plumbing vents don't appear to be sealed. Again flashing cement is the choice id make to seal around the old lead BOOT and the plumbing vent.

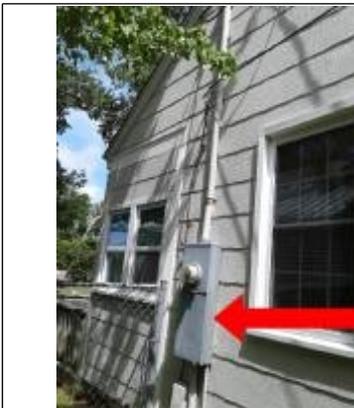
Main Panel and main breaker shut off for the house here.

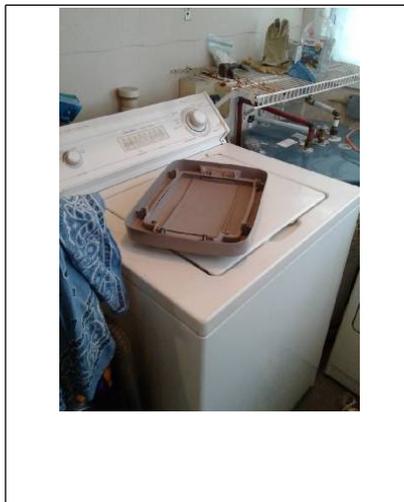
Vent hose doesn't go outside. I recommend a handyman create a opening of the exterior.

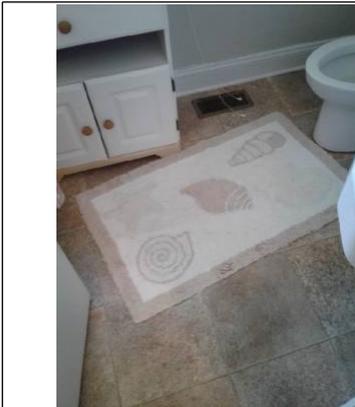
This left arrow receptacle trips the GFCI working properly. THE up arrow bottom half does not trip the circuit. I recommend a handyman evaluate and repair as for current safety standards.

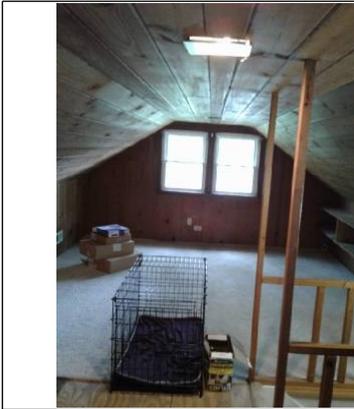
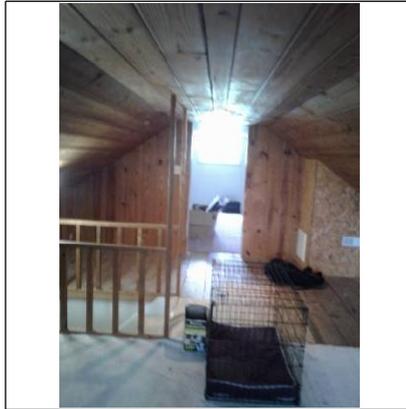
Comments There are HVAC vents and duct work but the owner has disconnected it from the system because of one thermostat downstairs and it doesn't balance well. I recommend consulting a honest COMPETENT HVAC contractor to reevaluate.

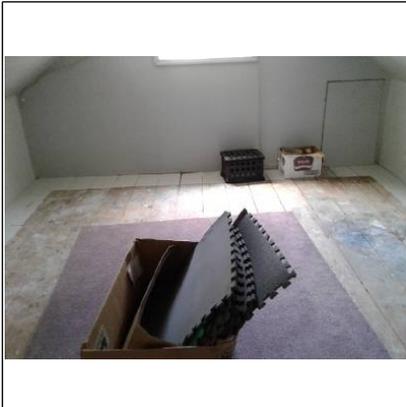
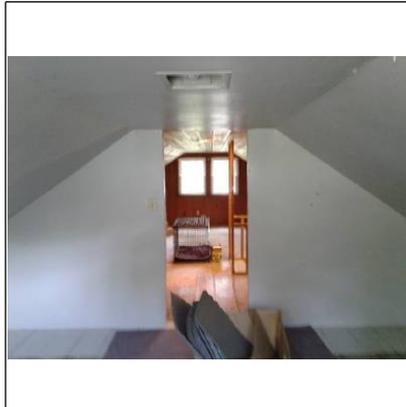
Comments Again HVAC SYSTEM is installed but disconnected at this time.

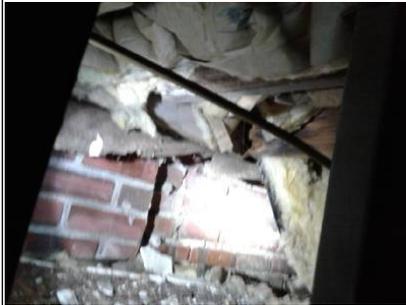
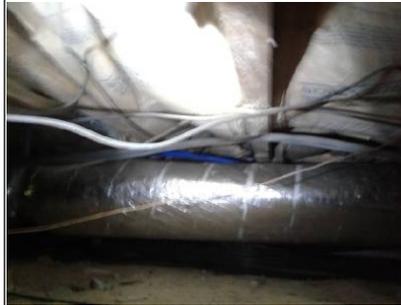
HVAC duct, plumbing pex pipe and wiring.

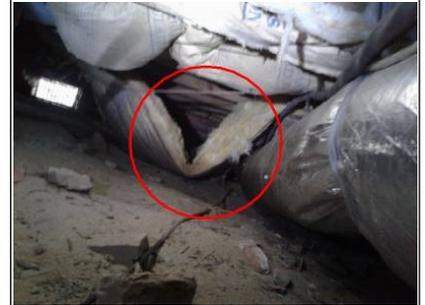
Falling delaminating insulation. There are a few places throughout the crawlspace that insulation can be reinstalled.

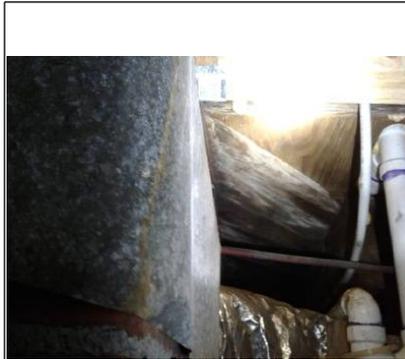
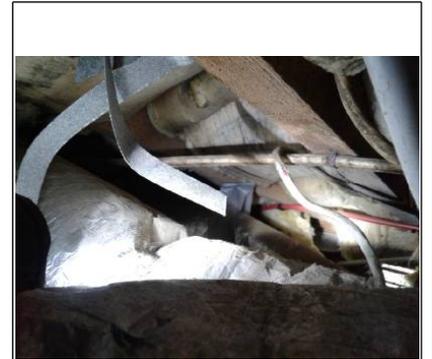
Example of moisture decay. Floor joists had at least 30 percent humidity and in places over 60 percent.

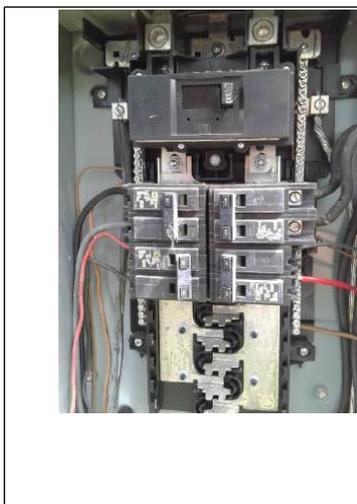
There is one screw missing here. I recommend adding it from hardware store?
