Worldwide ERC® Relocation Property Assessment

Transferee Property Address: 605 Ravenswood Road

City/State/Postal Code: Hampstead, NC 28443

Date: 07/09/2025 Time: 10:00 AM Weather: Cloudy Temp: 80 Estimated Age of Main Dwelling (yrs.): 38

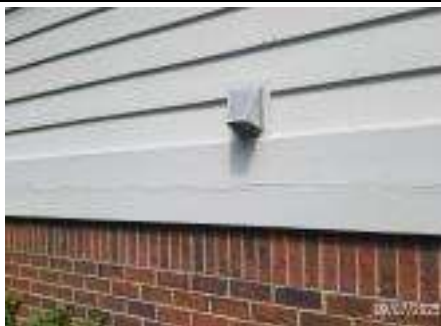
Split Trim at Front Left

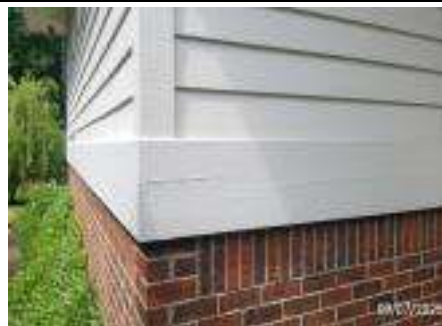
Split Trim at Front Left

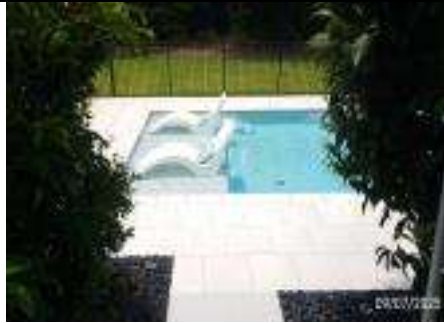
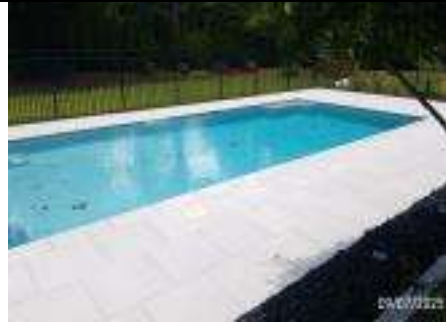
Variables such as construction type, conditions at the time of the assessment, safety, potential damage/liability and/or inspector discretion have limited the evaluation of this item at the time of this assessment. If applicable, further assessment should be considered.

Pool Not Evaluated
