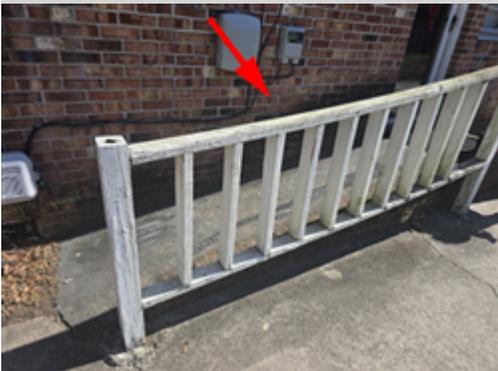
(B3 - 1.8) Porch

Also repair: damaged and loose right side porch handrail.

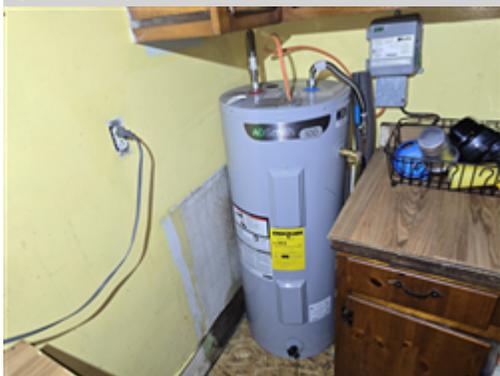
(D3 - 1.1) Unit #1

M# E6-30H45DV 100
S# 2409138061337

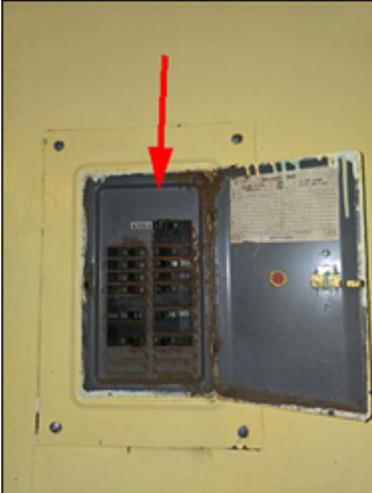
(E2 - 1.1) Main Panel #1

View of main electrical service panel in kitchen, cover on.

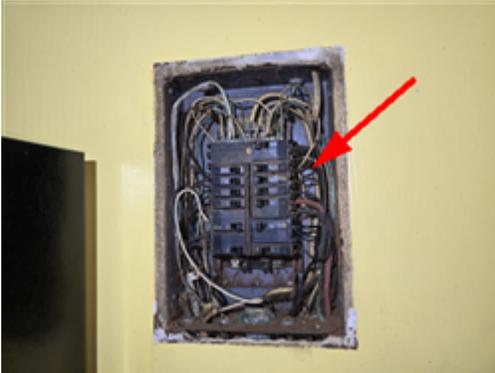
(E2 - 1.2) Main Panel #1

View of main electrical service panel in kitchen, cover off.

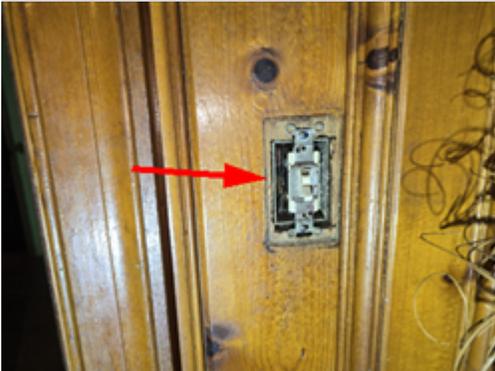
(E5 - 1.5) Interior and Exterior

Additional Photograph: This is a photograph of above noted item 1-1

-Comment # 5

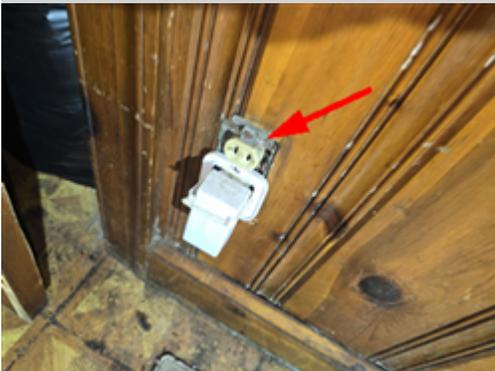
(E5 - 1.6) Interior and Exterior

Additional Photograph: This is a photograph of above noted item 1-1

-Comment # 5

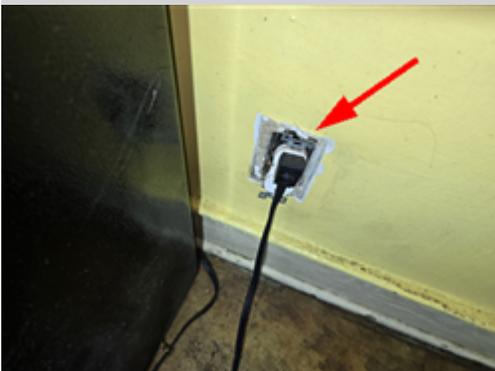
(E5 - 1.7) Interior and Exterior

Additional Photograph: This is a photograph of above noted item 1-1

-Comment # 5

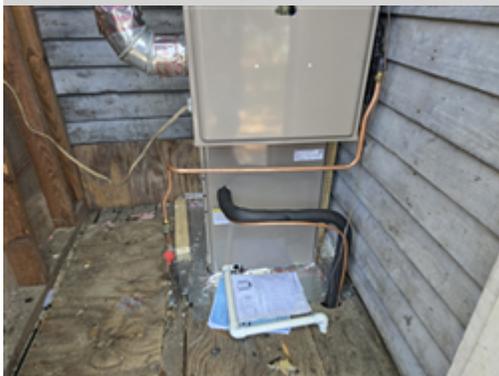
(F1 - 1.1) Heating Unit #1

View of gas furnace:

M# Z8ES080B12SMPS1A
S#C2H4650846

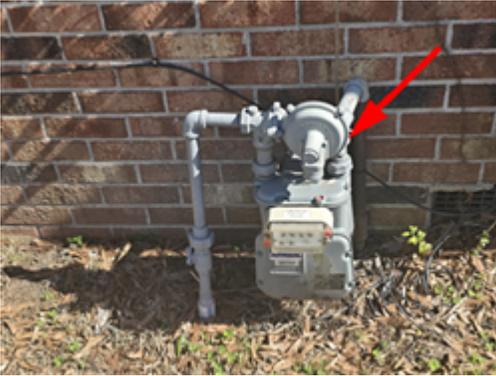
(F3 - 1.1) Exterior

View of gas service meter on rear of home.

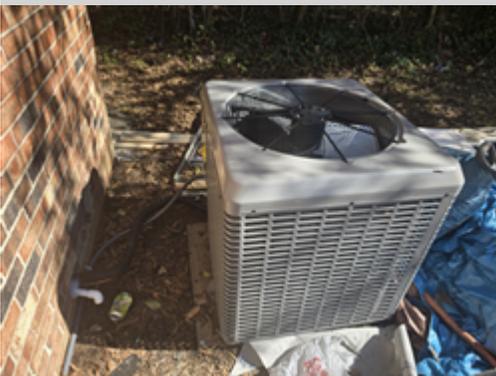
(G1 - 1.1) Cooling Unit #1

View of exterior A/C unit.
New unit.

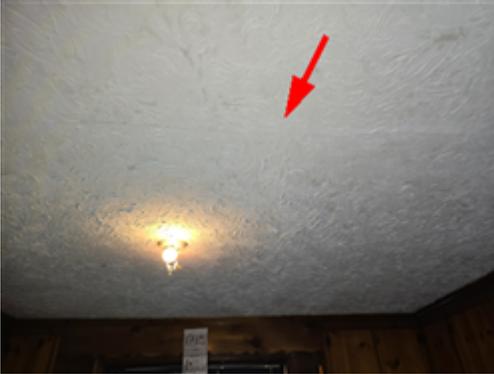
(H1 - 1.2) All Rooms

Random cracks were noted on ceiling of most bedrooms and in the kitchen area. The ceiling is cracked. No related concerns were noted throughout the adjacent inspection areas. The buyer should review the area of concern. If additional concerns or questions are present, invasive inspection and repair will be needed. A general repair specialist should be consulted for evaluation and repair to ensure that the ceiling is secure.

Additional Photograph: This is a photograph of above noted item 1-1

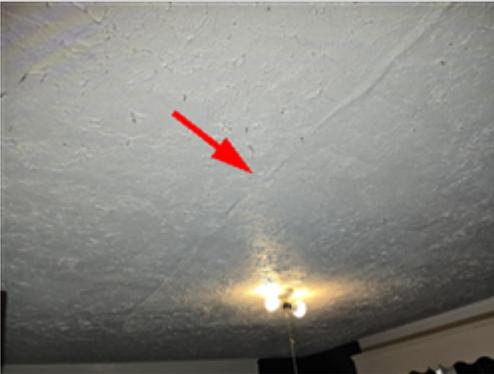
(H1 - 1.3) All Rooms

Additional Photograph: This is a photograph of above noted item 1-1

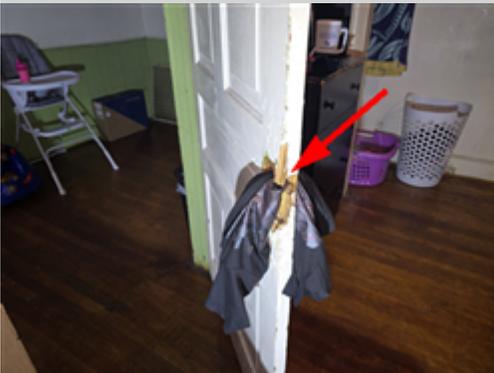
(H1 - 1.4) All Rooms

The door jambs at left front and right front bedrooms are split in the striker plate areas where the door lock is engaged to provide security. This could indicate improper installation or forced entry of the door. The door needs repair/replacement to ensure that the door closes securely and operates properly. A general repair specialist or licensed general contractor should be consulted for evaluation and repair.
