## Pre-listing Home Inspection Report

242 Black Bear Way, Ellsworth , ME 04605

Friday July 10, 2026

071026

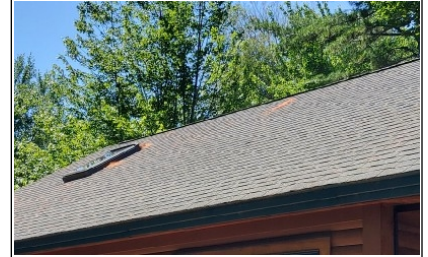
Roof covering

Asphalt shingles serving the home appears to be in satisfactory condition. There were no signs of active or past roof leaks observed in the home at the time of this inspection

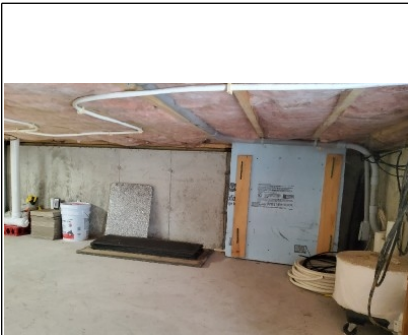
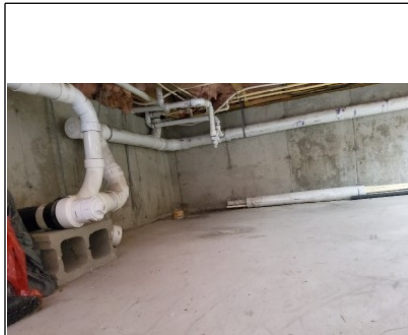
**Comments** Foundation showed only typical minor shrinkage cracks.  
 Foundation appeared to be in overall satisfactory condition.

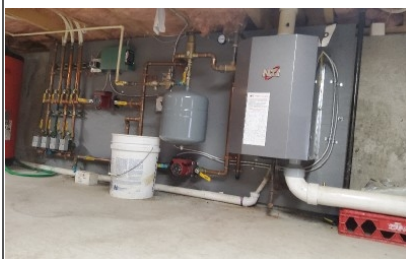
**Comments** Boiler was in normal working order at the time of the inspection.

Propane on demand hot water boiler

Recommend on demand hot water boiler be cleaned and serviced

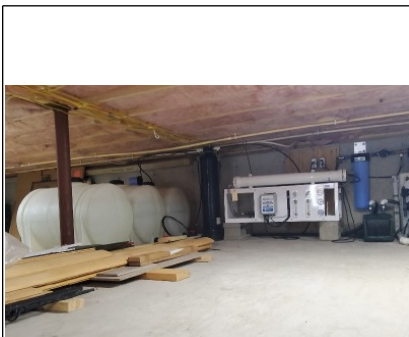
The owner disclosed that the water treatment system is serviced annually by a qualified water treatment company. Portions of the equipment are drained and stored off site by the contractor and reinstalled each year.

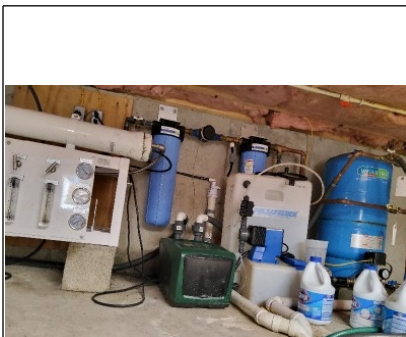
Filters and water treatment system

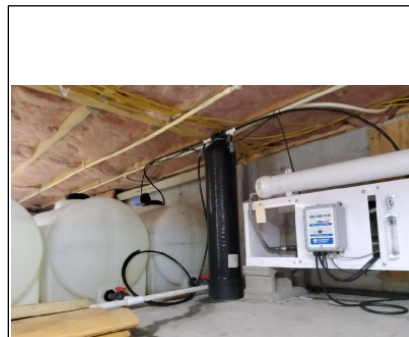
Carbon filter

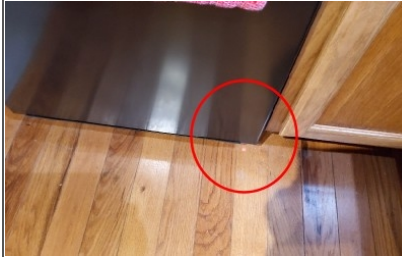
Dishwasher light indicator
