**CERTIFIED INSPECTION
SERVICES Inc.**

Home Inspection Report

17 Main Street, Albion, AK 04910

Friday November 8, 2024

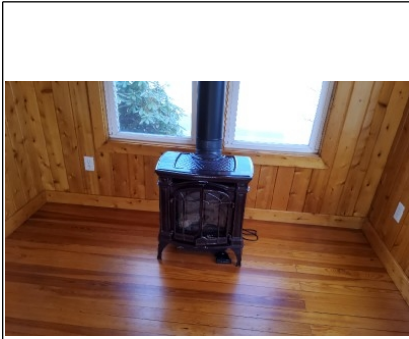
Propane heat stove is not ignited.
Inspectors can not ignite propane
heat stoves or appliances

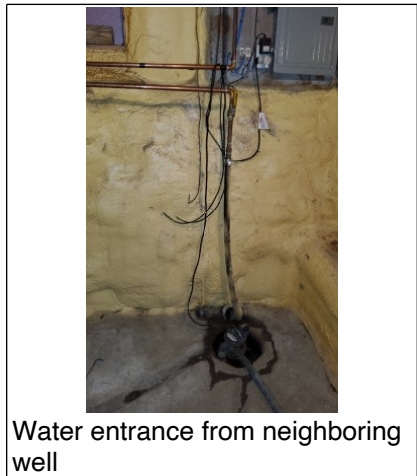
Water entrance from neighboring well

It was disclosed the water serving the home is served by a neighboring well. The water pressure is provided outside of the home.

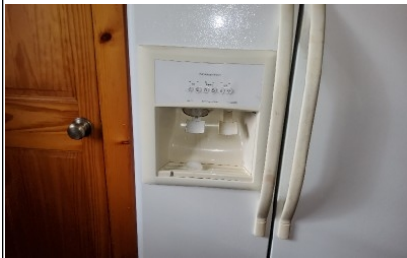
Ice and water dispenser is operational
